CORNER RESTORATION

CORNER: 1/4 corner between Sections 27 & 34,
T2N, R23E, W.M.

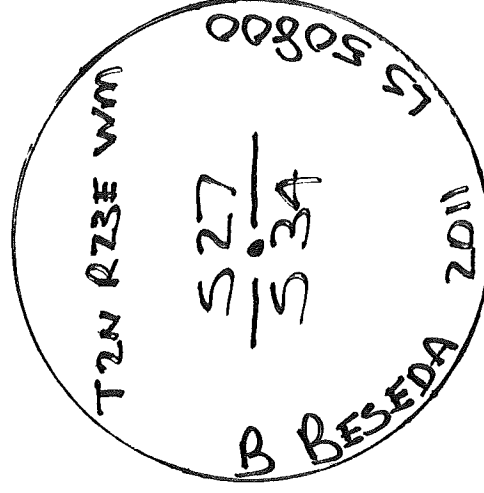
No evidence of the original corner was found. Corner position falls at the intersection of a road running to the west and a north-south fence. The fences have been built and rebuilt in the same location to the north and south. Cultivation has occurred for many years on both sides of the fence, creating a large berm along the fence. The road has also been in place for a long period of time with field cultivation up to both sides.

With no traces of the original monument found, the corner position was accepted to be at the intersection of the road centerline to the west and the ancient north-south fence.

Set 5/8" x 30" rebar with 2-1/2" diameter stamped aluminum cap at the 1/4 corner position.
Monument is set 0.1 feet +/- out of ground.

The following references being 5/8" x 30" rebar with yellow plastic cap stamped "B BESEDA PLS #50800" were set flush with natural ground and bear as follows from the section corner, unless otherwise noted.

1. North 49°30'49" West 47.12 feet. Set at east end of fence
2. North 27°23'30" West 36.09 feet.
3. North 22°29'35" East 18.97 feet.
4. South 00°10'24" East 24.81 feet. Set in north south fence.
