CORNER RESTORATION

CORNER: Corner common to Sections 33 & 34, T2N, R23E and Sections 3 & 4, T1N, R23E, W.M.

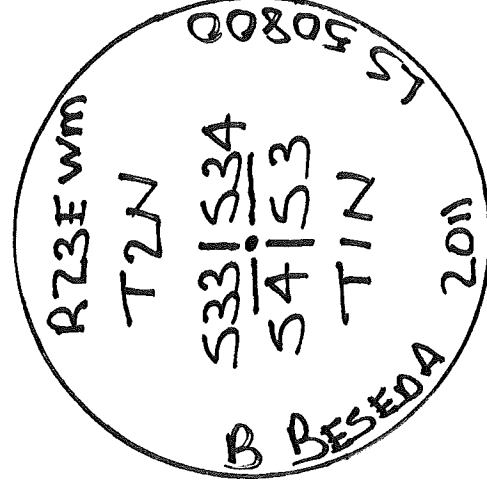
Corner position falls at the intersection of ancient fences running north and east from this location. There is a newer east-west fence that was rebuilt 15 feet south of this position. No evidence of the original corner was found.

With no traces of the original monument found, the corner position was accepted to be at the intersection of the ancient fences running north and east from this location.

Set 5/8" x 30" rebar with 2-1/2" diameter stamped aluminum cap, at the 1/4 corner position.
Monument is set 0.1 feet +/- out of ground.

The following references being 5/8" x 30" rebar with yellow plastic cap stamped "B BESEDA PLS #50800" were set flush with natural ground and bear as follows from the section corner, unless otherwise noted.

1. North 60°55'58" East 17.82 feet.
2. South 75°25'26" East 39.79 feet.
3. South 30°35'21" East 19.39 feet.
4. South 42°23'10" West 23.26 feet.
