# Columbia River Heritage Trail Sign Report

JUNE 27, 2023

Report prepared by the Morrow County  
Planning Department.

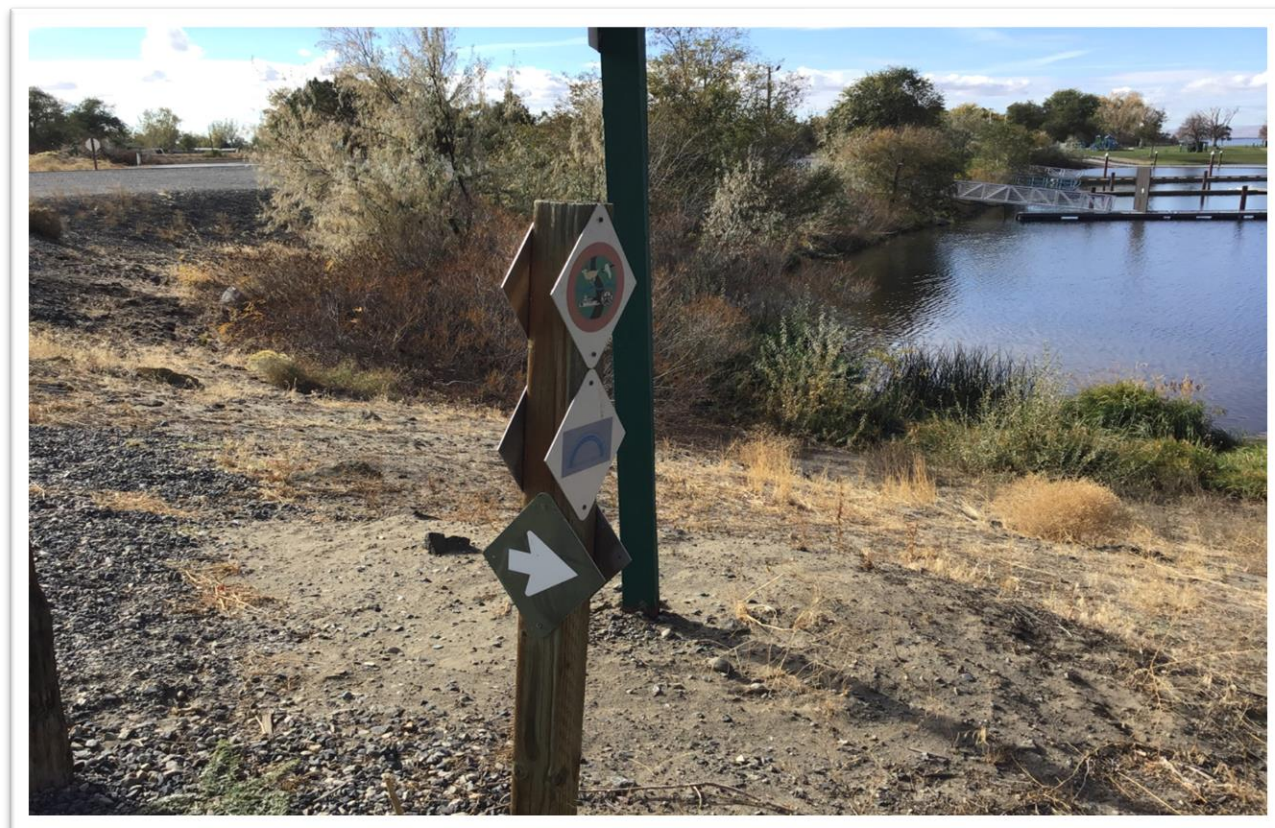
**Figure 1:** Located at Boardman marina park

The trail marker shown in Figure 1 will require new stickers to be posted on the metal placard. The sticker “Columbia River Heritage Trail” and “City of Boardman” have faded.

The Birds of River, Shoreline interpretive panel shows signs of extreme weather damage. This sign is located in a key spot along the river and without any restorative measures this sign will continue to be an eye-sore for those using this portion of the Heritage Trail. Subsequently, this interpretive panel now fails to educate trail goers on it's given material.

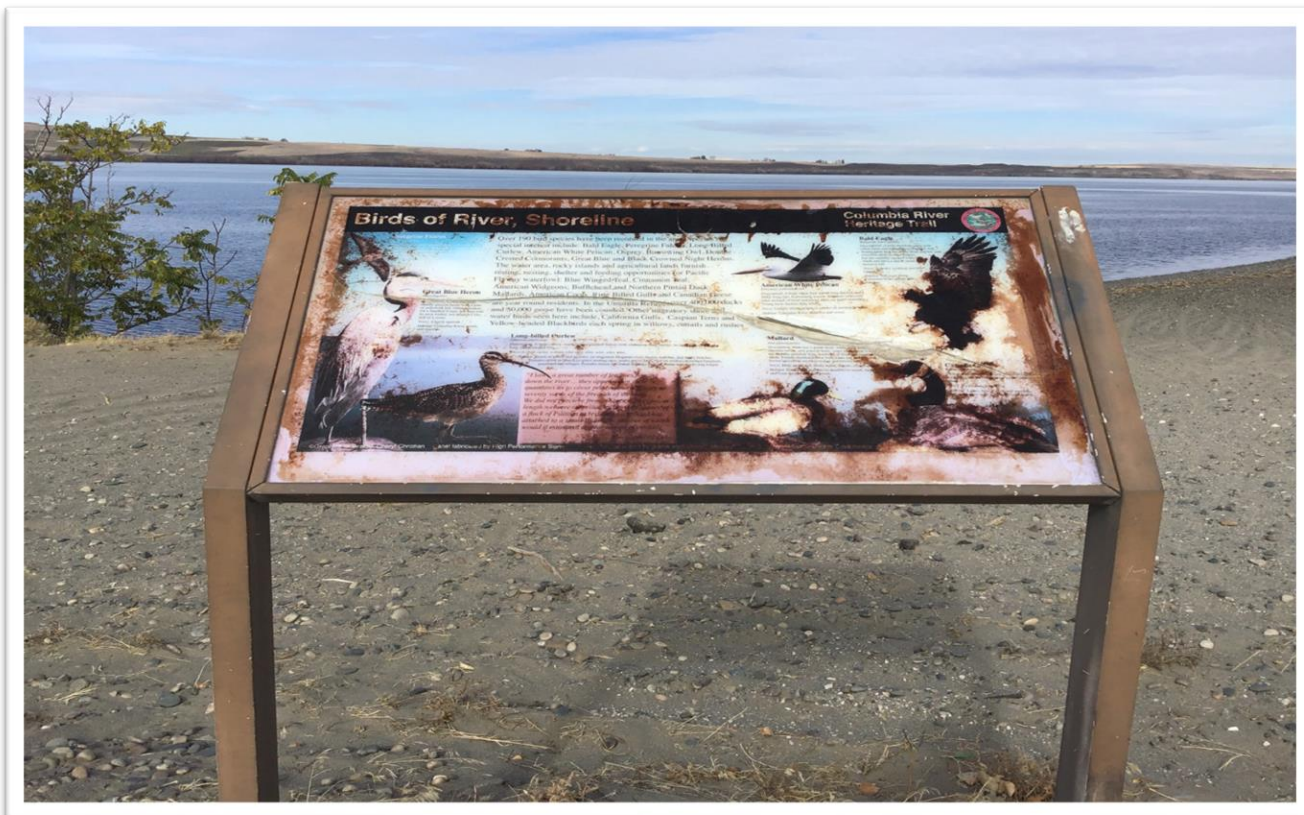
Figure 2: located at 45.846917° N and 119.701429° W

The next trail marker is halfway through section two, near the Port of Morrow offices. Although this is posted near the offices, it still falls within the borders of section two of the *Heritage Trail* as described in the concept plan. This sign will need to be replaced due to vandalism. It has been spray painted and part of the sign is no longer visible. This post is missing a *CRHT* which could be added to maintain consistency with Boardman Parks and Recreation District.

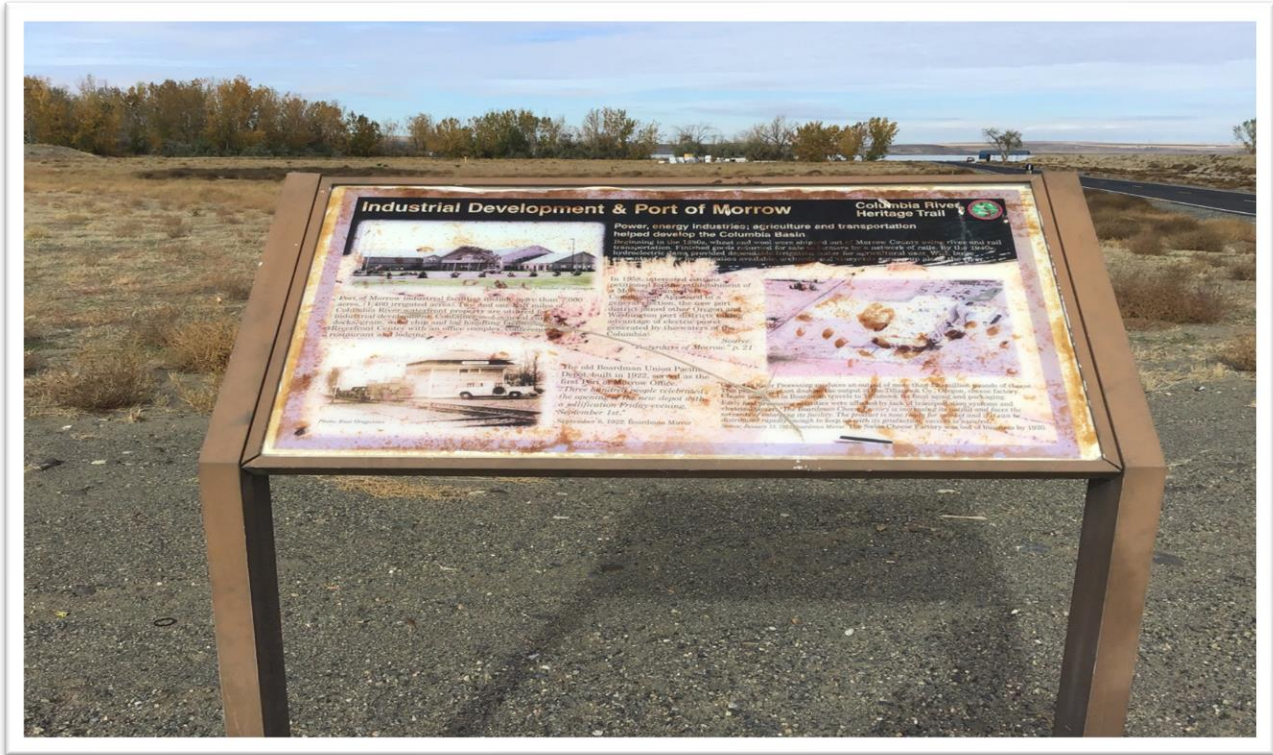
**Figure 4:** Industrial Development & Port of Morrow located at 45.848753° N and 119.688655° W

The first trail sign that can be found in this section of the *Heritage Trail* is an interpretive panel. This panel depicts some of the industrial development that has taken place in the Port of Morrow. This sign has suffered from damage due to the intense sun exposure it receives. The text from the panel will need to be replaced. The rest of this sign is in good condition showing no evidence of vandalism (see fig. 4).

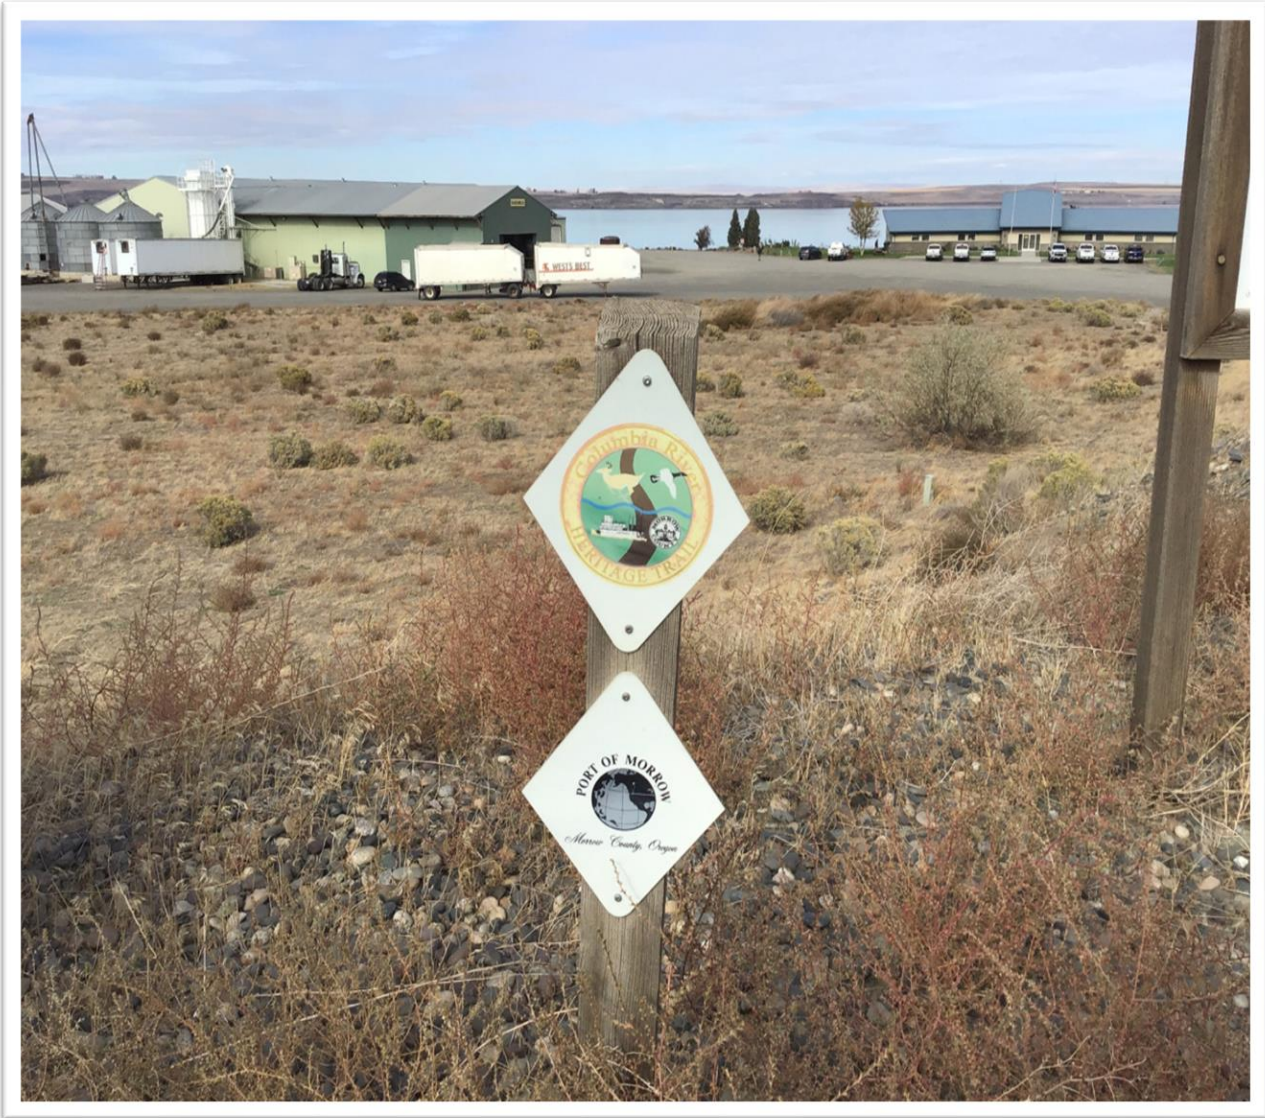
Figure 5: located at 45.850999° N & 119.675869° W

Directly adjacent to the interpretive panel, this trail marker sign has been partially “sun washed.” While this sign can still be used to navigate this portion of the trail, it would be beneficial to replace the logo sticker (see fig. 5).

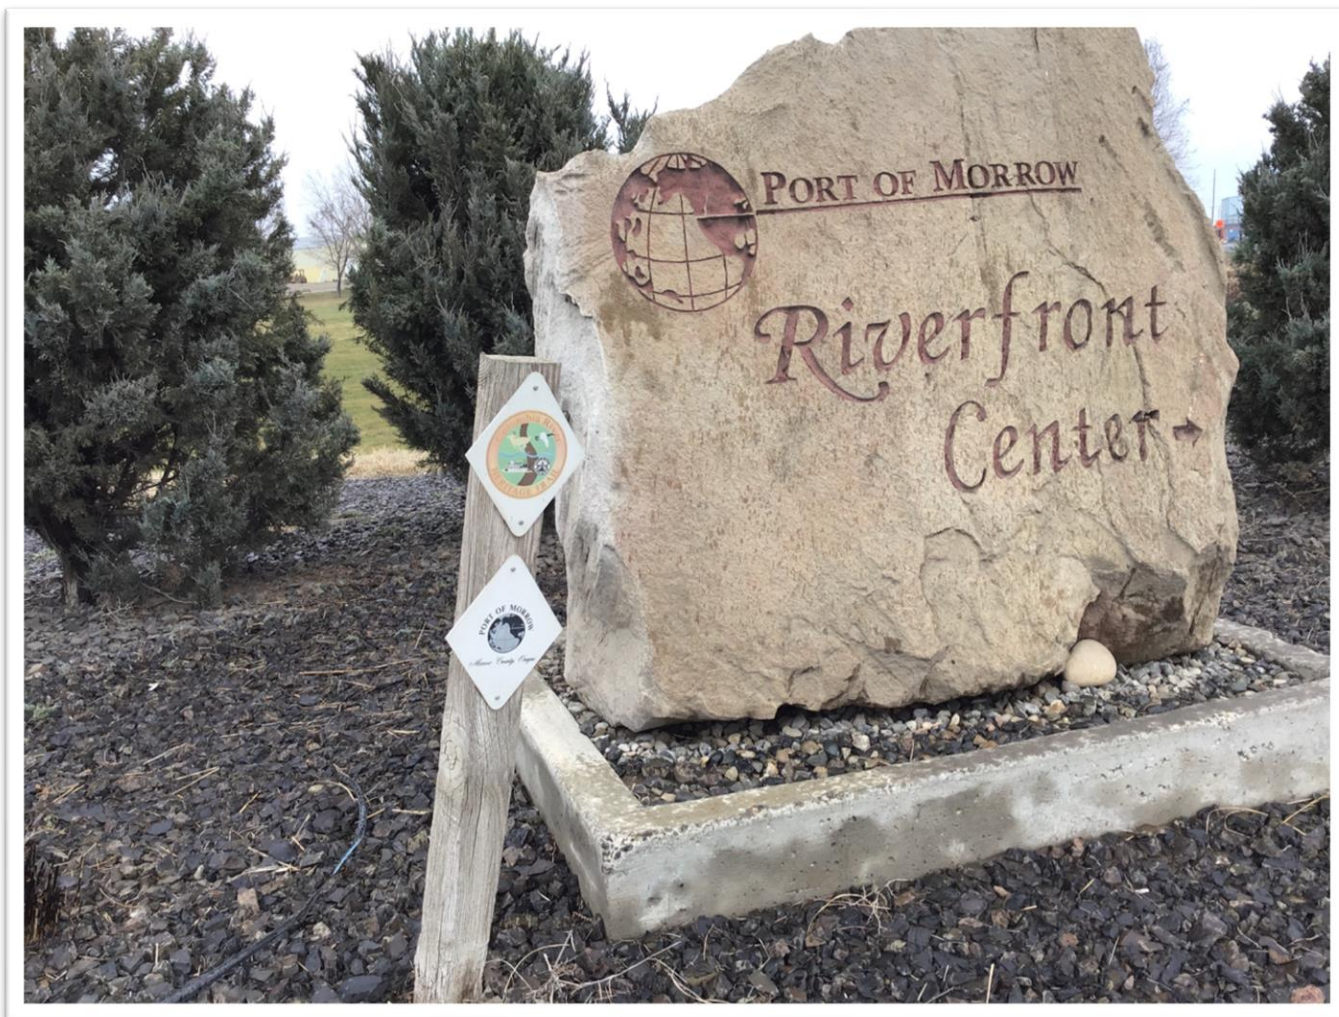
Figure 6: located at 45.842967°N & 119.675778°W

The second trail marker in this section is located at the corner of Ulman Boulevard and Columbia Avenue. This sign will need to have its logo sticker replaced because of the sun damage it has received. While this sign is still visible it no longer fits within the goals outlined at the beginning of this report – goal three, help promote use. This specific sign is in an area where Port and employees in the industrial area could begin their walk of the *Heritage Trail* (see fig. 6).

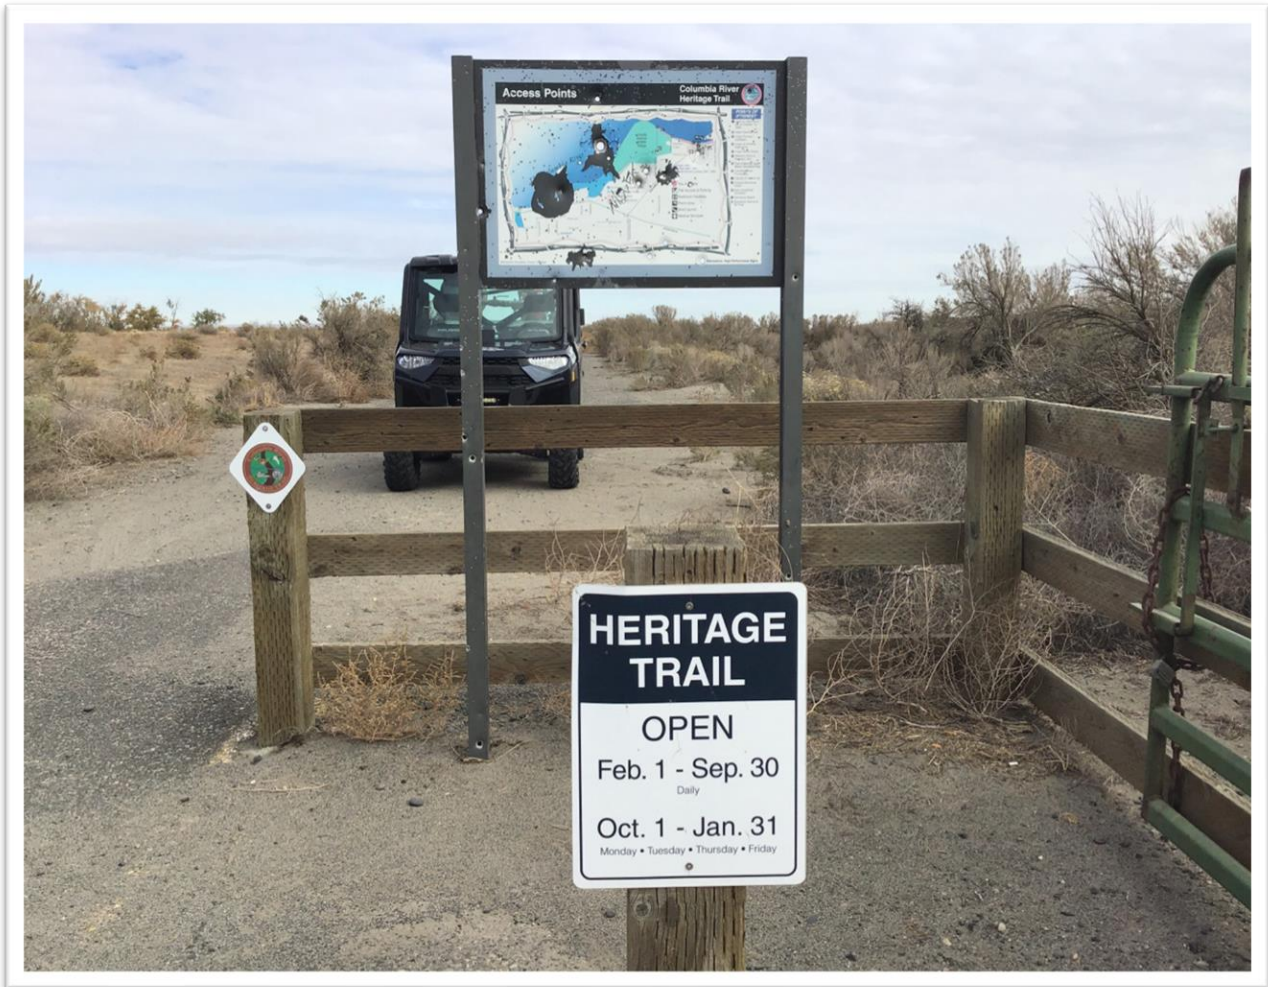
**Figure 7:** located at 45.878897° N and 119.610537° W

The interpretive panel located at the western access point of the trail on the Refuge has multiple gunshot holes. (see fig.7 below). This makes for an unsalvageable base plate on this sign. There will need to be a new base plate installed and a new map placed.

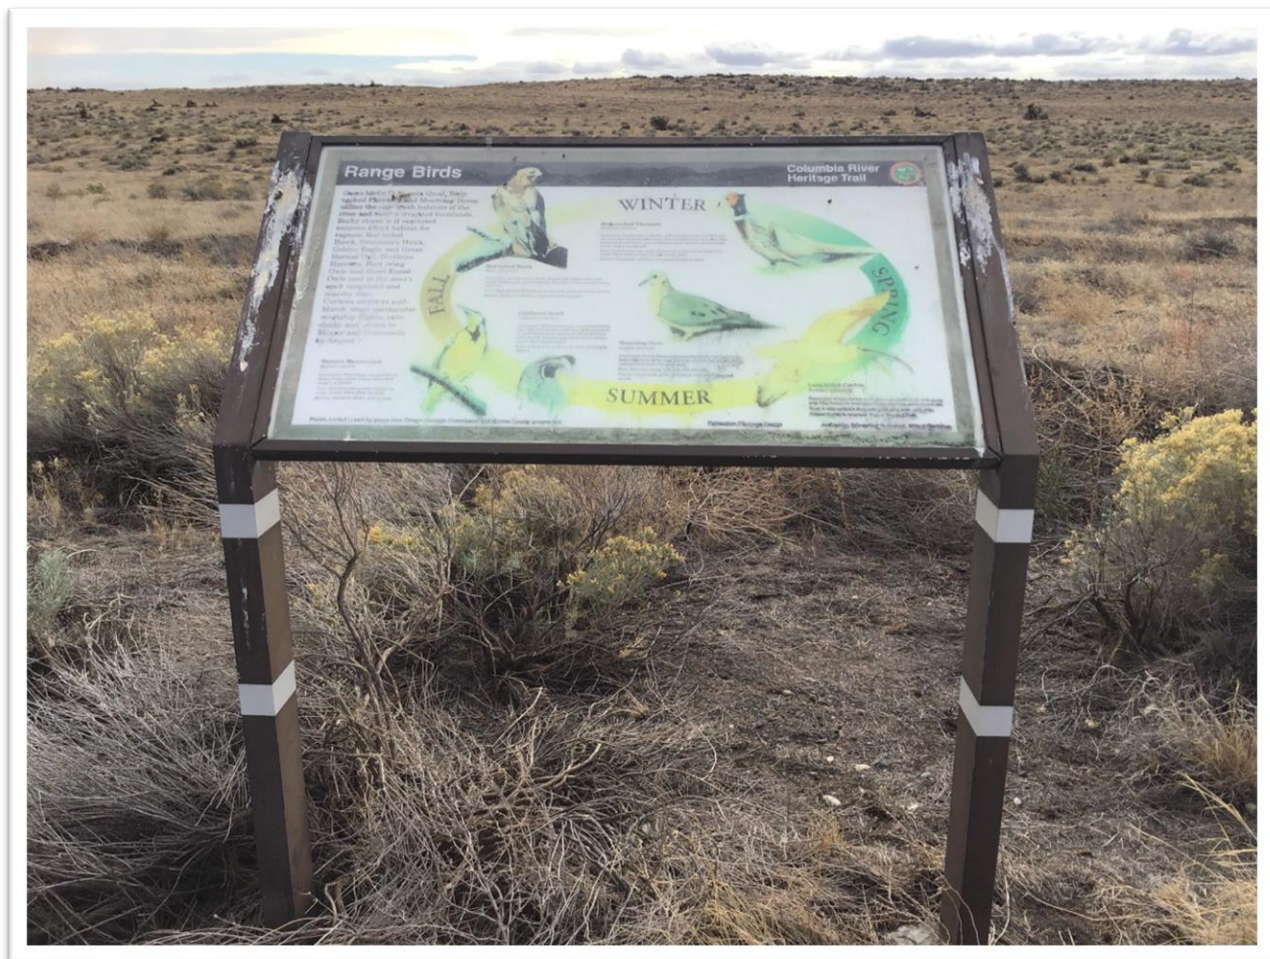
Figure 8: located at 45.885790° N and 119.597867° W

The range birds interpretive panel has suffered from sun damage. This can be fixed by new graphics being inserted. The rest of this sign and the sign structure is in good condition (see fig. 8).

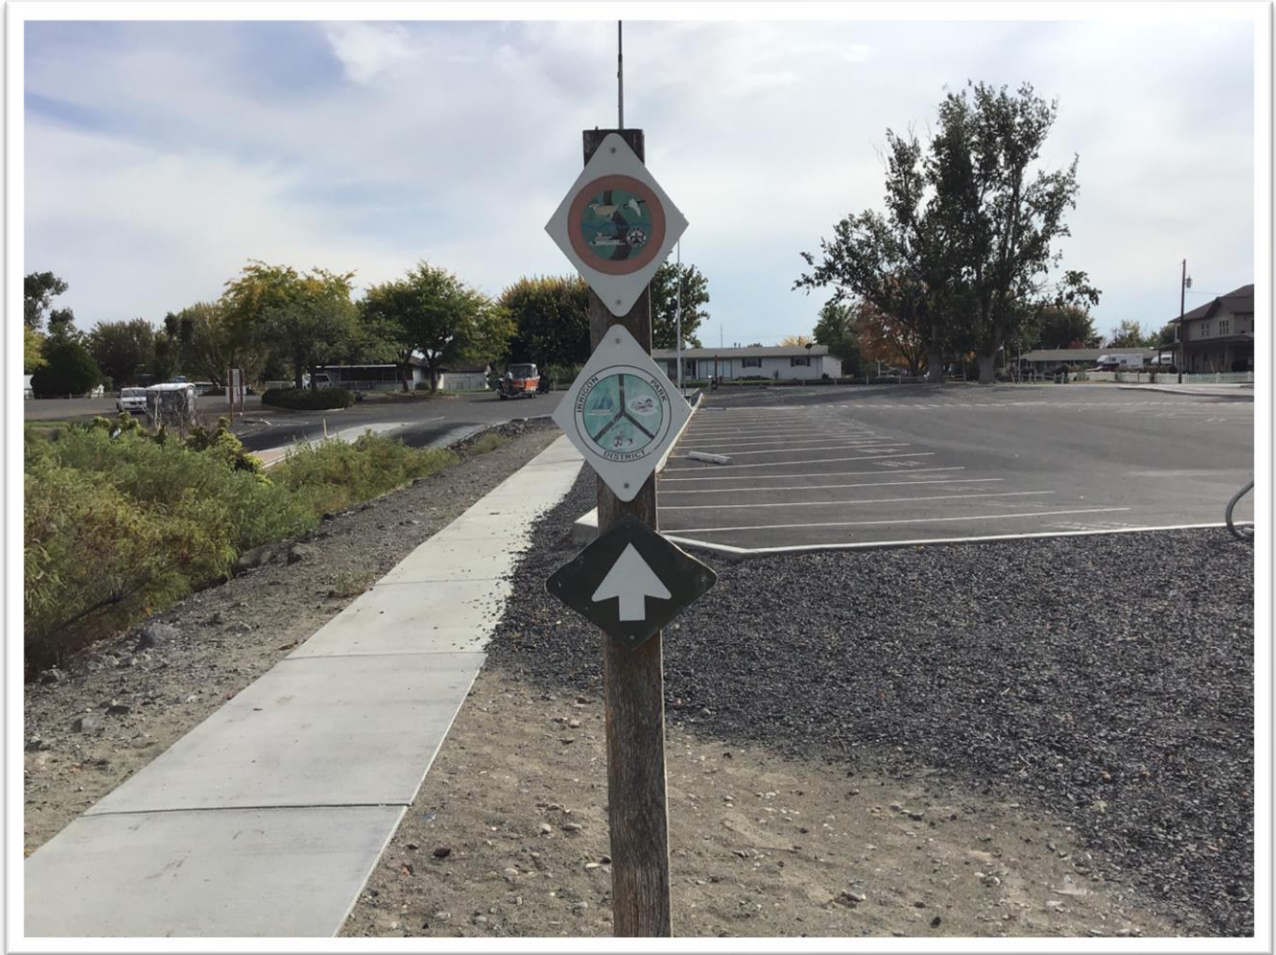
**Figure 9:** located at 45.901175° N and 119.492282° W

Section V of the *Heritage Trail*, better known as the City of Irrigon section, begins near the fish hatcheries and continues to the edge of the Irrigon Marina Park. Signs begin near the boat launch in the marina and are placed throughout the rest of the area. Section managers include, the Army Corp of Engineers (ACOE), and Oregon Department of Fish and Wildlife (ODFW). Many of the trail markers in this section have suffered from a significant weathering. The first of these damaged signs is in the parking lot of the boat launch at the marina park. This weather damage is significant and the text on the decal is no longer visible (see figure 9).

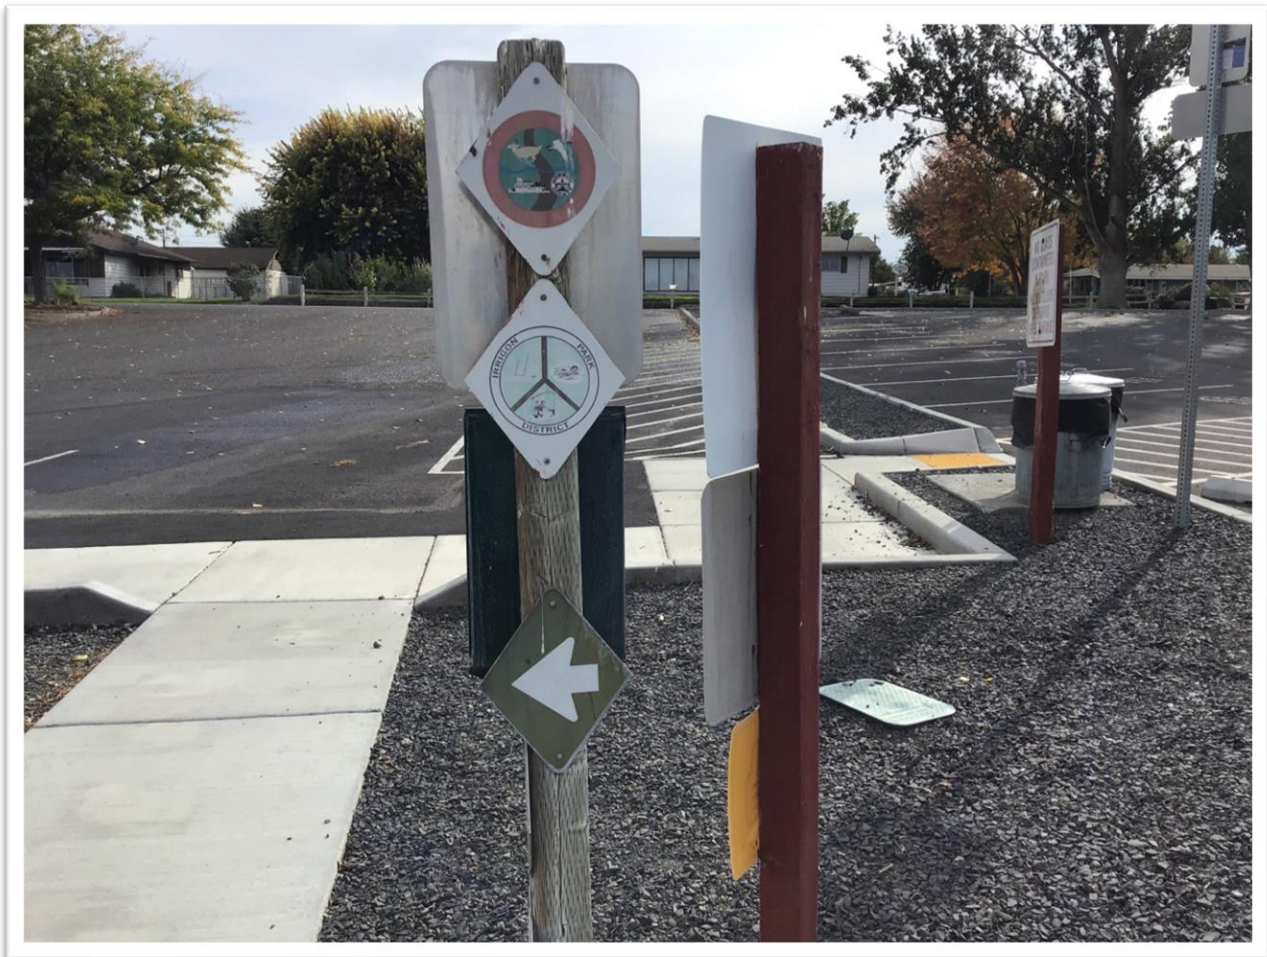
**Figure 10:** located at 45.900720° N and 119.492230° W

This trail marker sign is located only a few yards away from the previous and suffers from many of the same weathering effects. There is no longer any visible text on this decal and there is what appears to be white paint covering some part of the graphic (see figure 10).

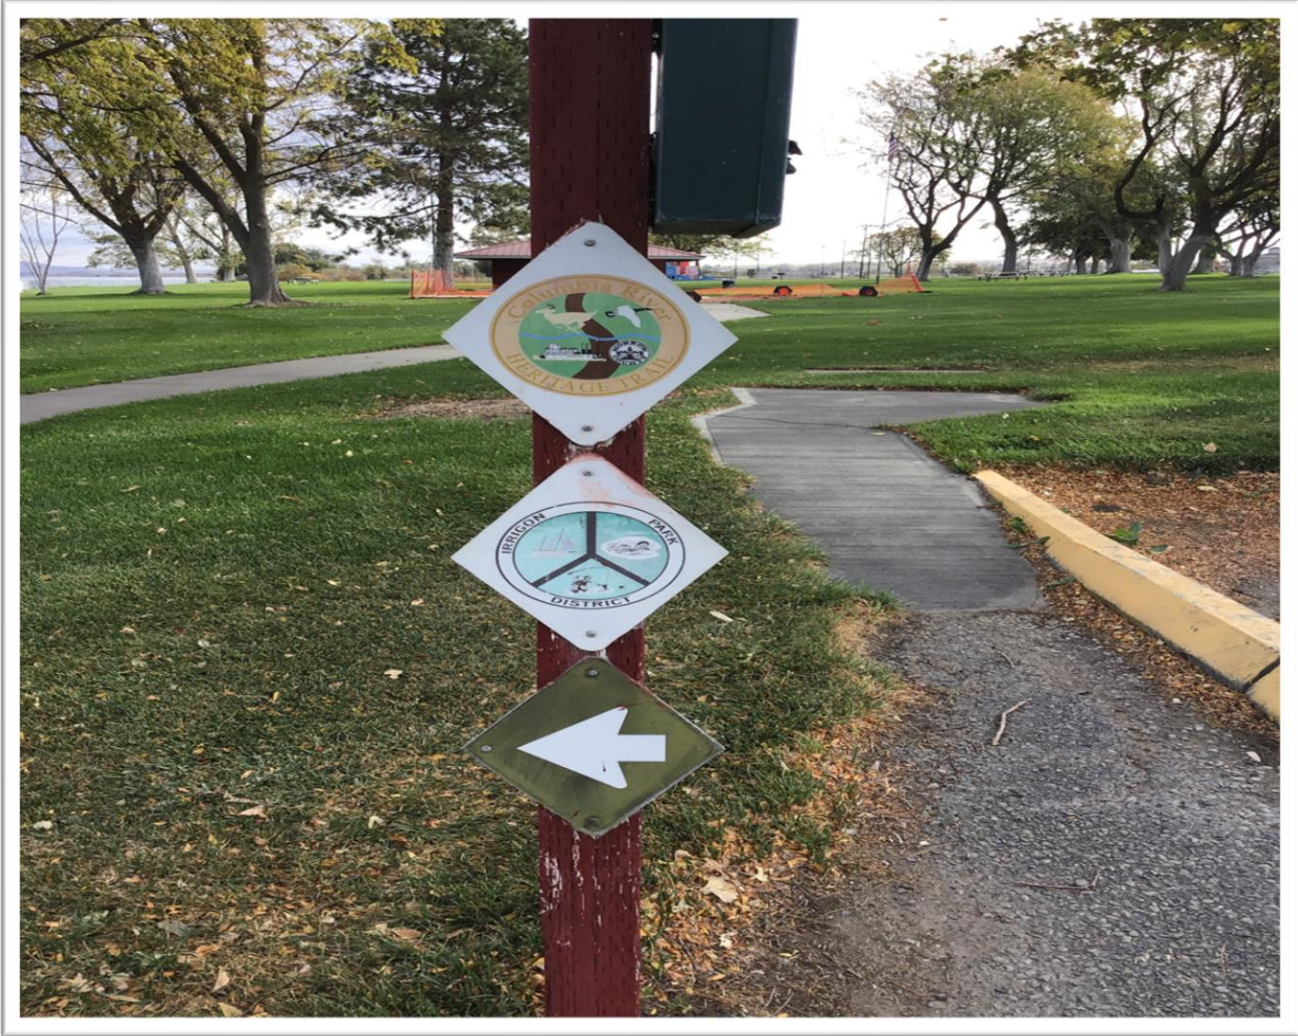
Figure 11: located at 45.900650° N and 119.490882° W

On the east side of the Irrigon boat launch area there is another trail marker and two interpretive panels. This trail marker sign suffers from similar general wear and tear that is seen on other signs in this area. This sign, however, has not experienced the same level of weather exposure as other signs in this area (see fig. 11).

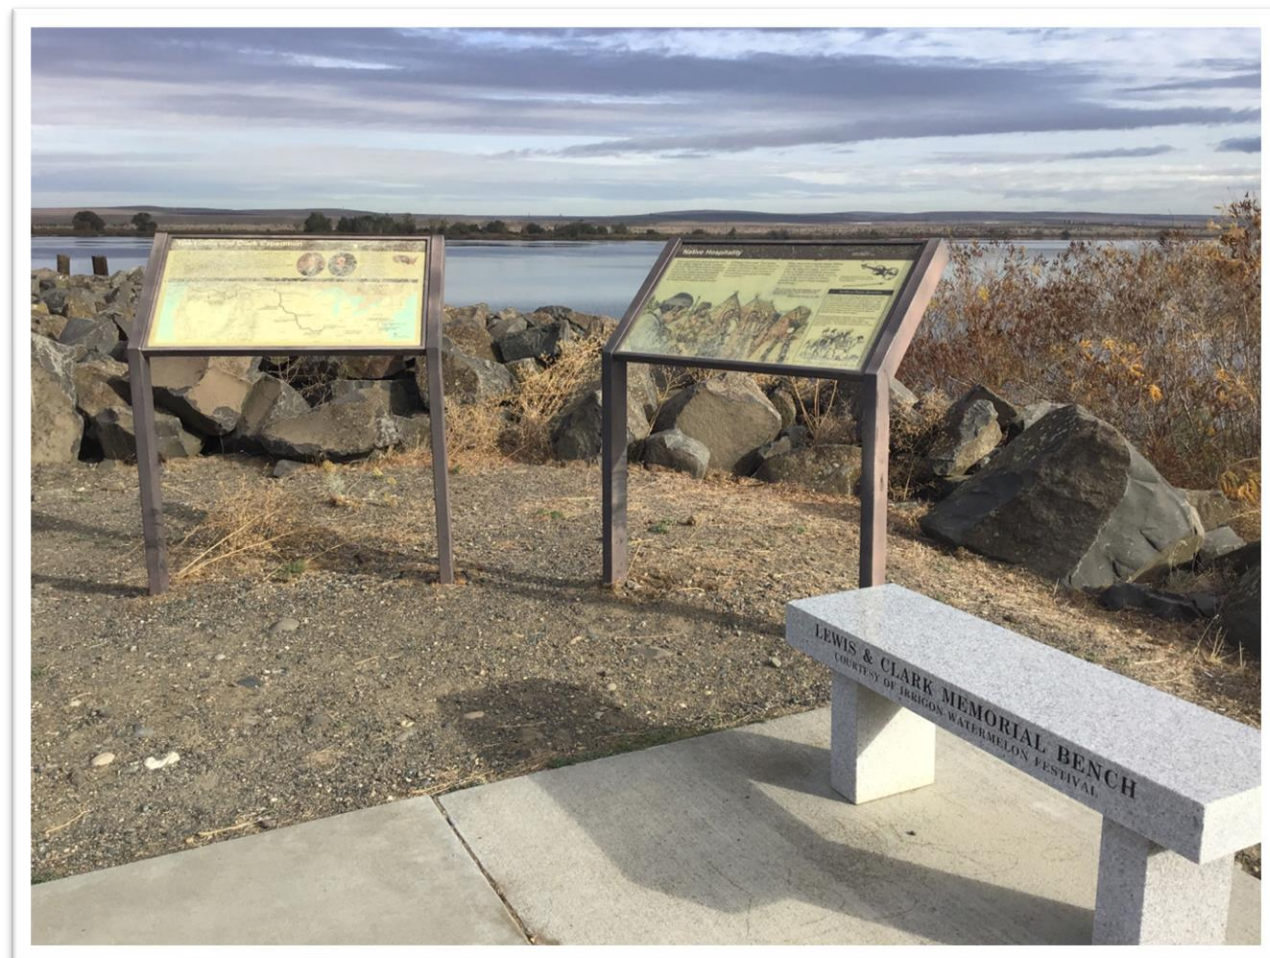
**Figure 12:** located at 45.901210° N and 119.490868° W

The two interpretive panels in the Irrigon marina area are next to the Lewis and Clark Memorial bench. These two signs have serious sun damage and have become difficult to read. There is nothing on these interpretive panels which directly connects them to the C.R.H.T. Where this area is owned by the ACOE and managed by Irrigon Parks District a consultation with ACOE and environmental applications will be required before replacing any structure that impacts that includes ground disturbance (see fig. 12).

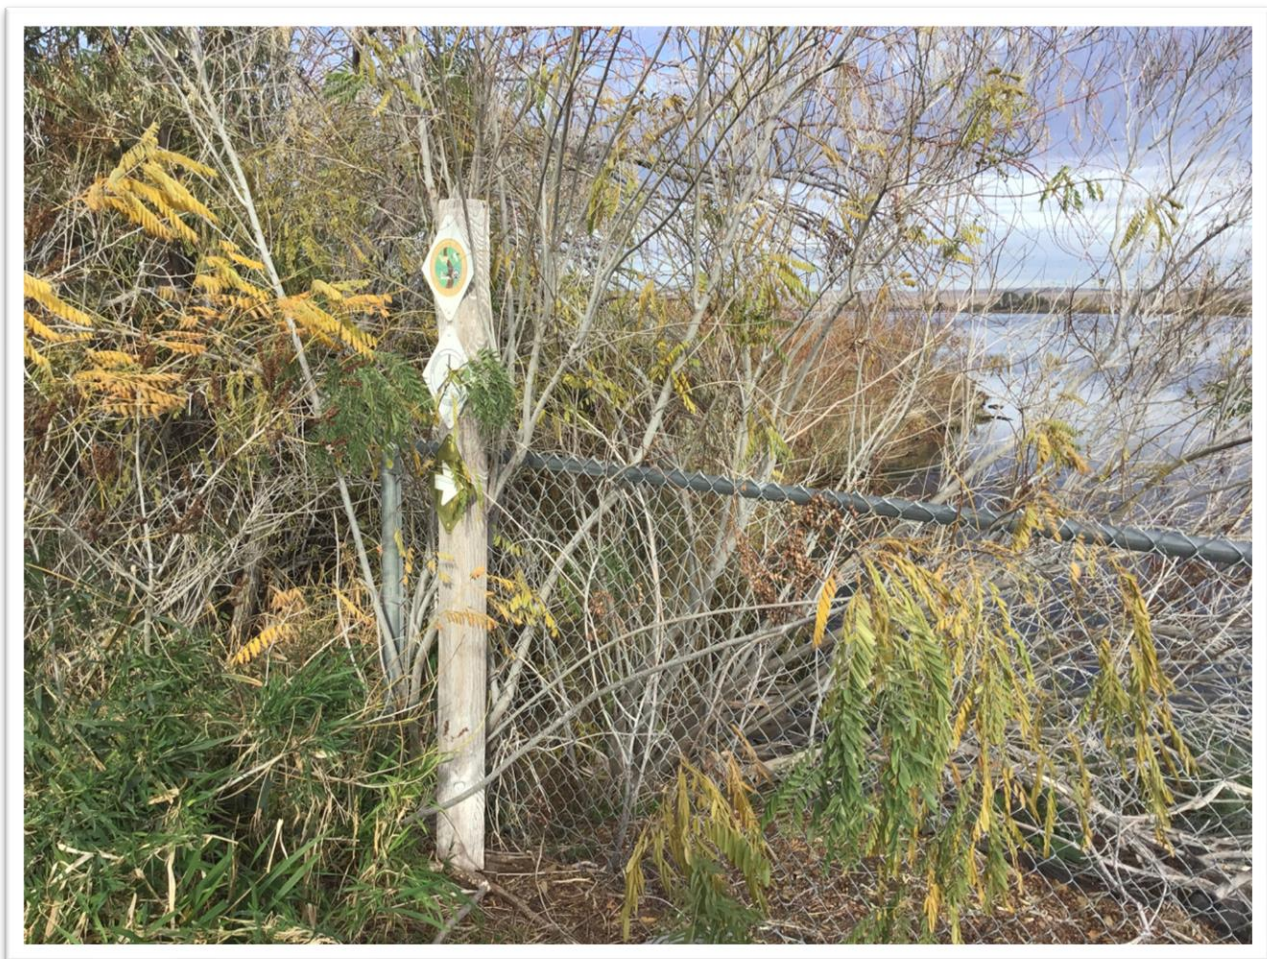
**Figure 13:** located at 45.900936° N and 119.490501° W

This next trail marker, like others, will need to have the graphic replaced because of sun exposure. Unlike the other signs in this area, there are some trees that partially block the sign. Removing overgrowth would enhance visibility and accessibility of this section (see fig. 13).

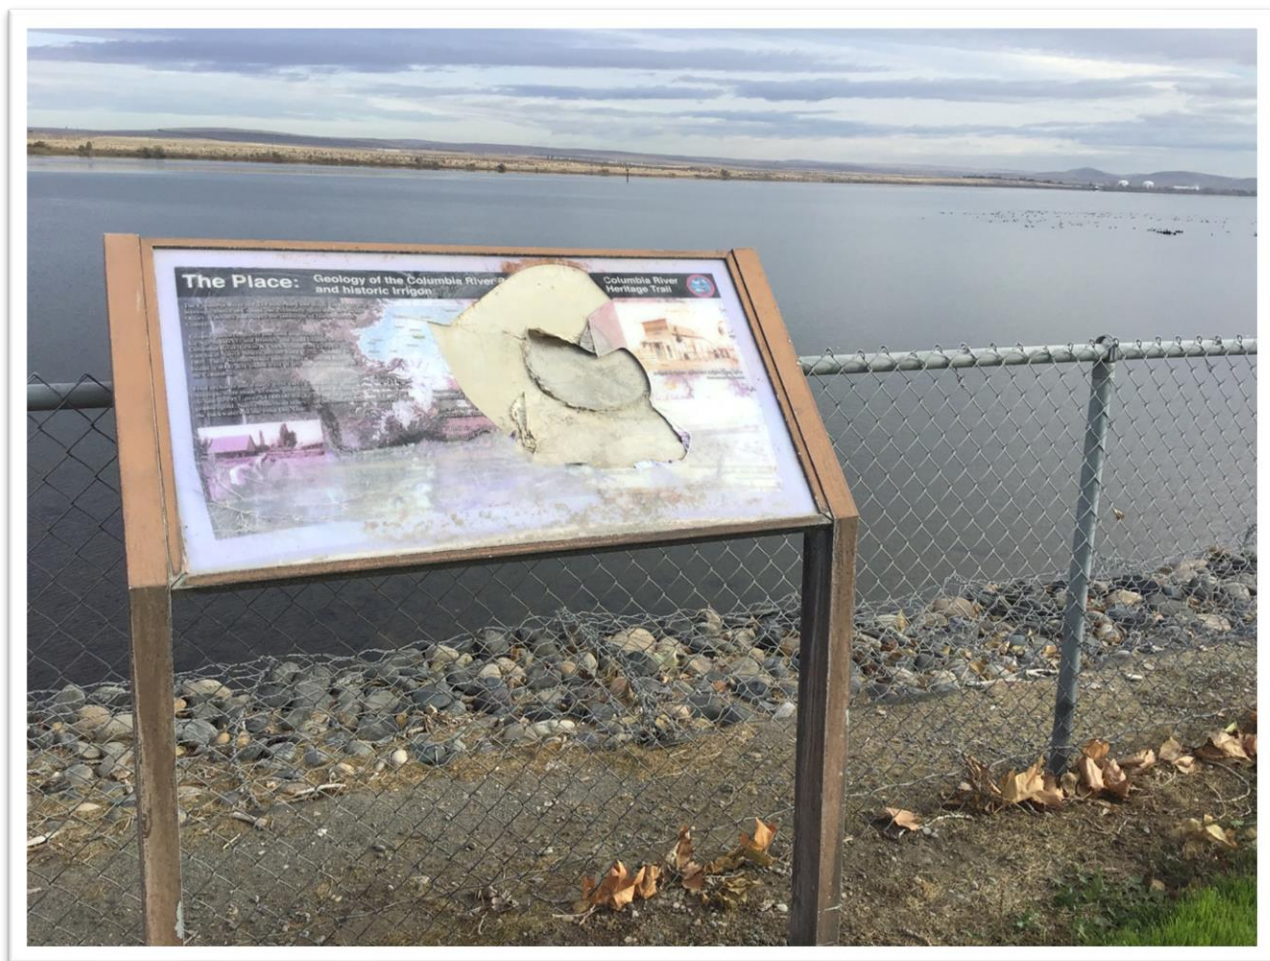
**Figure 14:** located at 45.901096° N and 119.487991° W

Further east from figure 13, the next sign is an interpretive panel that will need to have its content replaced. There is a significant amount of the original graphic that is missing and what is left has suffered from sun exposure. There will also need to be a new protective shield installed on this sign. All other parts of this panel seem to be in good condition (see figure 14).

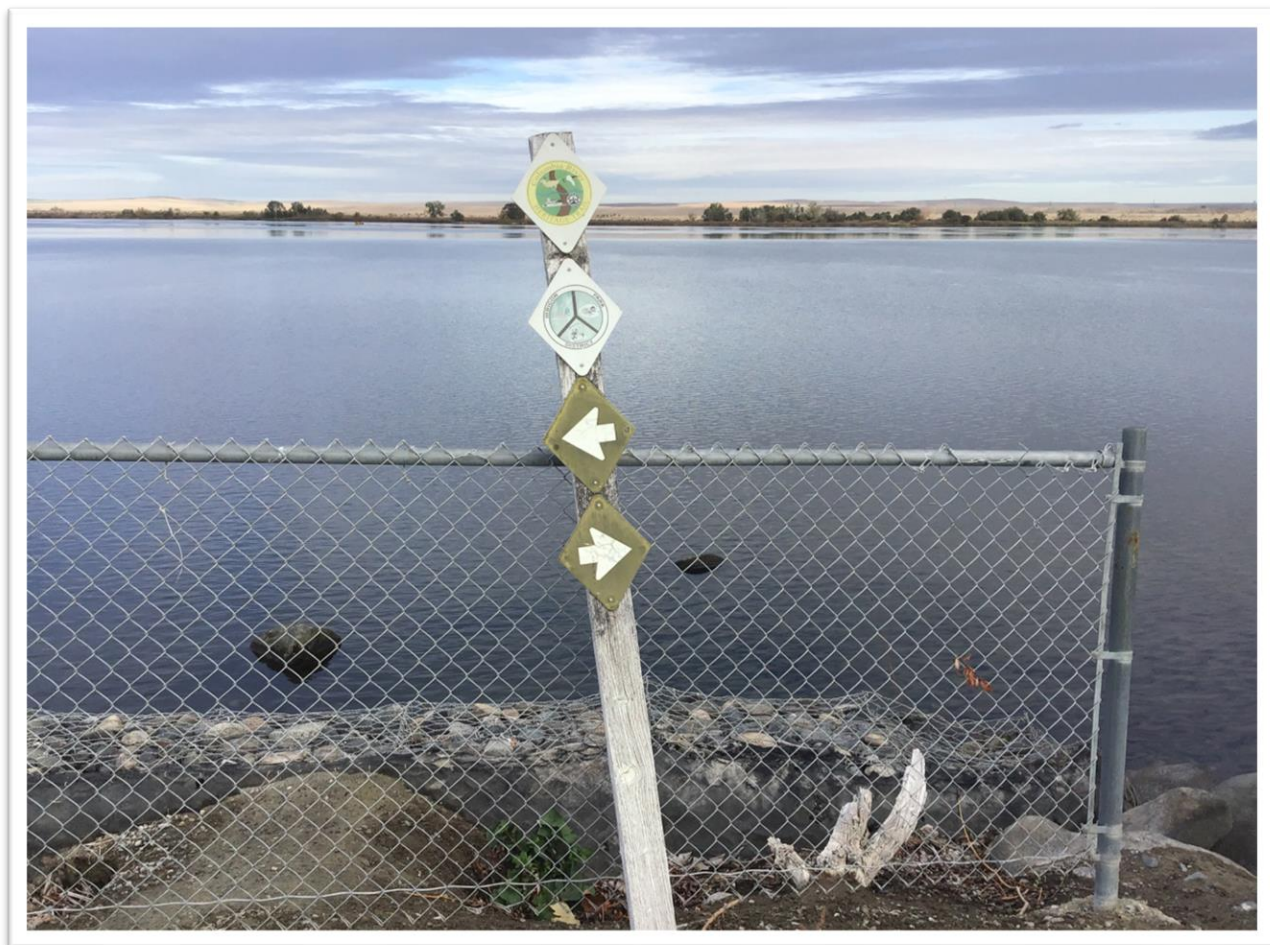
**Figure 15:** located at 45.901122° N and 119.487317° W

Approximately 200 feet further east is another trail marker site (see figure 15). This sign will need only the Columbia River Heritage Trail sticker replaced. While replacing the sticker for this sign it could also be set upright since it is leaning to the side currently. However, any ground disturbance will require consultation with ACOE.

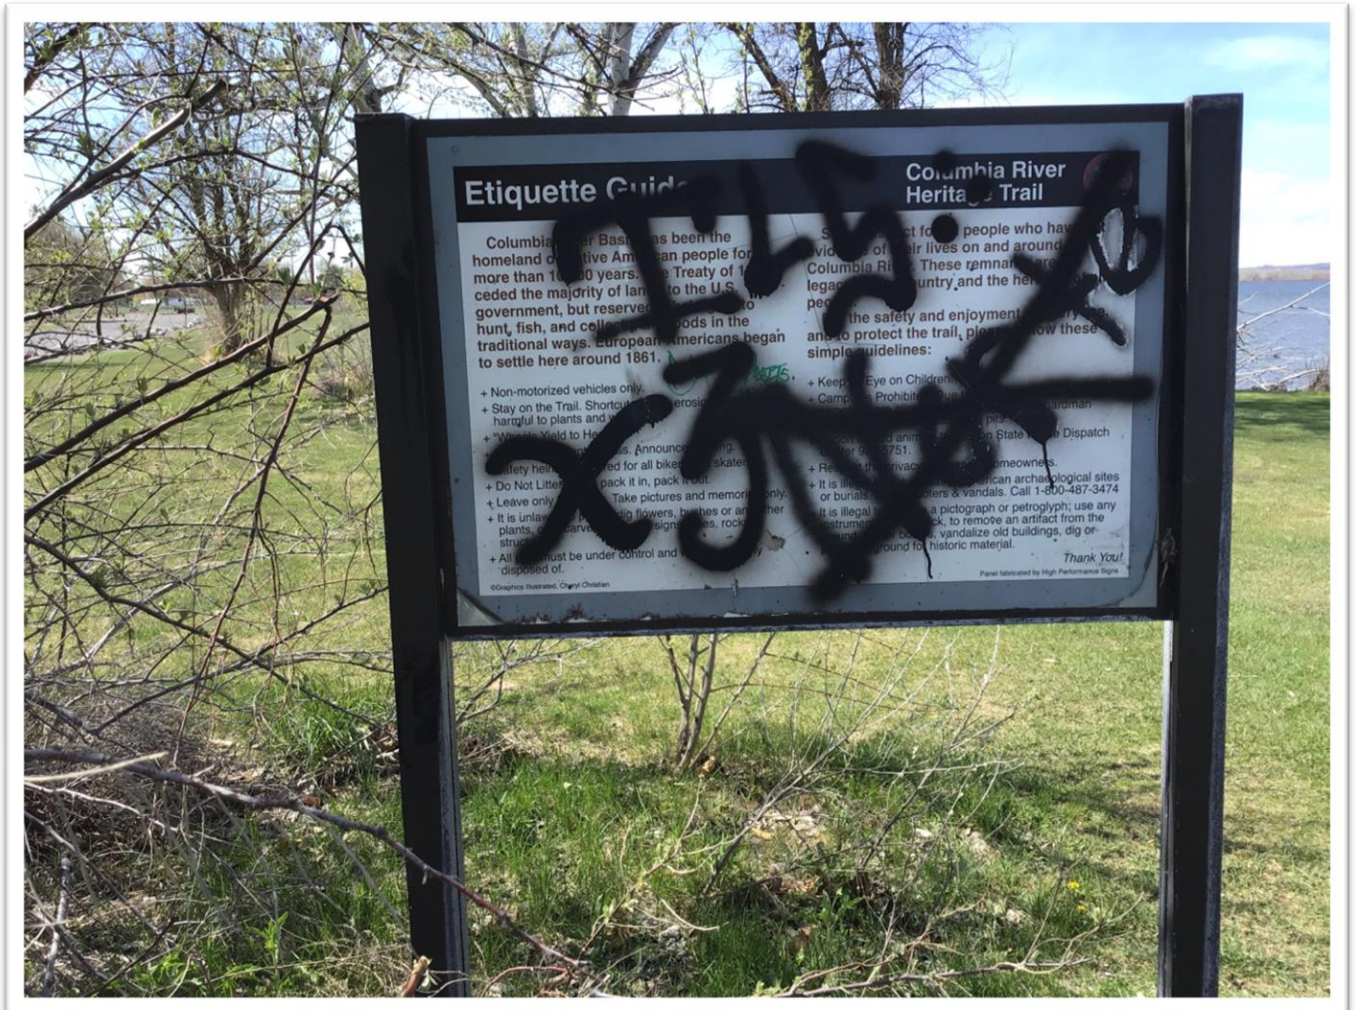
Figure 16: located at 45.901608°N and 119.483711°W

Section VI begins at an access point on the eastern most edge of the Irrigon Marina Park area. The interpretive panel has suffered significant damage and graffiti (see figure 16).

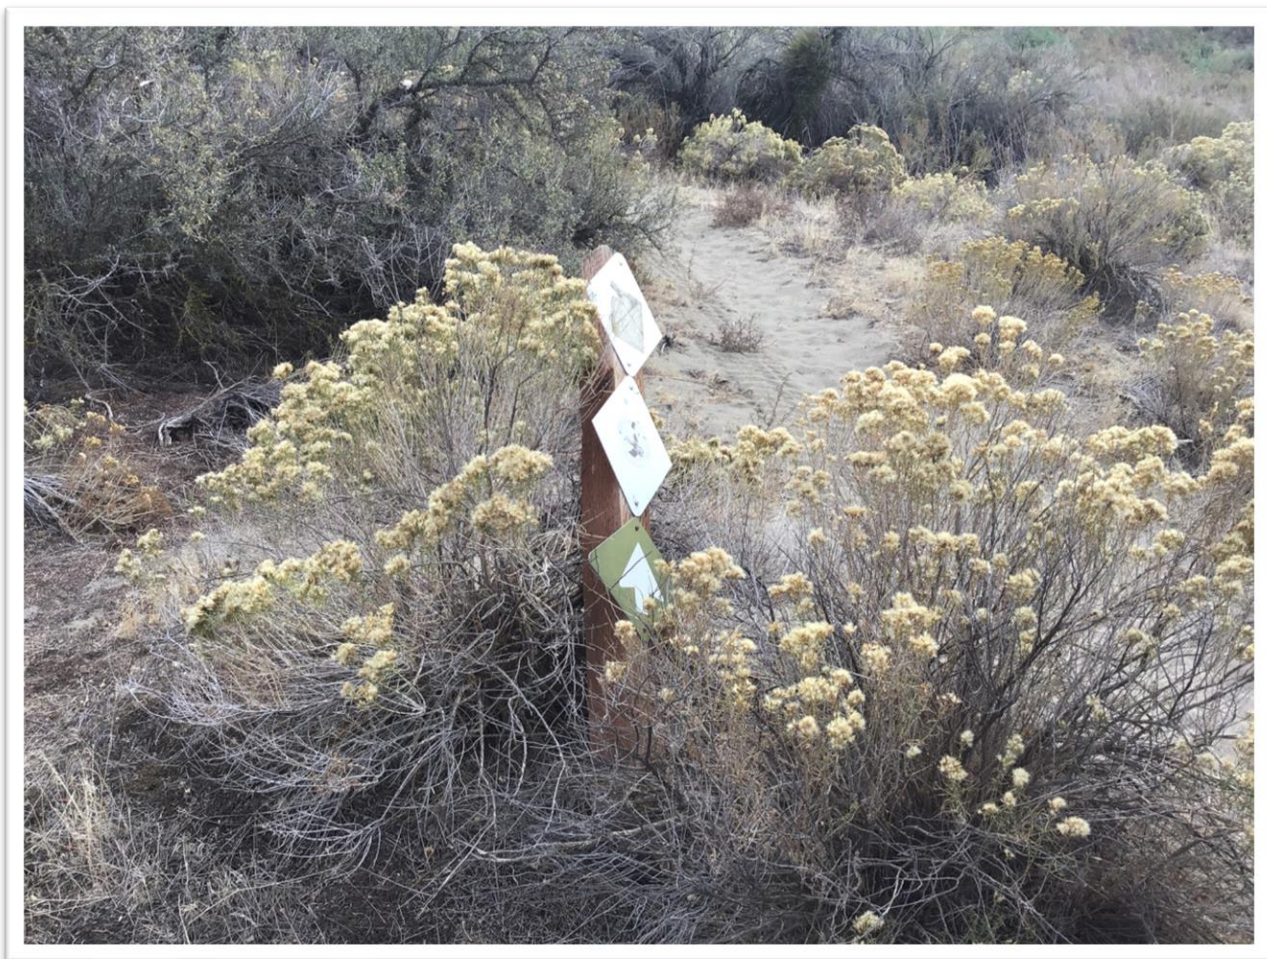
**Figure 17:** located at 45.901656° N and 119.472589° W

This trail marker has suffered from extensive sun exposure and the *CRHT* graphic is unidentifiable (see figure 17). This sign post has also been knocked over leading to a less coherent trail-going experience. Where this sign is located on federally-owned land, a consultation with ACOE is required before this post can be moved or leveled.

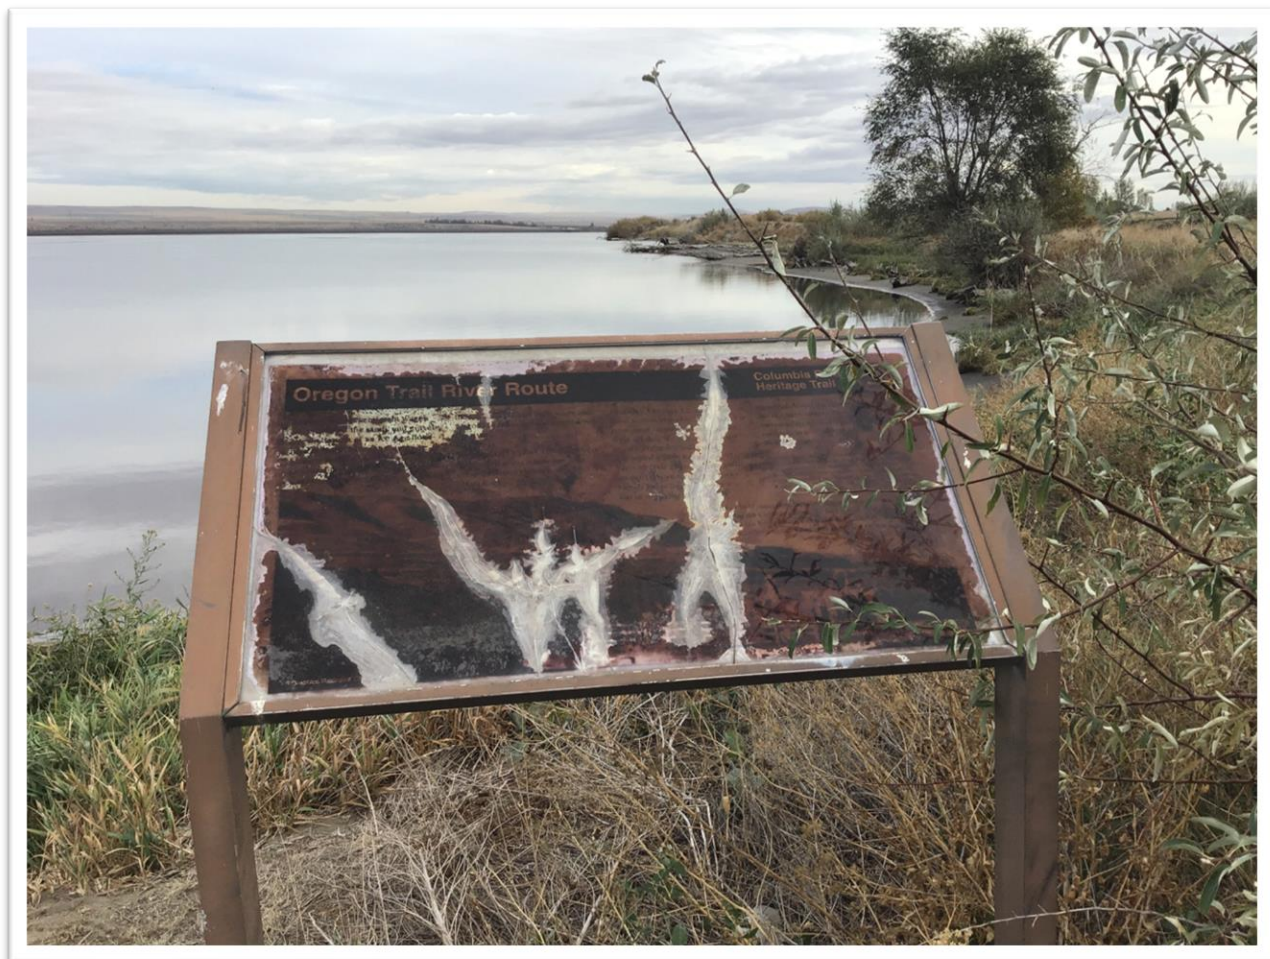
**Figure 18:** located at 45.902805° N and 119.467700° W

The only interpretive panel in this section of the *Heritage Trail* is no longer able to be used because of the gouges in its graphic and the general sun damage (see figure 18).
