# Columbia River Heritage Trail Sign Report

JUNE 27, 2023

Report prepared by the Morrow County  
Planning Department.

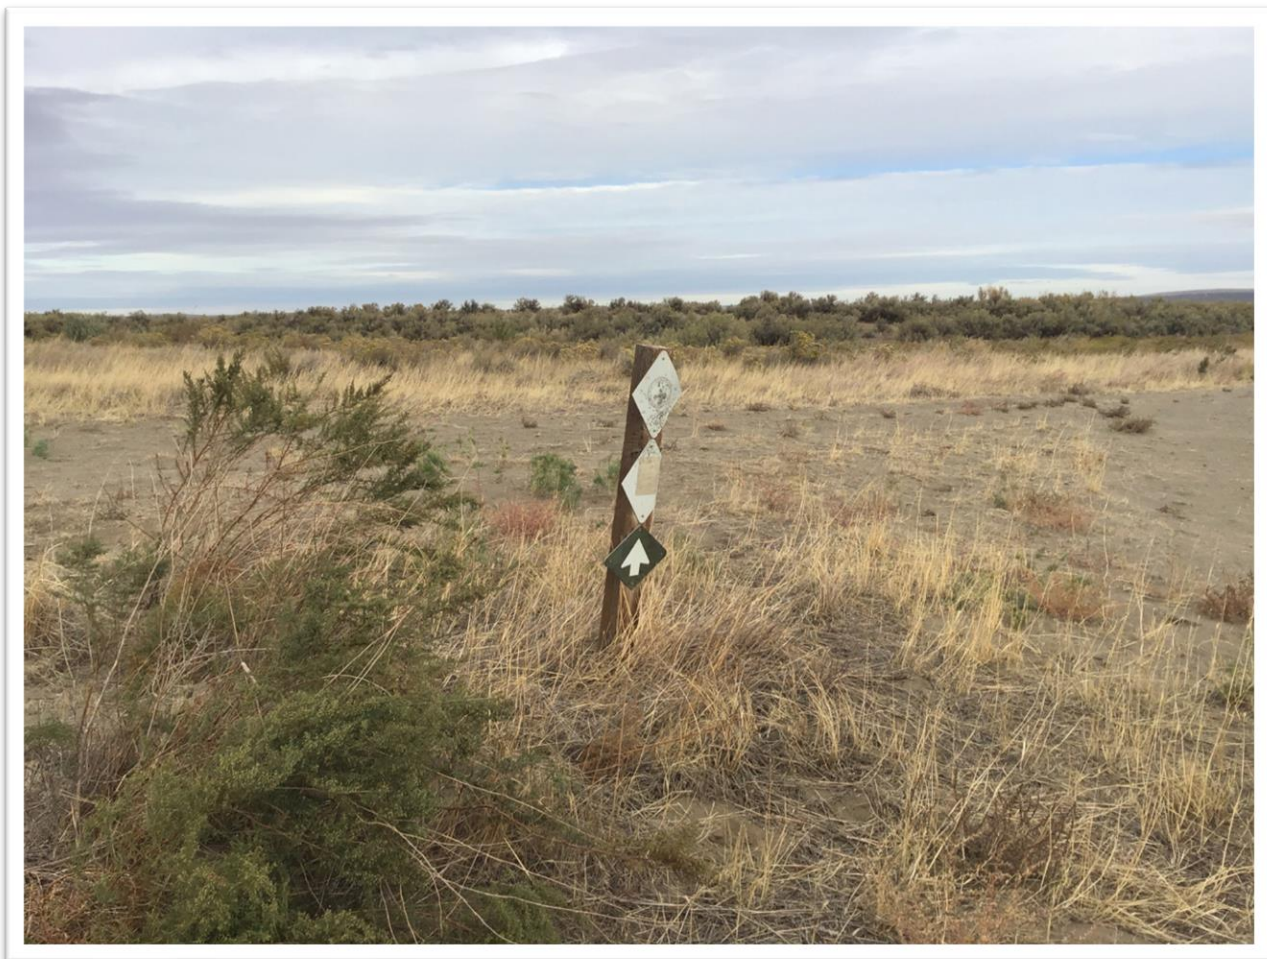
**Figure 19:** located at 45.904313° N and 118.460856° W

The most rugged part of this section has heavily damaged trail marker signs. This specific trail marker has been bent, has bullet holes and the *CRHT* graphic is extremely faded. The post is also no longer level. This trail marker is on federal lands managed by ODFW and will require federal consultation prior to adjusting the sign post (see figure 19).

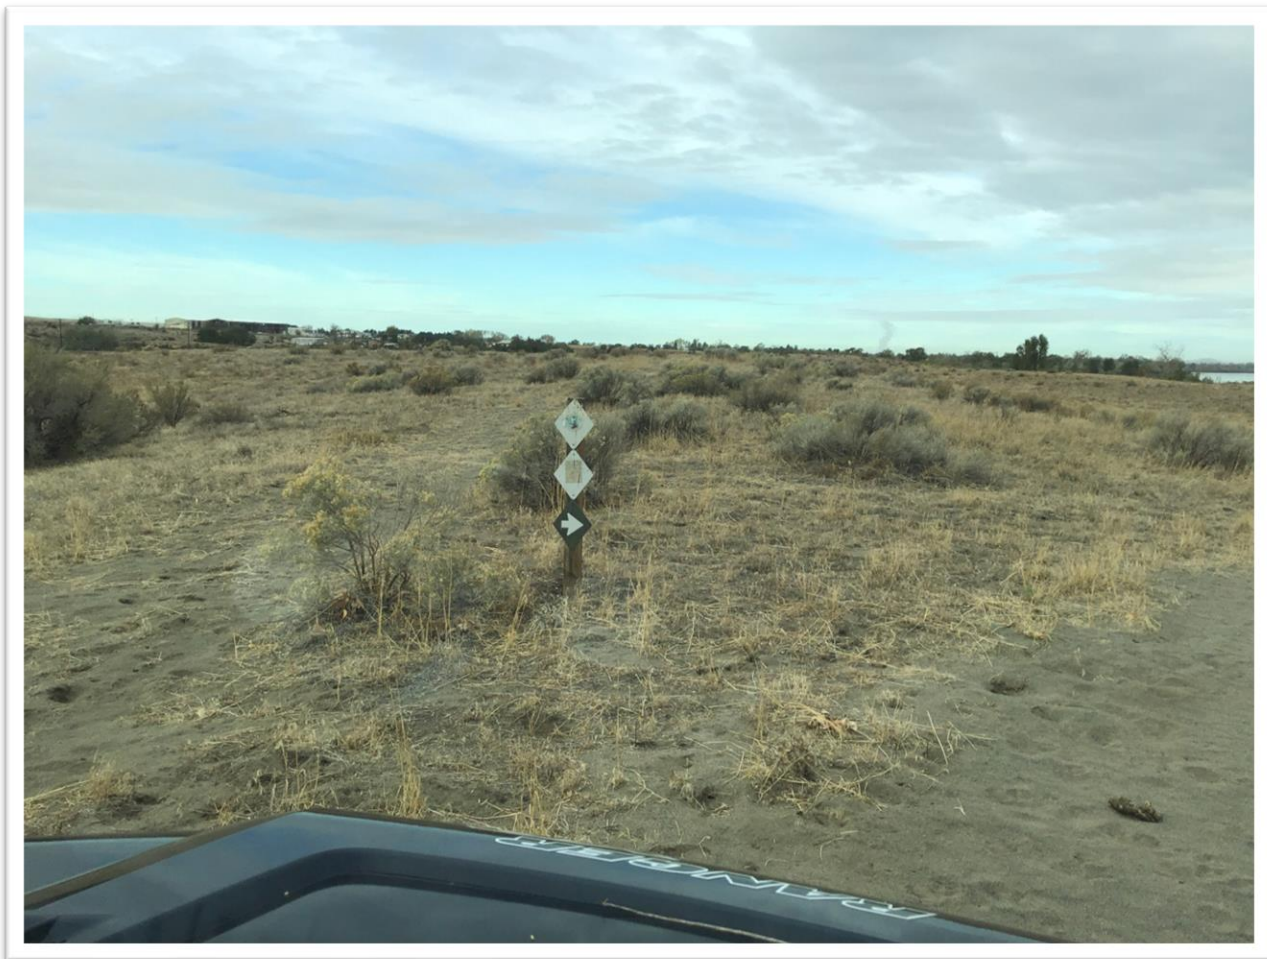
**Figure 20:** located at 45.903839° N and 119.459447° W

This trail marker has suffered from sun exposure but is generally in good condition. The post is still level and the placard is in good condition only requiring a new graphic (see figure 20).

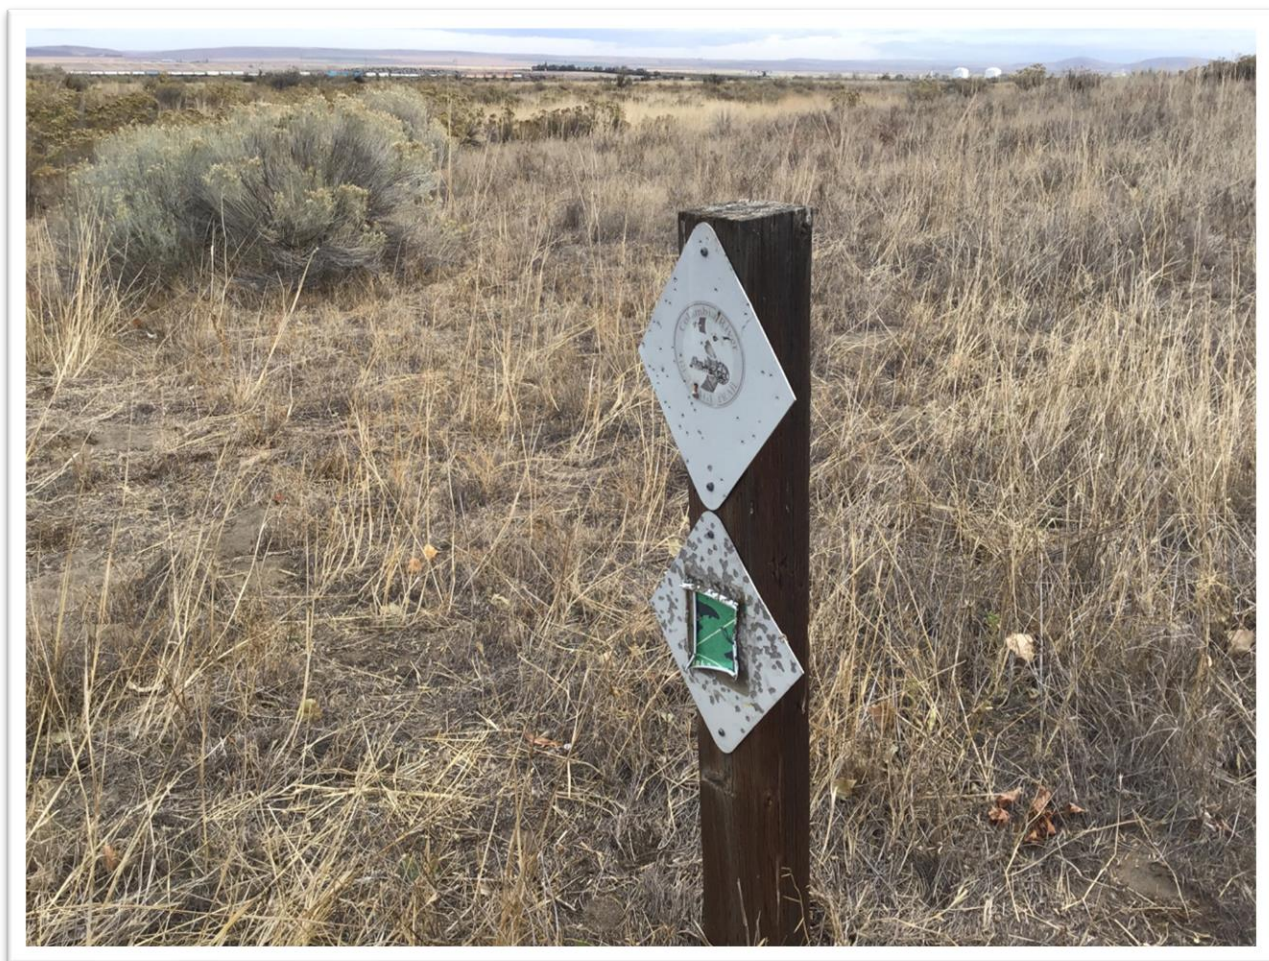
**Figure 21:** located at 45.905677° N and 119.454373° W

This trail marker sign will need to have the whole sign replaced. The sign has some denting that appear to be from bullets. Both the ODFW and CRHT metal placards will need to be replaced. Coordination with ODFW is recommended (see figure 21).

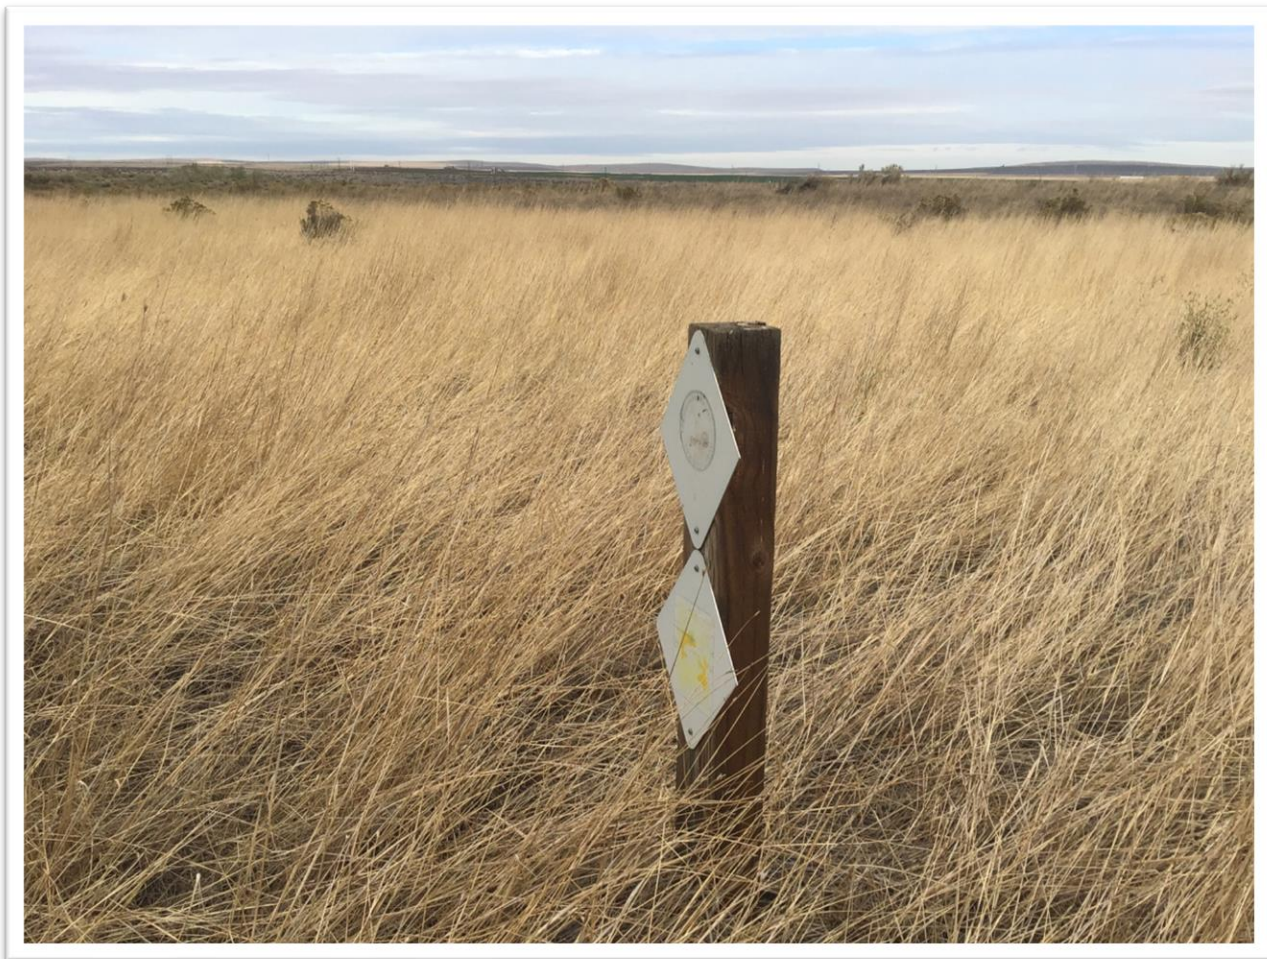
**Figure 22:** located at 45.906539° N and 119.450618° W

The next trail marker sign in this section will need the graphic replaced (see fig. 22). The post is in good condition which will make maintenance on this sign much easier. Coordination with ODFW is recommended.

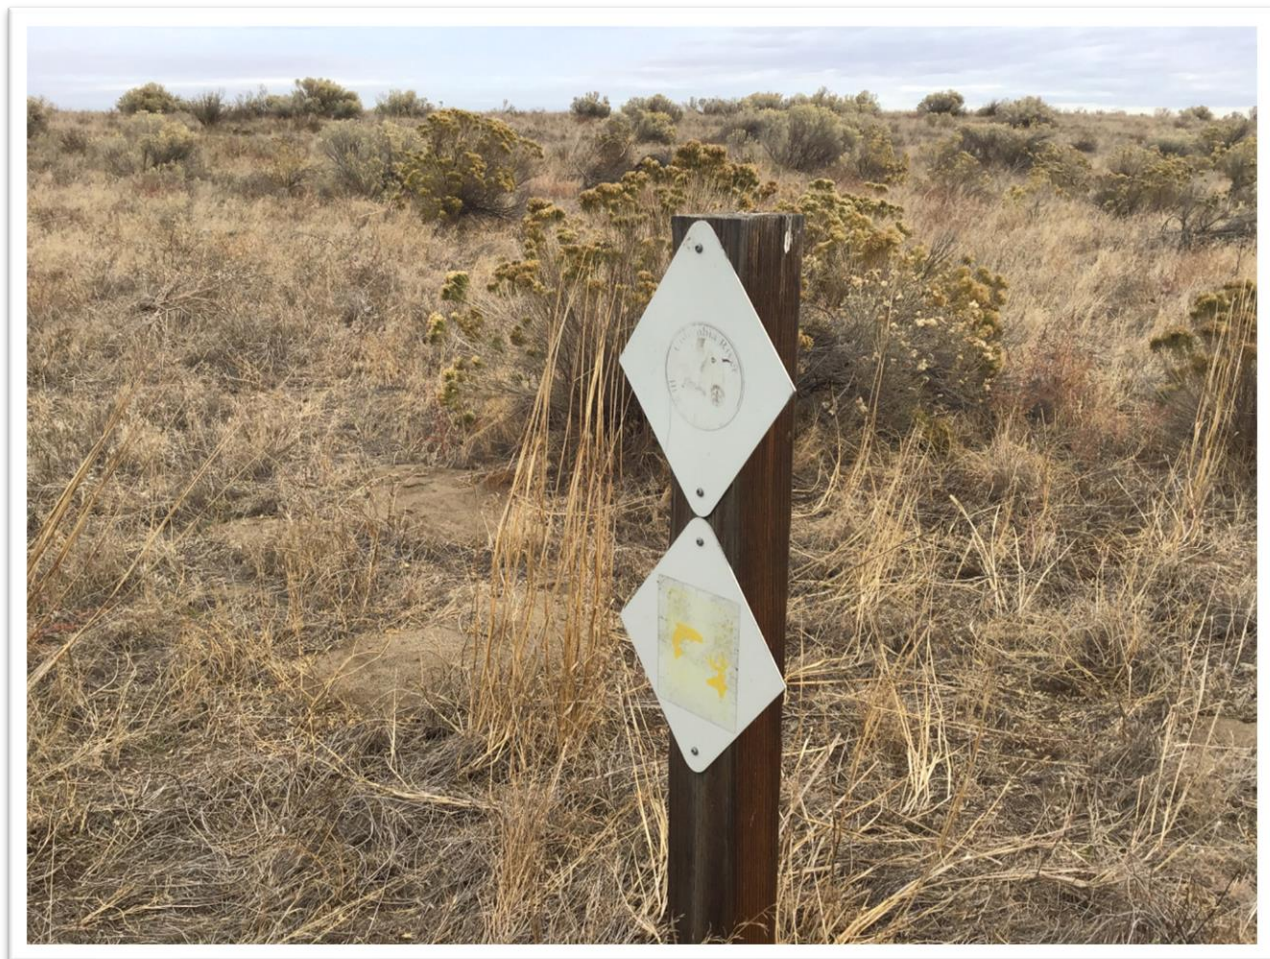
**Figure 23:** located at 45.907860° N and 119.447151° W

Very similar to the previous trail marker this post is in good condition but the sun has caused a substantial amount of fading to the sign graphics (see figure 23). This sign will need the graphic replaced to restore continuity and ease of navigation to this section. Coordination with ODFWA is recommended.

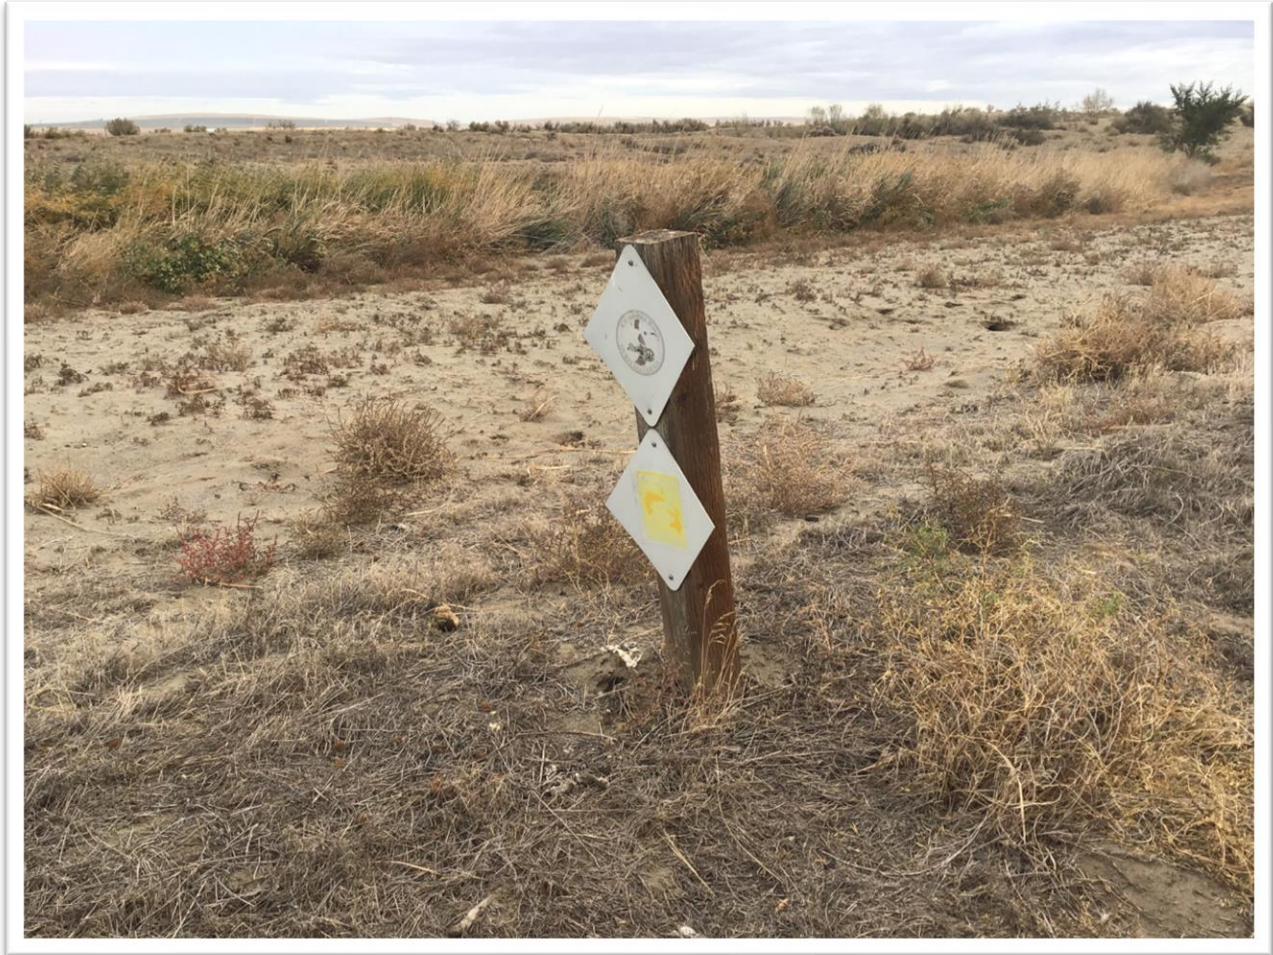
**Figure 24:** located at 45.909203° N and 119.443786° W

This trail marker sign will need the *CRHT* graphic to be replaced because of fading that has taken place (see figure 24). Replacement of the graphic and coordination with ODFW is also recommended.

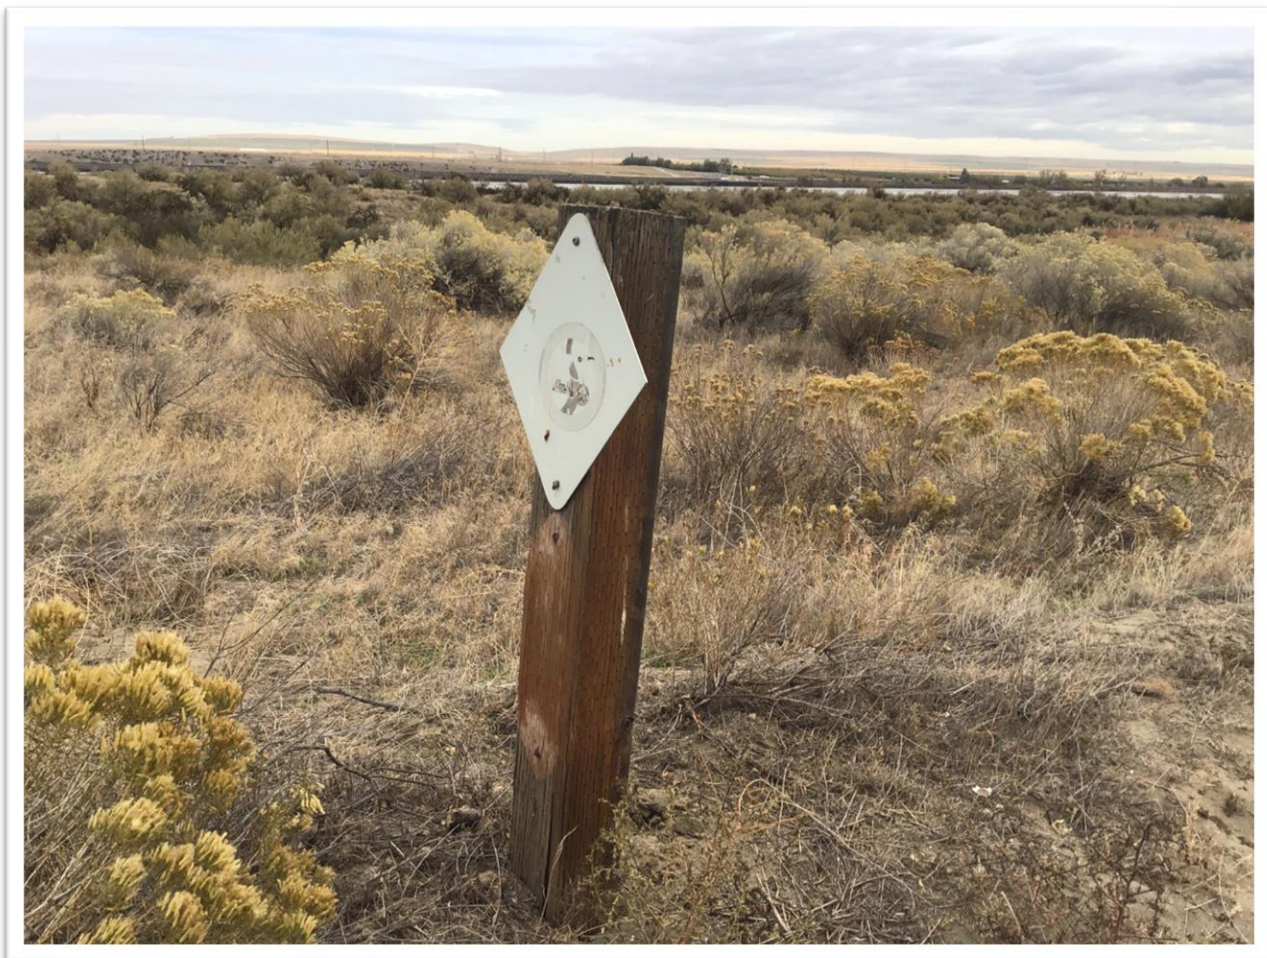
**Figure 25:** located at 45.910545° N and 119.440345° W

Third to the last trail marker for the *CRHT* presents a similar case as the majority. The trail graphic has faded and will need to be replaced. This sign seems to be missing an ODFW sign below the main *Heritage Trail* sign. There appear to be screw holes from where a sign used to be (see figure 25). Coordination with ODFW is recommended.

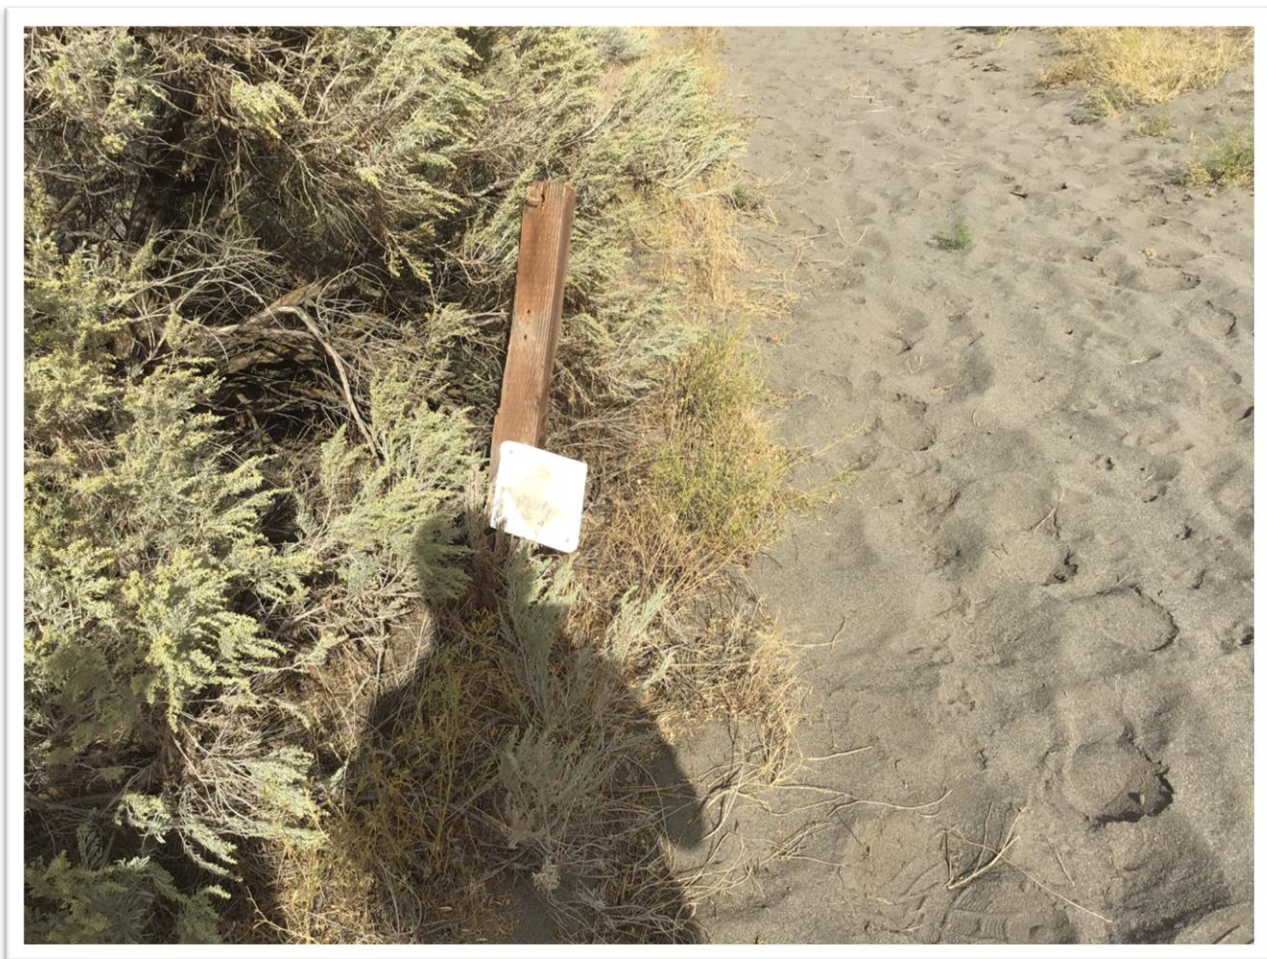
**Figure 26:** located at 45.911542° N and 119.437586

This trail marker sign post has been knocked to the ground and the *Heritage Trail* appears to be missing. There are screw holes where the metal marker sign used to be (see figure 26). The other sign on the post looks like it belongs to ODFW and is very faded. This post cannot be moved until consultation with ACOE and ODFW. Environmental and cultural consultation is likely.

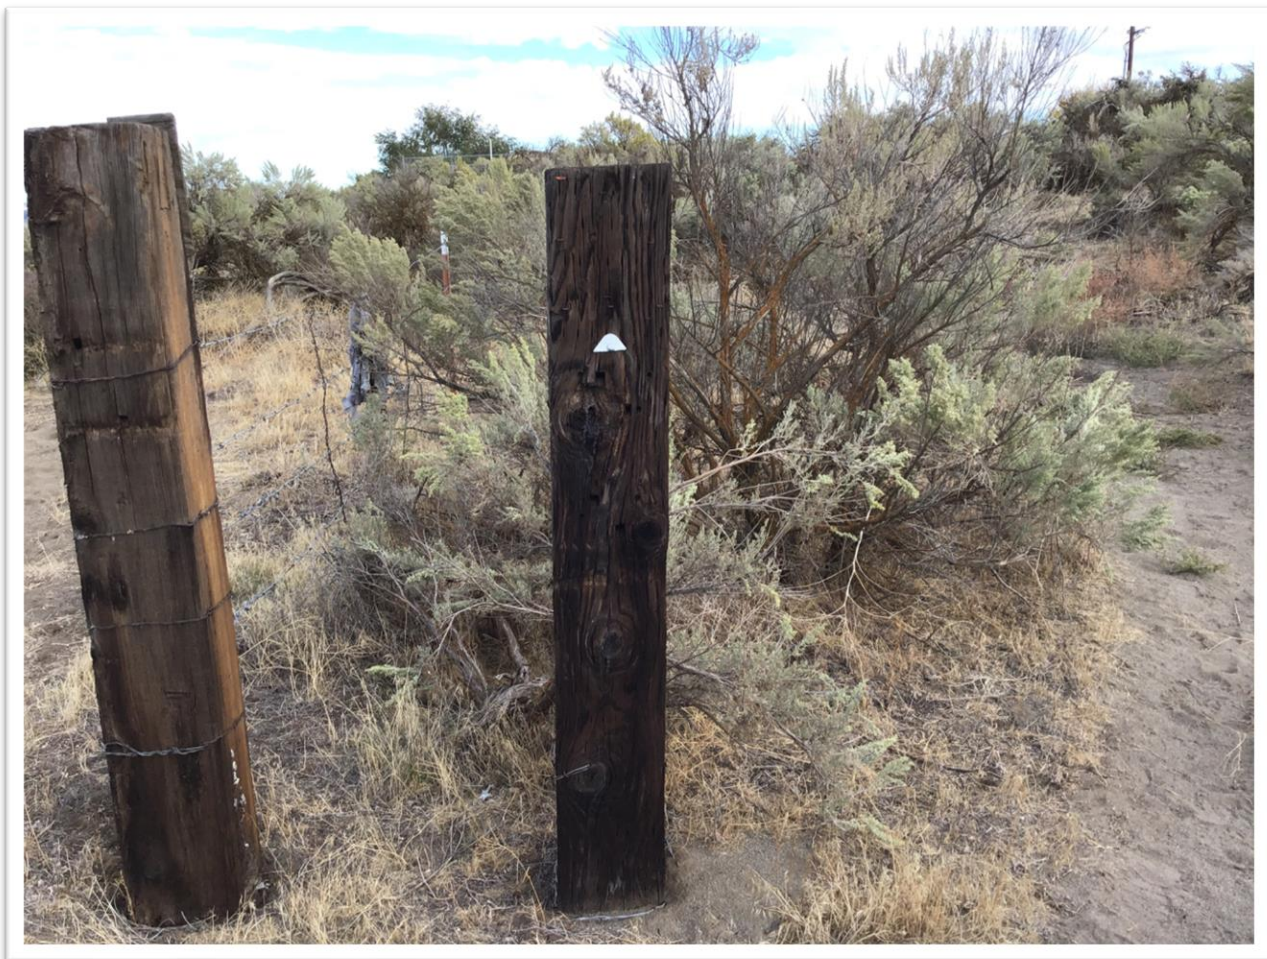
**Figure 27:** located at 45.913100° N and 119.432253° W

The last trail marker is almost completely gone, however, the post is standing and in good condition. There is a small part of the metal placard at the top of the post. This sign is near the east access point and is more susceptible to people seeking to vandalize the trail. This post will need a new sign and sticker for navigation purposes (see figure 27). Consultation with ODFW is recommended.

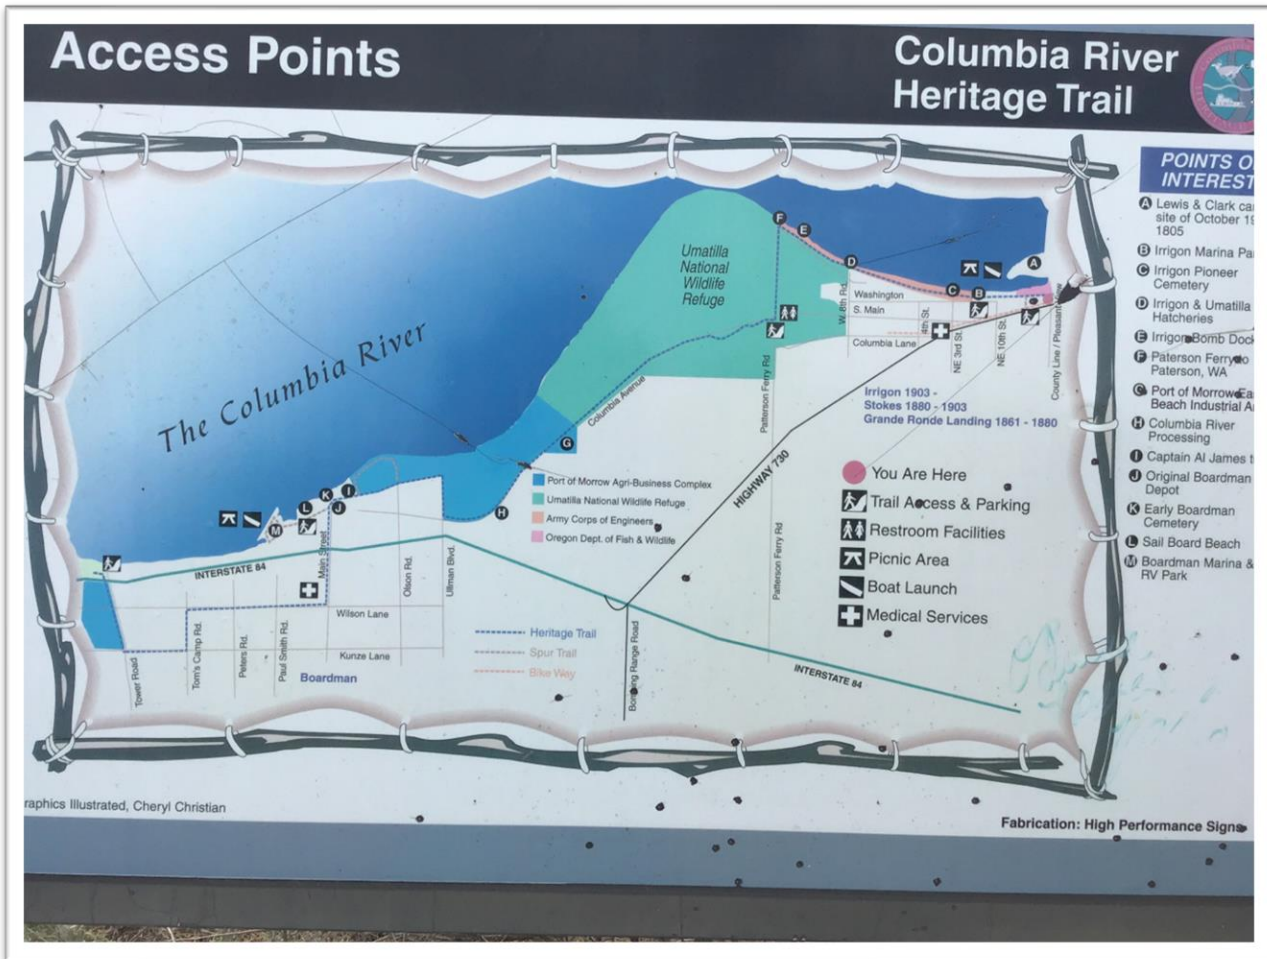
Figure 28: located at 45.913023° N and 119.431535° W

On the Morrow/Umatilla County border there is an access point to the Heritage Trail. This sign has some graffiti and small BB holes. There is just enough damage here to create a small amount of potential confusion (see figure 28). Consultation with ACOE and ODFW is recommended.
