Re: **WD # 2022-0436 Approved**  
Wetland Delineation Report for Percheron Industrial Campus  
Morrow County; T3N R24E S28 TL100 (Portion)

USGS VICINITY MAP PERCHERON WETLAND AND WATER DELINEATION REPORT		FIGURE <b>1</b>
AKS ENGINEERING & FORESTRY, LLC 12965 SW HERMAN RD, STE 100 TUALATIN, OR 97062 503.563.6151    WWW.AKS-ENG.COM		DRWN: RAS CHKD: SKT AKS JOB: 8858-04

<b>WETLAND AND WATER DELINEATION OVERVIEW MAP</b>		FIGURE
		<b>5</b>
PERCHERON WETLAND AND WATER DELINEATION REPORT		DRWN: RAS
AKS ENGINEERING & FORESTRY, LLC		CHKD: SKT
12965 SW HERMAN RD, STE 100		AKS JOB:
TUALATIN, OR 97062		<b>8858-04</b>
503.563.6151 WWW.AKS-ENG.COM

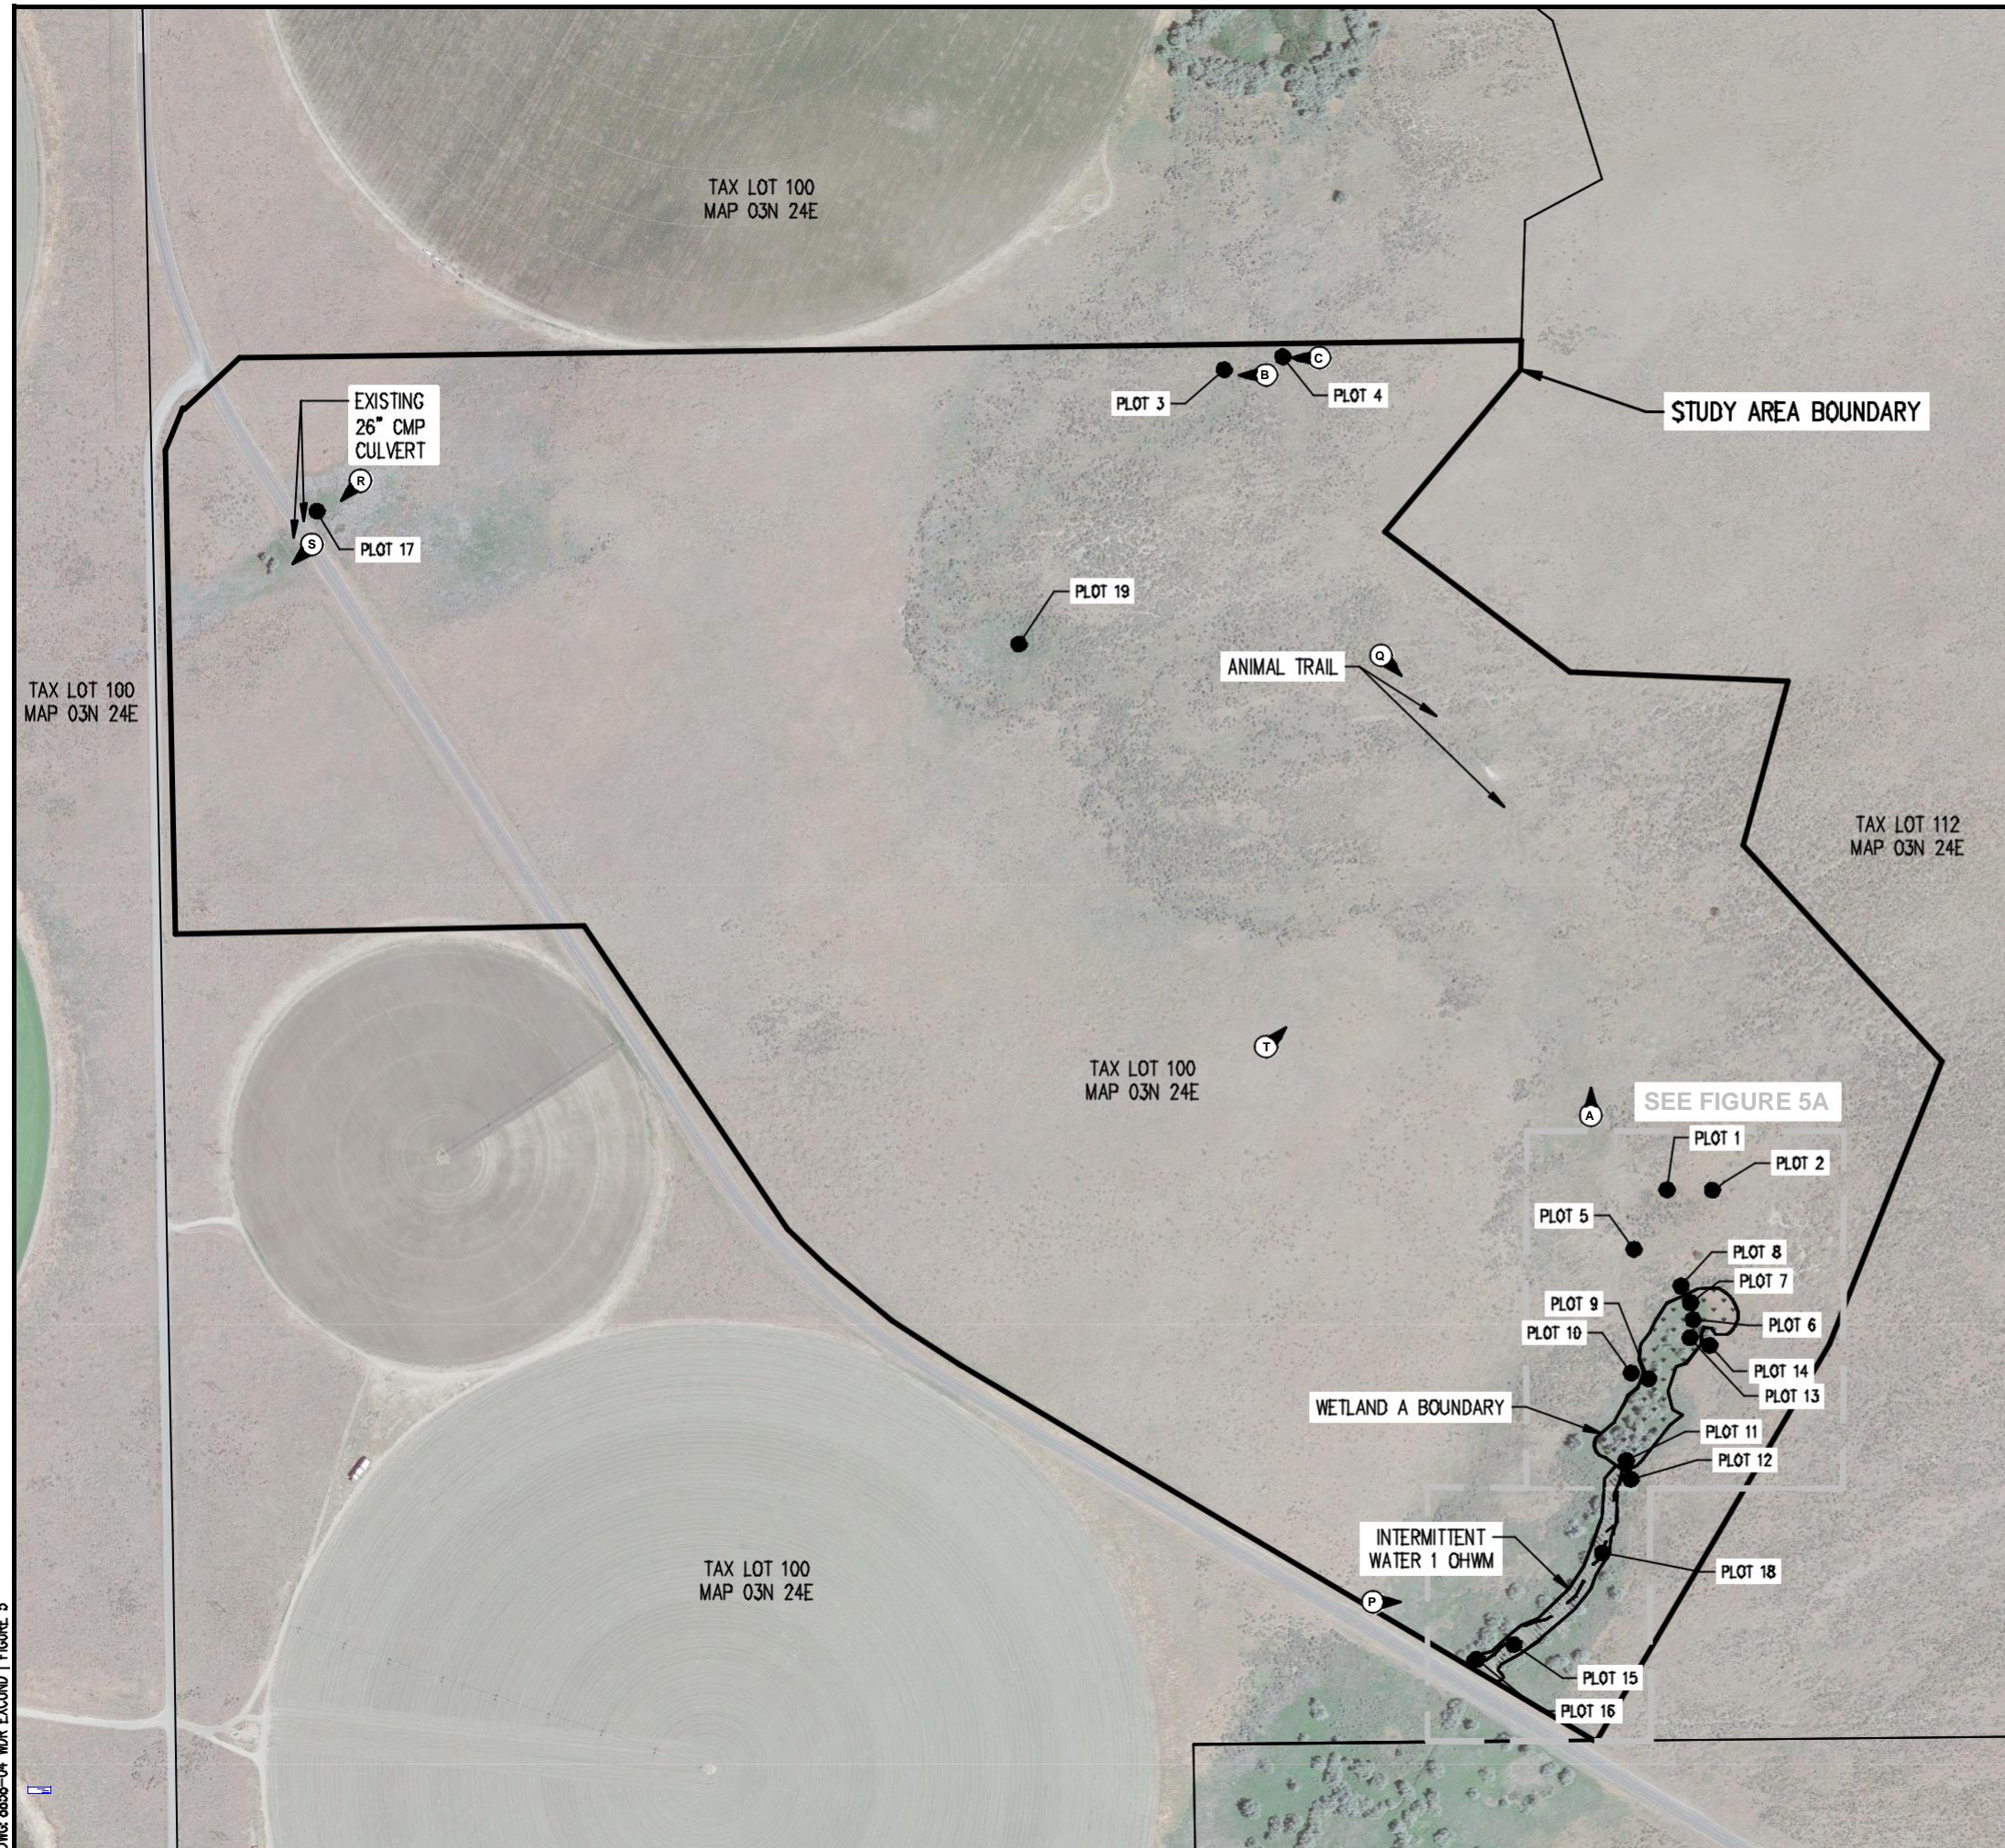
- TOTAL ON-SITE WETLAND A PEM/PFO DEPRESSIONAL AREA:  
76,362 SF± (1.75 ACRES)
- TOTAL ON-SITE INTERMITTENT WATER 1 AREA:  
38,141 SF± (0.88 ACRES) (171 LF±)
- PHOTO POINT LOCATION AND ORIENTATION

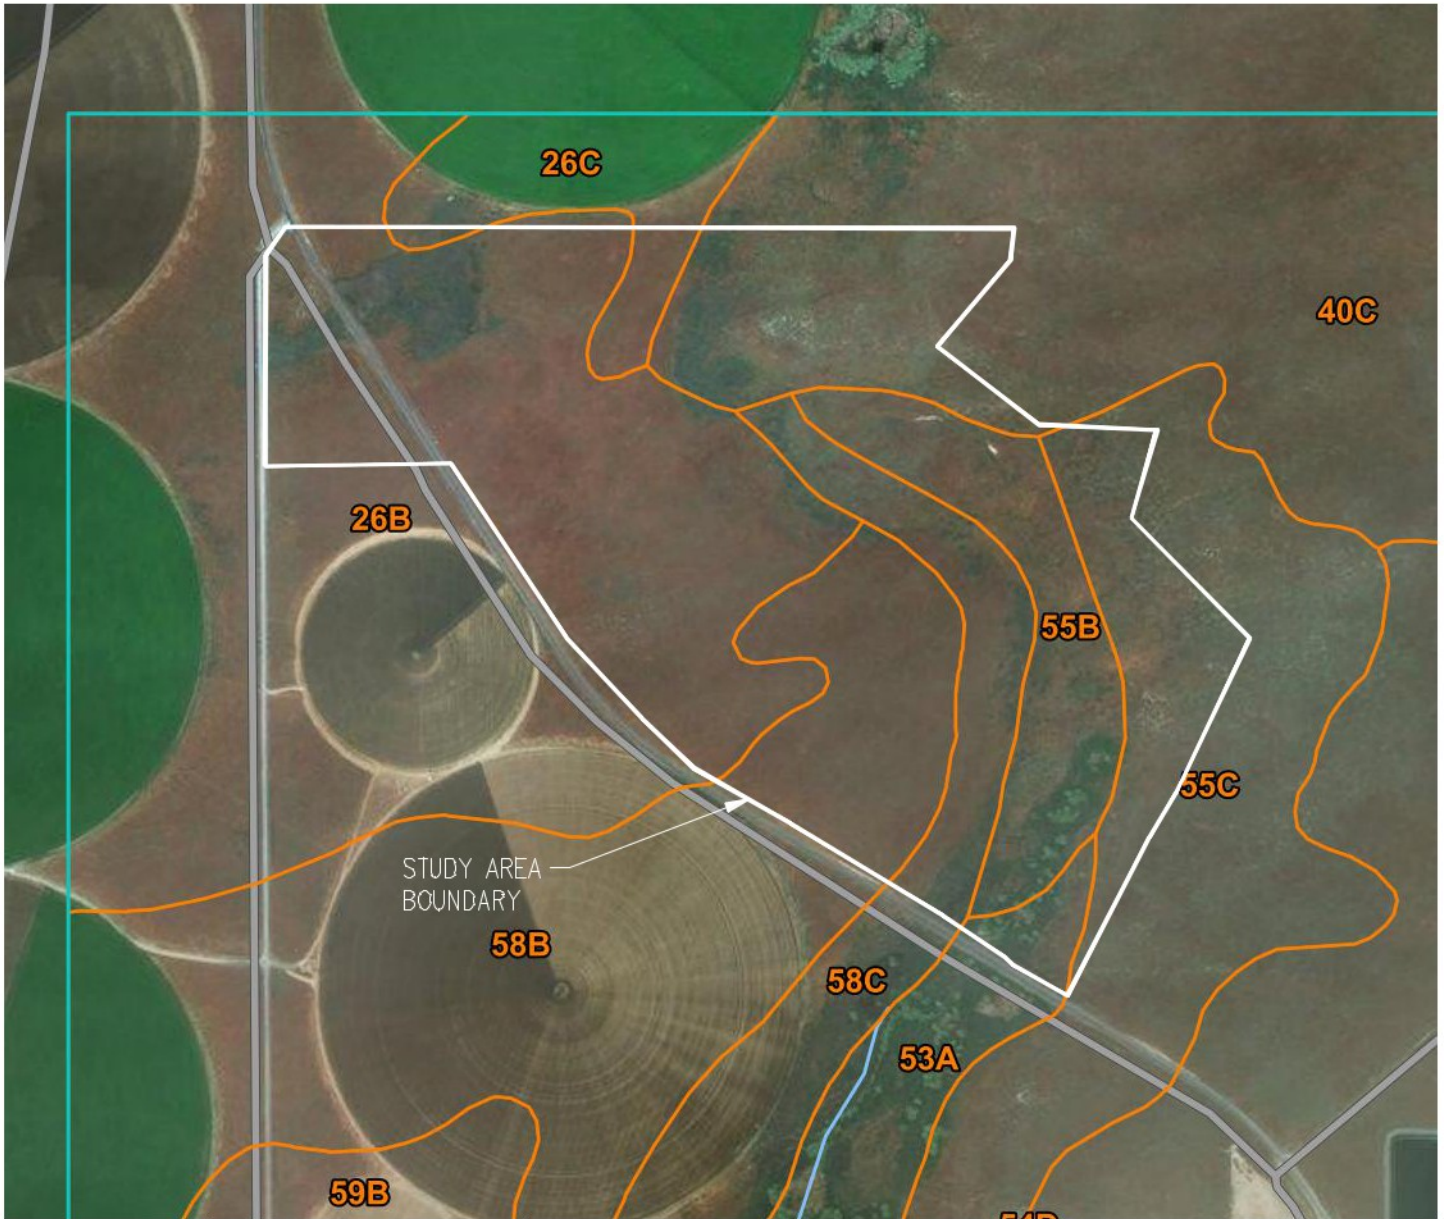
<b>NRCS SOIL SURVEY MAP</b> <b>PERCHERON WETLAND AND WATER DELINEATION REPORT</b>		<b>FIGURE</b> <b>3</b>
<b>AKS ENGINEERING &amp; FORESTRY, LLC</b> 12965 SW HERMAN RD, STE 100 TUALATIN, OR 97062 503.563.6151    WWW.AKS-ENG.COM		DRWN: RAS CHKD: SKT AKS JOB: 8858-04

MAP UNIT SYMBOL	MAP UNIT NAME
26B	KOEHLER LOAMY FINE SAND, 2-5% SLOPES; NON-HYDRIC
26C	KOEHLER LOAMY FINE SAND, 5-12% SLOPES; NON-HYDRIC
53A	ROYAL SILT LOAM, 0-3% SLOPES; NON-HYDRIC
55B	SAGEHILL FINE SANDY LOAM HUMMOCKY, 2-5% SLOPES; NON-HYDRIC
55C	SAGEHILL FINE SANDY LOAM HUMMOCKY, 5-12% SLOPES; NON-HYDRIC
58B	TAUNTON FINE SANDY LOAM, 2-5% SLOPES; NON-HYDRIC
58C	TAUNTON FINE SANDY LOAM, 5-12% SLOPES; NON-HYDRIC
40C	QUINCY LOAMY FINE SAND, 2-12% SLOPES; NON-HYDRIC

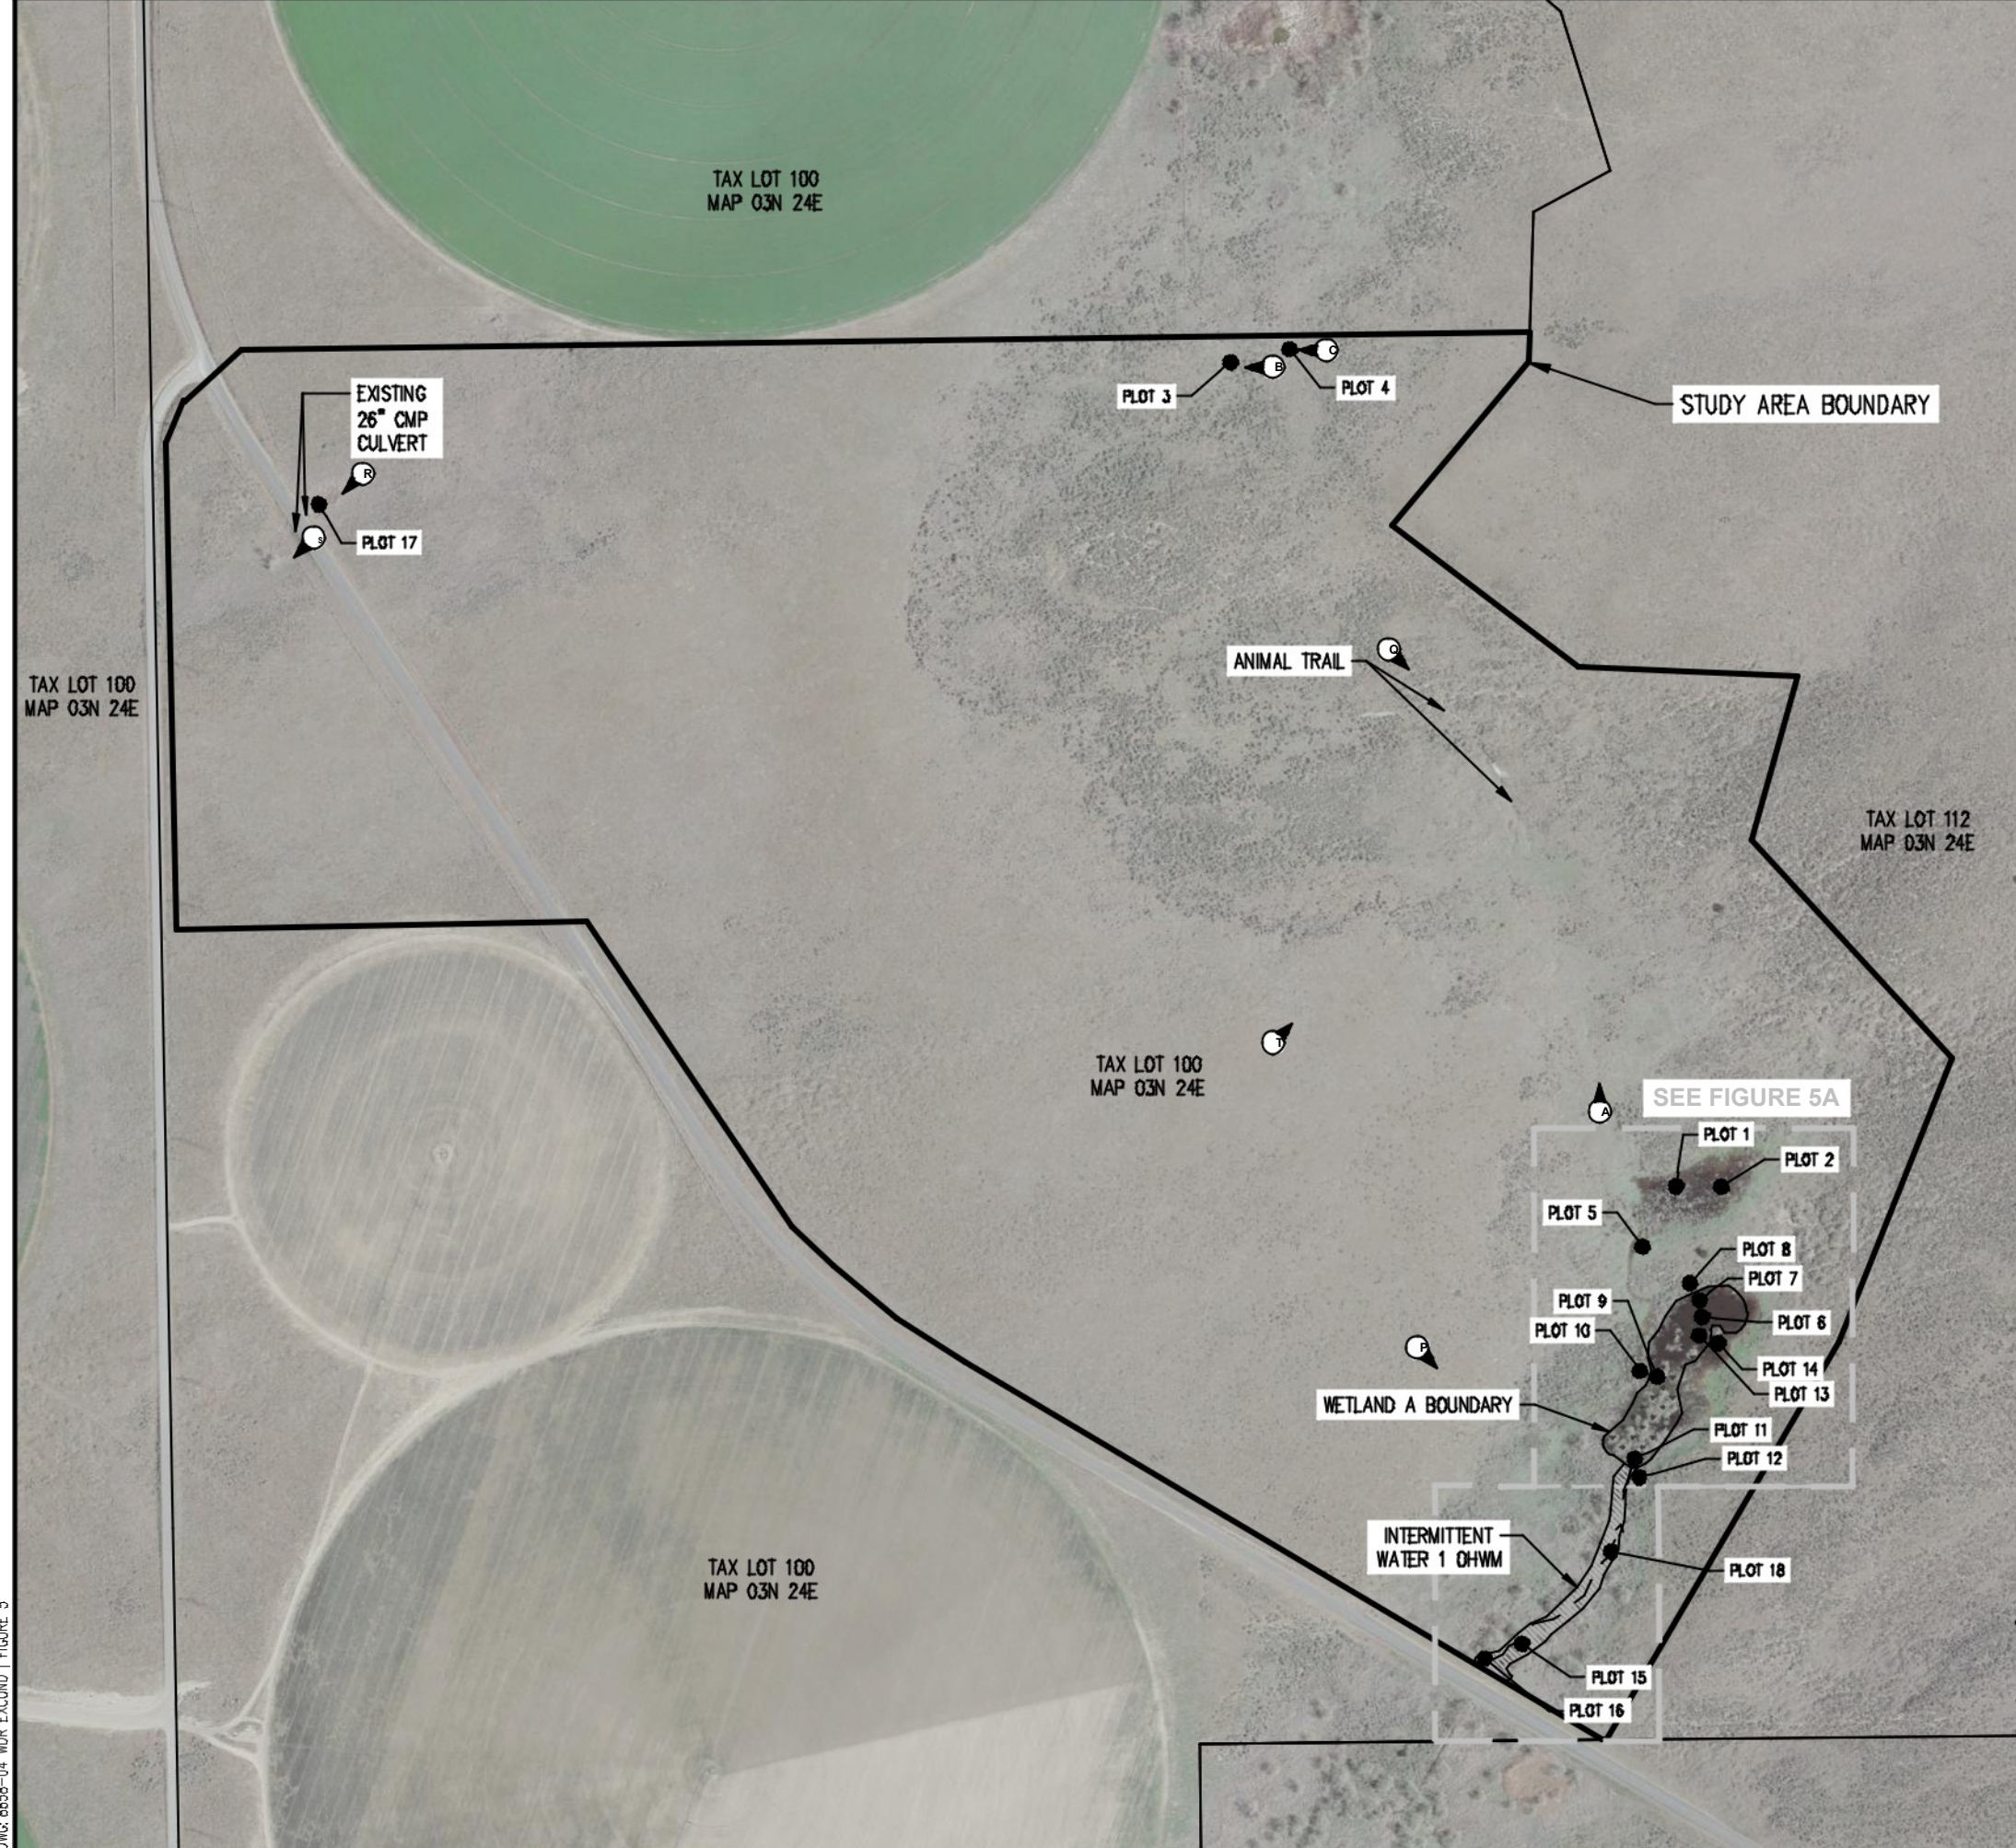
DWG: 8858-04\_MDR\_EXCOND | FIGURE 5

- TOTAL ON-SITE WETLAND A PEM/PFO DEPRESSIONAL AREA:  
75,480 SF± (1.73 ACRES)
- TOTAL ON-SITE INTERMITTENT WATER 1 AREA:  
38,141 SF± (0.88 ACRES) (171 LF±)
- PHOTO POINT LOCATION AND ORIENTATION

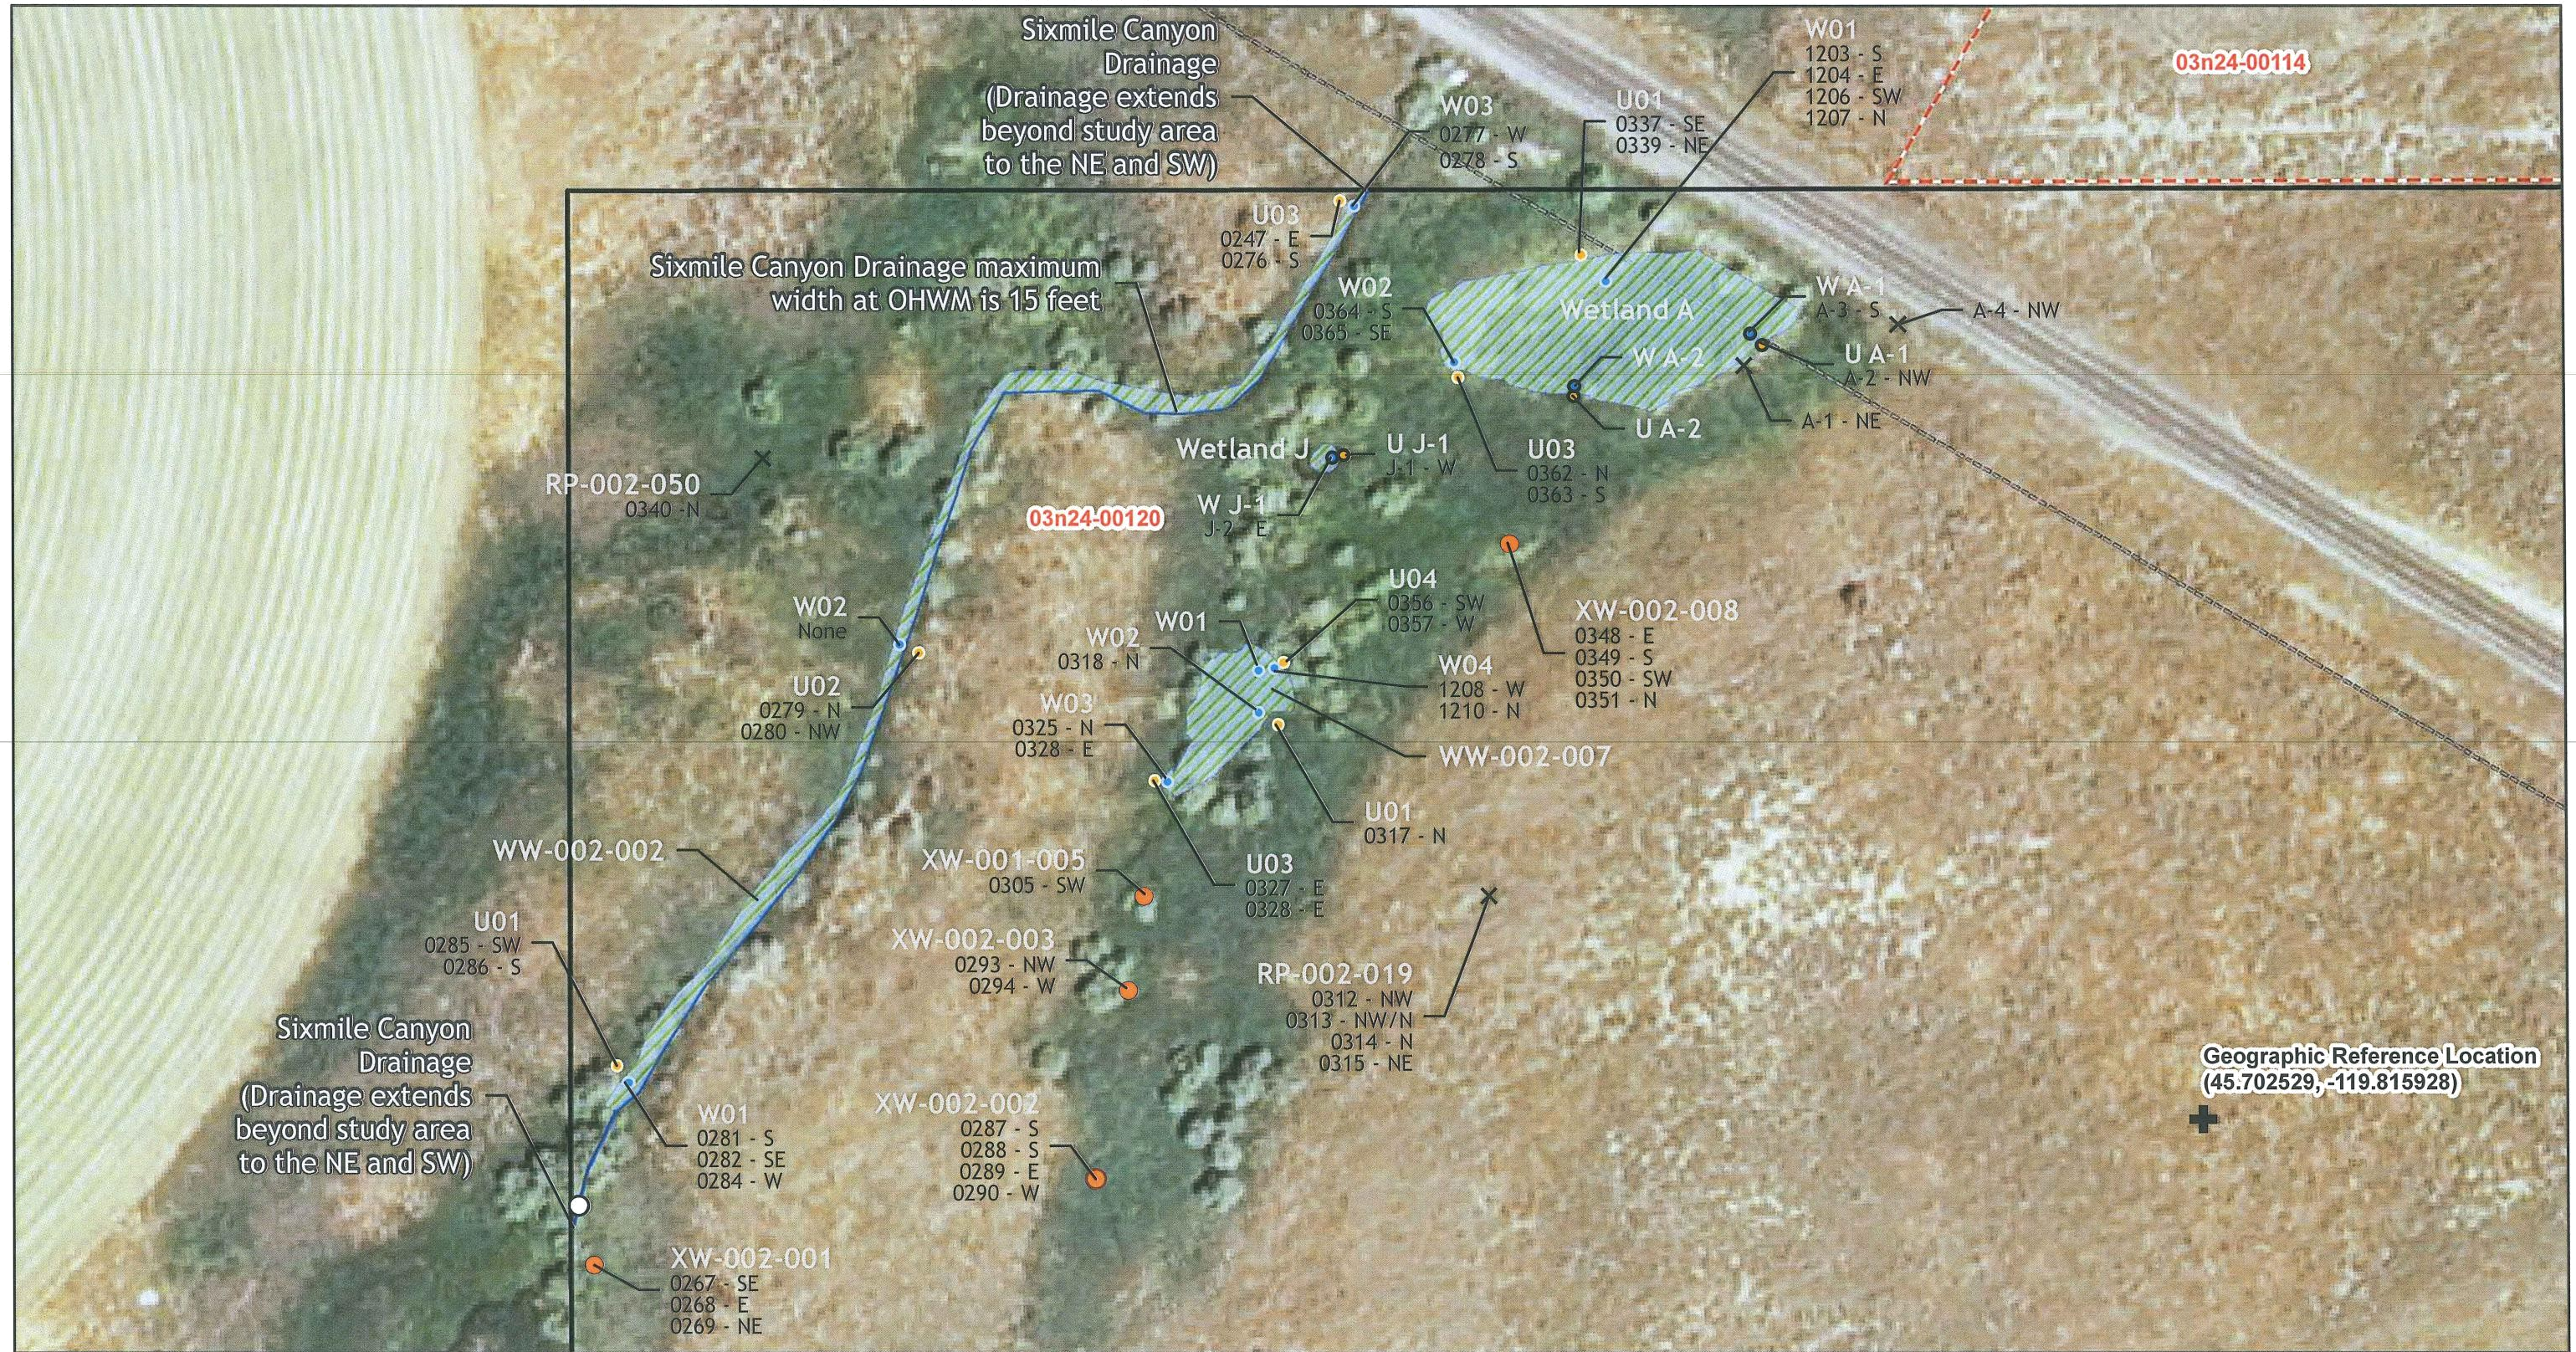
DSL WD # 2010-0023 <sup>2 of 11</sup> **Figure 5.1.1: Wetland A Area**  
 Approval Issued 12/24/2013  
 PGE Carty Generating Station  
 Approval Expires 12/24/2018

- Site Boundary
  - Access Road
  - Tax Lots
  - 2012 / 2013 E&E Field Data
    - Wetlands
    - Photo Location
    - Point marks transition to intermittent flow (to NE) THIS REACH
  - Soil Points
    - Upland
    - Wetland
    - Delineated Water Features
  - 2009 E&E Field Data Soil Sample
    - Upland
    - Wetland
- OHWM = 15' MAX WIDTH SIXMILE CANYON  
Field Data Accurate to +/- 1 meter

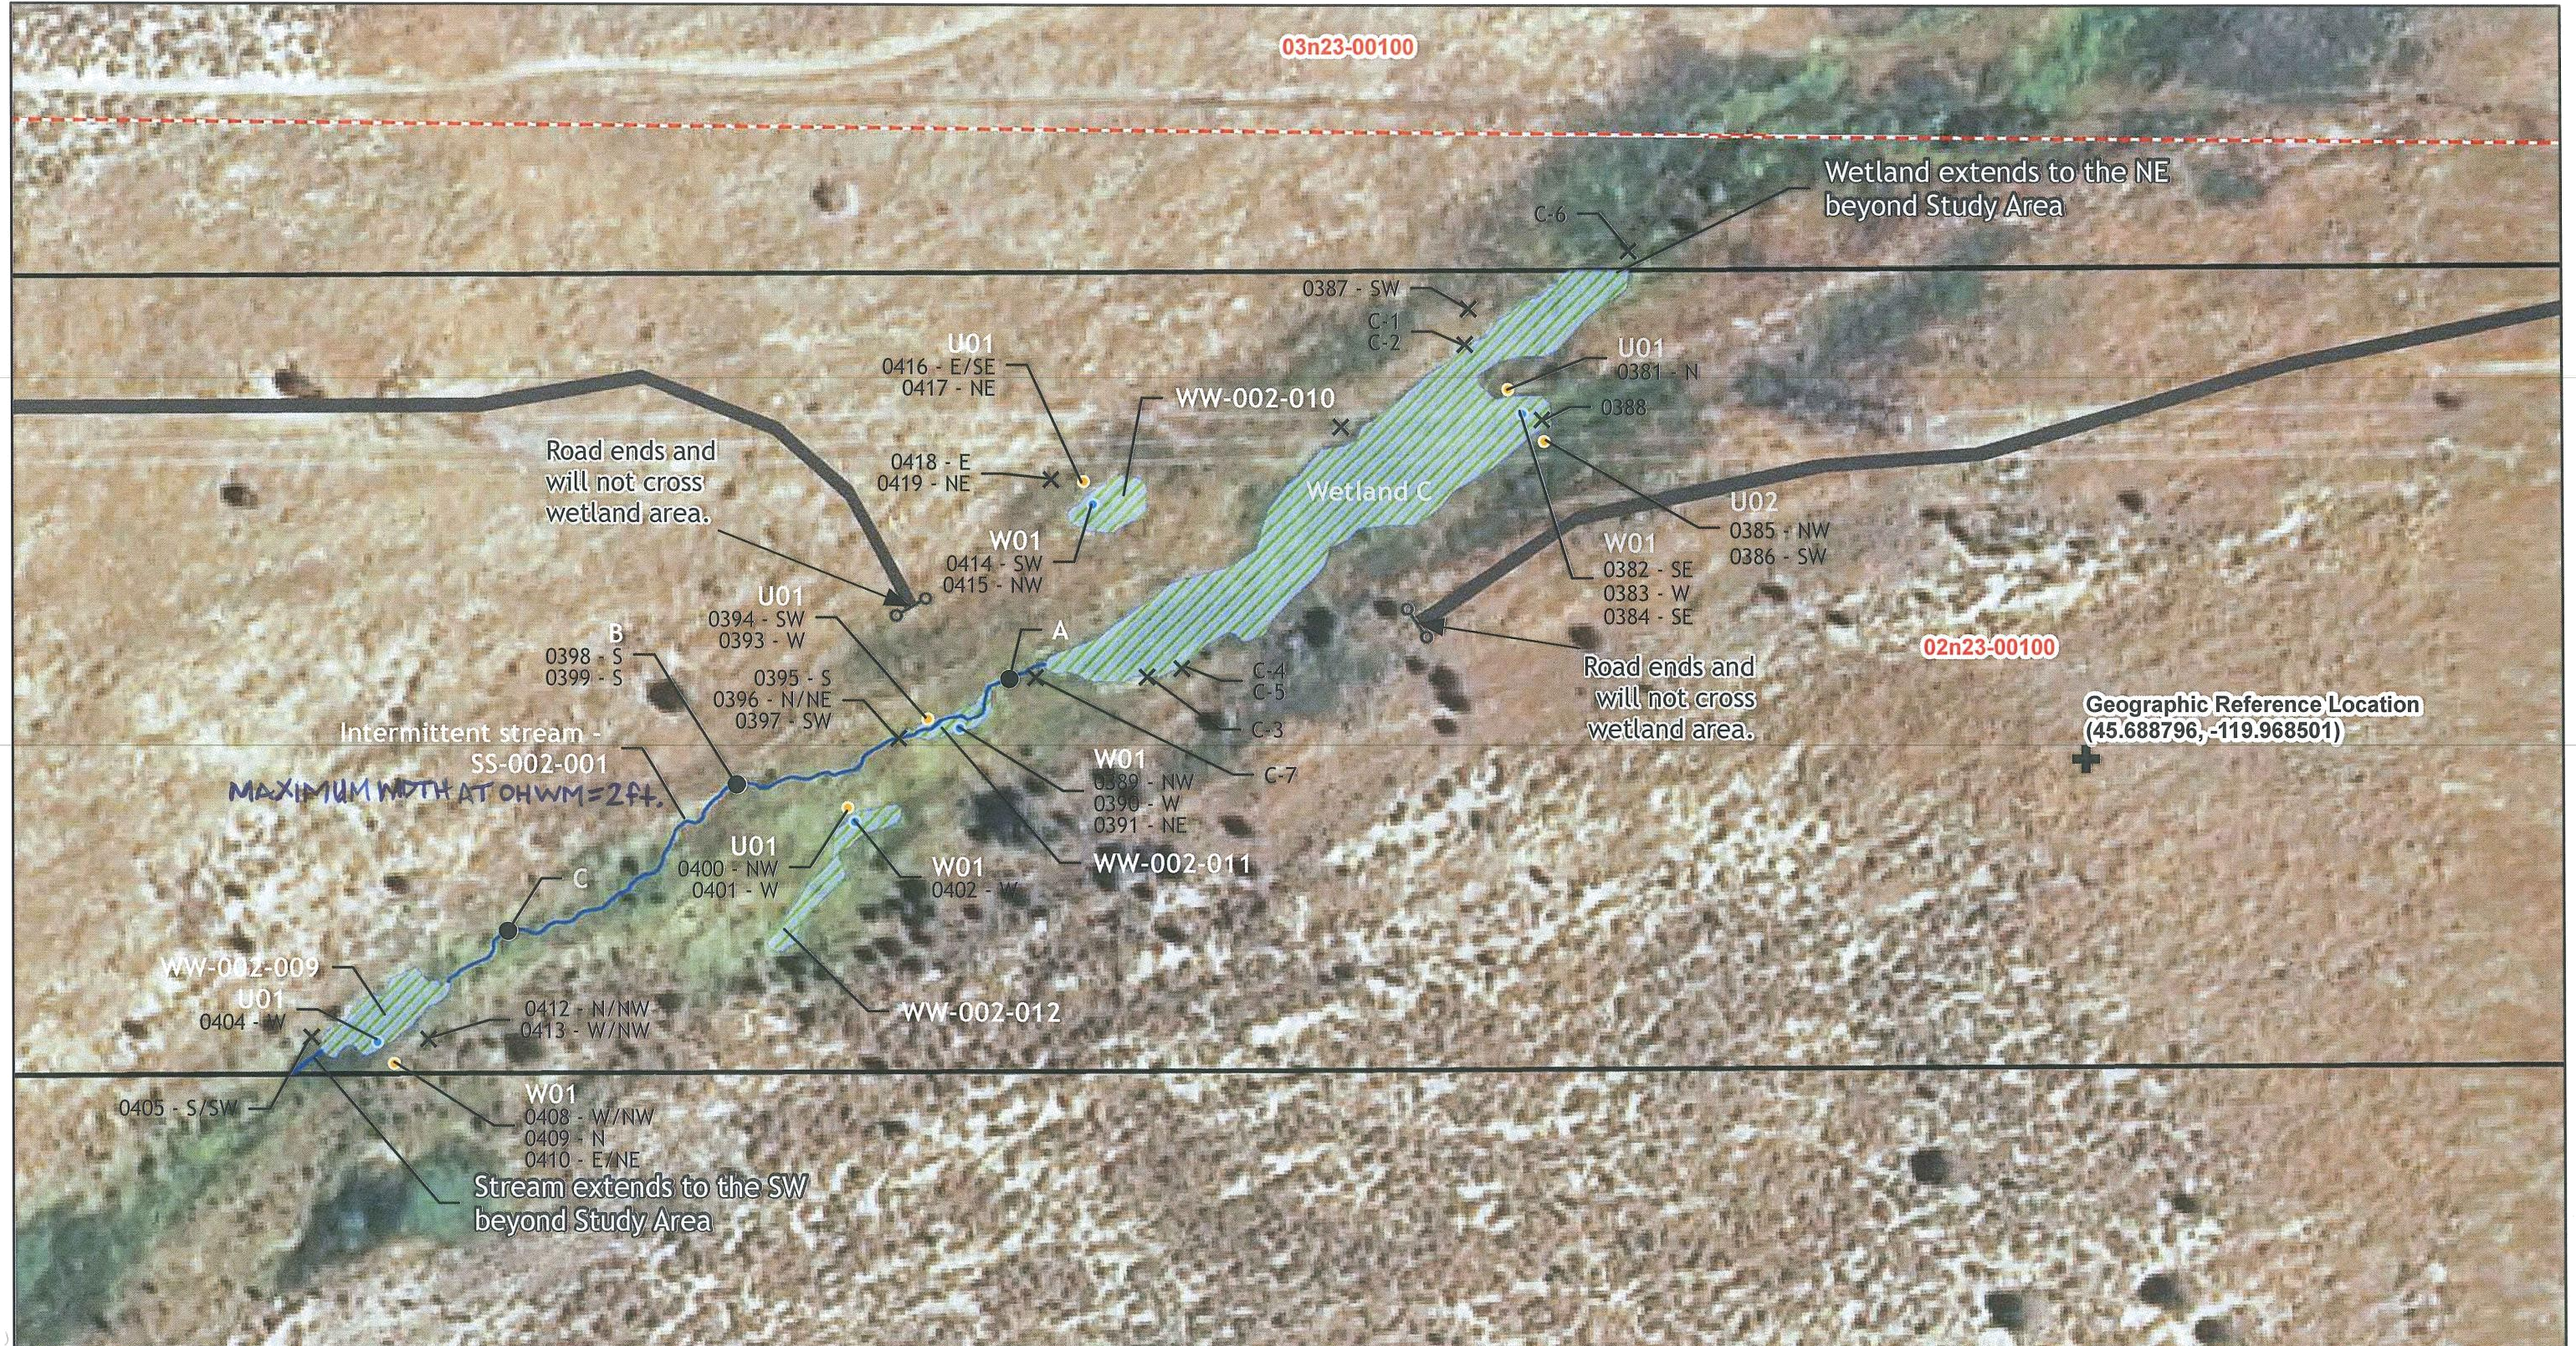
**Figure 5.3.1:  
Wetland C Area**  
PGE Carty Generating Station  
December 2013

\* SS-002-001  
intermittent &  
jurisdictional  
within study area  
OHWM MAX WIDTH = 2ft.

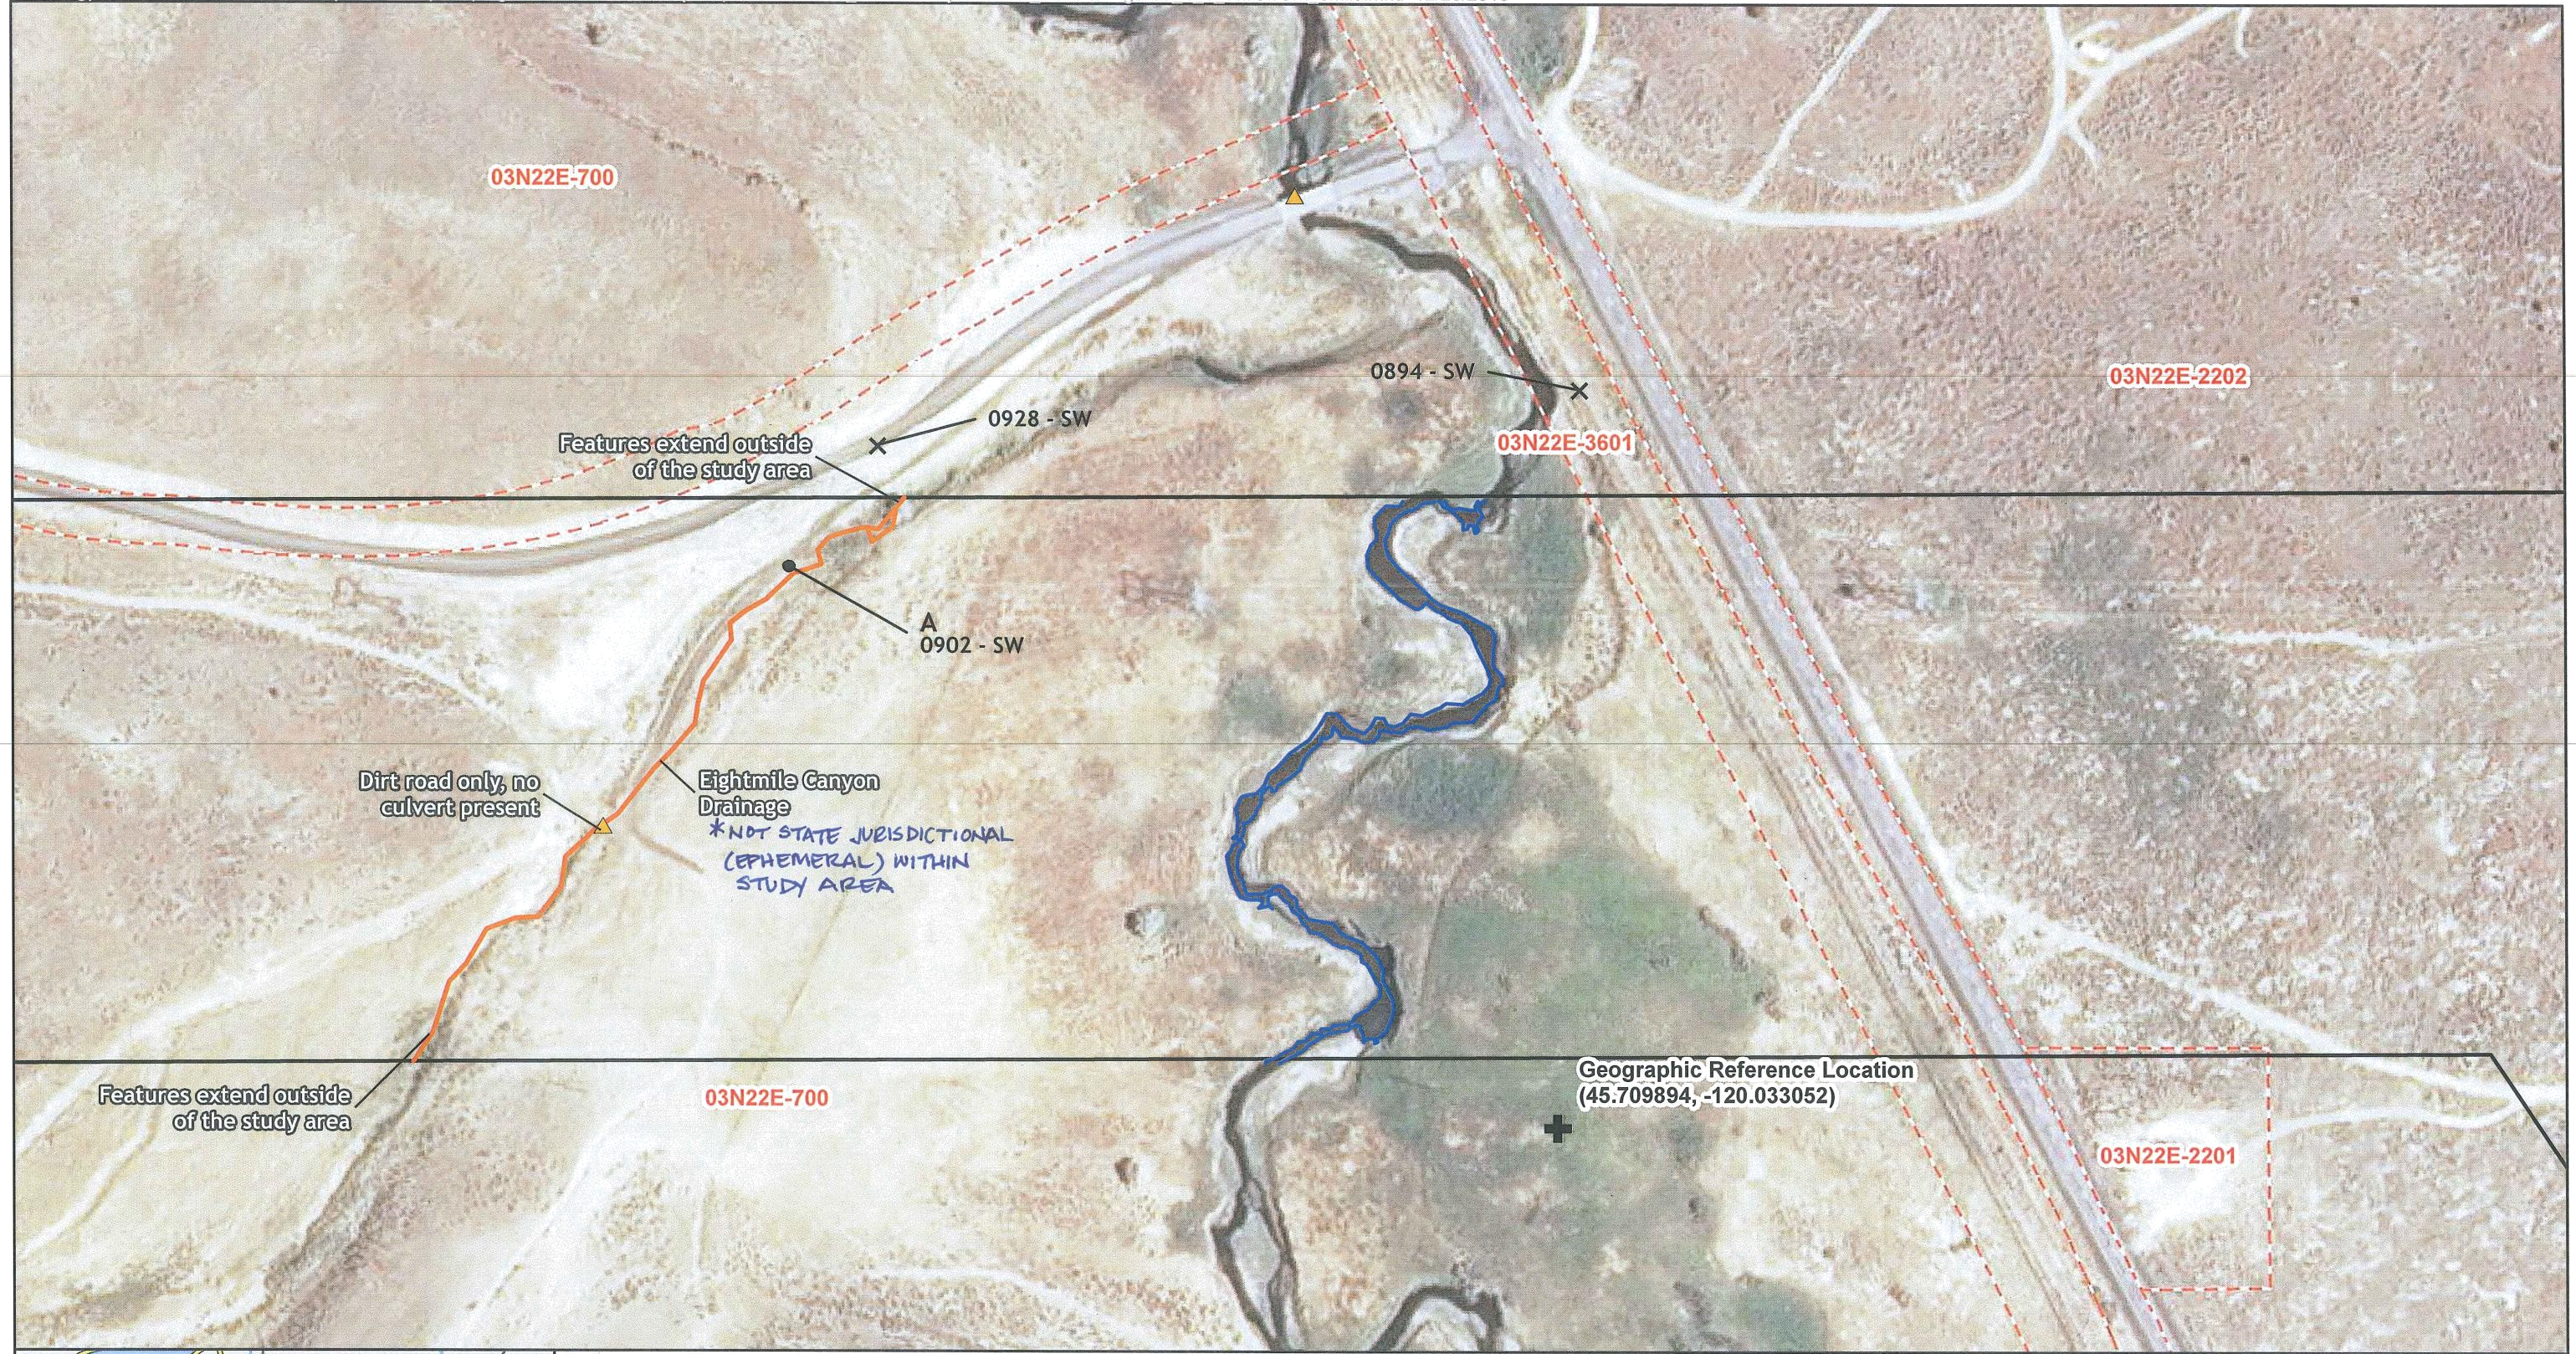
Green signature is a stand of russian thistle

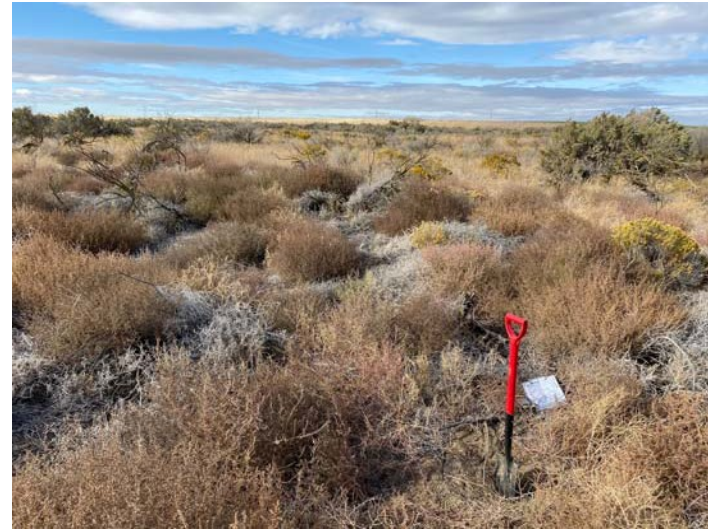
**Photo B.** View of Plot 3 facing west during the October 14, 2021 site visit.

Plots 3 and 4 were documented near the northernmost boundary of the study area in the lowest elevations. Both plots were dominant in Russian thistle (FACU) and cheatgrass (NOL) and subdominant in tall tumbled mustard (FACU). There were animal trails throughout the area (likely deer) that are visible on aerial photos. No channel or defined bed and bank were observed in the vicinity of Plots 3 and 4. Both plots lacked hydric soils and indicators of wetland hydrology and were therefore determined to be upland.

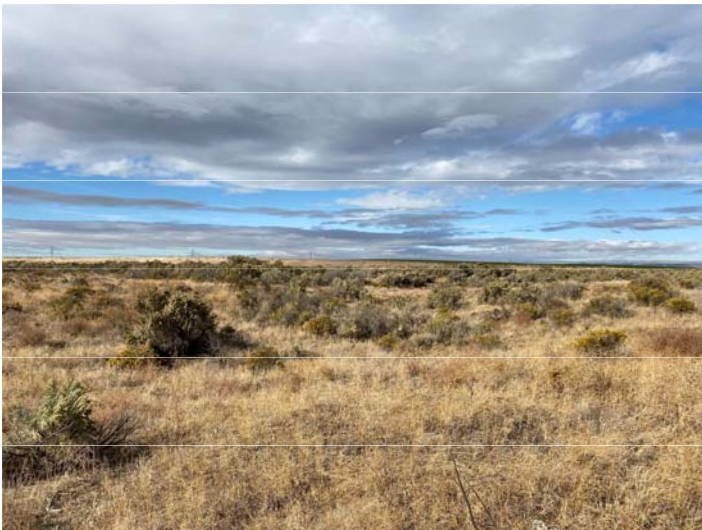
**Photo C.** View west of upland Plot 4 during the October 14, 2021 site visit.

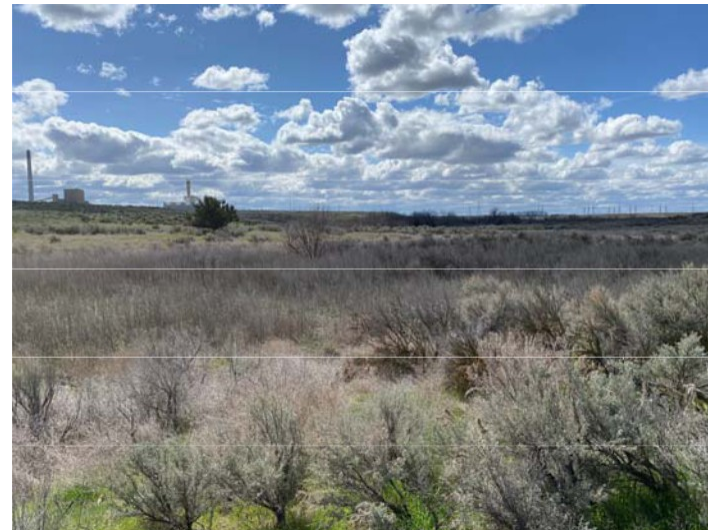
**Photo D.** View facing south towards Plots 1 and 2 and of higher elevation topographic area including Wetland A with juniper tree during March 31, 2022 site visit.

Plots 1 and 2 were documented in the potential inundation signature just north of Wetland A visible on the April 2021 aerial. There is an approximate 20 feet tall land bridge (with one Juniper species on top [*Juniperus spp.*, assumed FACU or drier]) separating the potential inundation signatures from one another (Photos D and H, Appendix F). The vegetation associated with Plots 1 and 2 were dominant in Scotch cottonthistle (NOL), and twoscale saltbrush (FAC). No channel or defined bed and bank was observed

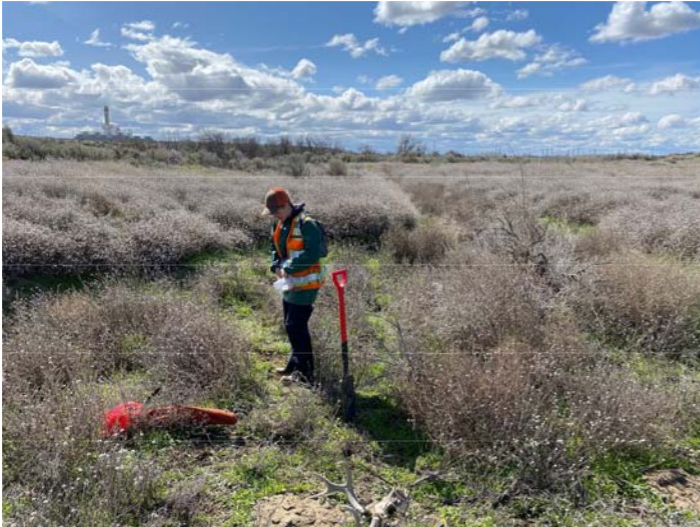
**Photo E.** View of Plot 5 during the March 31, 2022 site visit.

Plot 5 was taken in a low topographic location that was approximately 1.5 feet lower in elevation than the surrounding area. The plot was dominant in yellow star-thistle (NOL) and tumbled mustard (FACU). Plot 5 lacked hydric soils and indicators of wetland hydrology and was therefore determined to be upland. No defined bed and bank or OHWM were observed. There was no defined channel observed connecting to Wetland A or to the north of the plot.

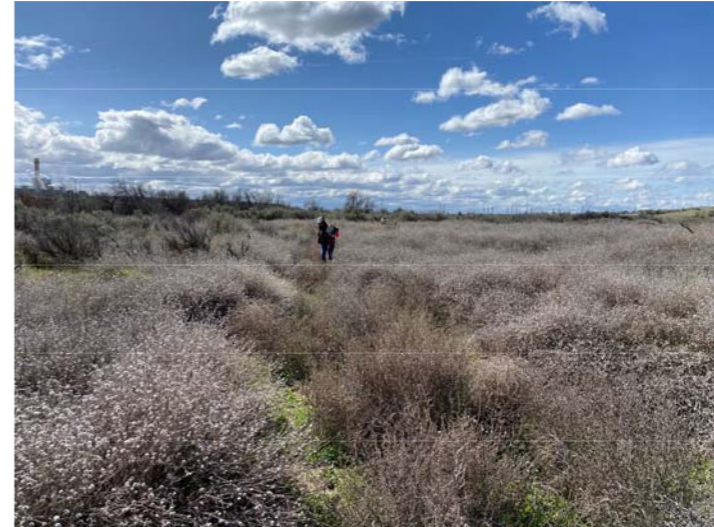
**Photo F.** View south from Plot 5 showing no channel or defined bed and bank present during March 31, 2022 site visit.

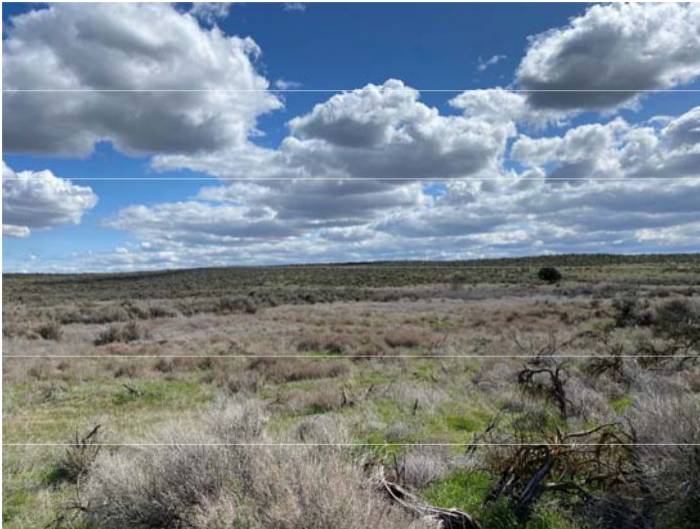
**Photo G.** View east towards Plots 1, 2, and 5 showing undulating topography and rolling shrub steppe plains during March 31, 2022 site visit.
