Re: **WD # 2022-0436 Approved**  
Wetland Delineation Report for Percheron Industrial Campus  
Morrow County; T3N R24E S28 TL100 (Portion)

USGS VICINITY MAP PERCHERON WETLAND AND WATER DELINEATION REPORT		FIGURE <b>1</b>
AKS ENGINEERING & FORESTRY, LLC 12965 SW HERMAN RD, STE 100 TUALATIN, OR 97062 503.563.6151    WWW.AKS-ENG.COM		DRWN: RAS CHKD: SKT AKS JOB: 8858-04

<b>WETLAND AND WATER DELINEATION OVERVIEW MAP</b>		FIGURE
		<b>5</b>
PERCHERON WETLAND AND WATER DELINEATION REPORT		DRWN: RAS
AKS ENGINEERING & FORESTRY, LLC		CHKD: SKT
12965 SW HERMAN RD, STE 100		AKS JOB:
TUALATIN, OR 97062		<b>8858-04</b>
503.563.6151 WWW.AKS-ENG.COM

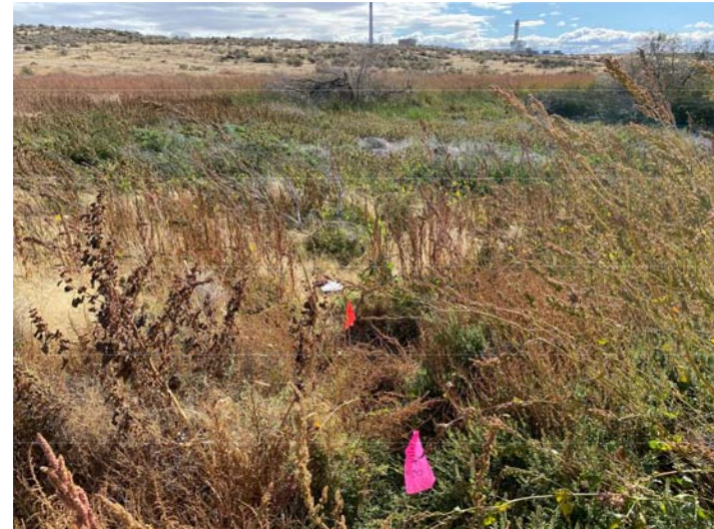
**Photo H.** View facing south from upland Plot 8 and Wetland A boundary towards Plot 7 and Plot 6 in the center of Wetland A approximately 5 feet lower in elevation than Plot 8. Photo taken during October 14, 2021 site visit.

The adjacent upland surrounding Wetland A is characterized by a low terrace situated approximately 3 to 5 feet higher in elevation on average that gives way to a higher elevation shrub steppe habitat in the surrounding landscape. The low terrace setting is depicted by the lighter green area shown on Google Earth aerials. During both the October 14, 2021 and March 31, 2022 site visits, the upland area adjacent to Wetland A as documented by paired upland Plots 8, 10, 12, and 14, was dominated by burningbush (FAC) and twoscale saltbush (FAC) with lesser amounts of swainson pea (FACU), Amaranthus species (FACU), lambsquarters (assumed FAC), prickly Russian thistle (FACU), catnip (FACU), Scotch cottonthistle (NOL) and yellow star-thistle (NOL). Slight differences in vegetation were observed between the fall and spring visits. During the October 14, 2021 site visit, there were some species observed in the upland area that had finished their life cycle by the spring visit such as: spider flower species (*Cleomella spp.*, NOL), clasping pepperwort (*Lepidium perfoliatum*, FACU), and prickly lettuce (*Lactuca serriola*, FACU). During the March 31, 2022, site visit there was additional tall tumbled mustard (*Sisymbrium altissimum*, FACU) and bare ground. A few yellow fritillaries (*fritillaria pudica*, NOL) were observed blooming in the higher elevation upland area. All upland plots lacked hydric soils and indicators of wetland hydrology.

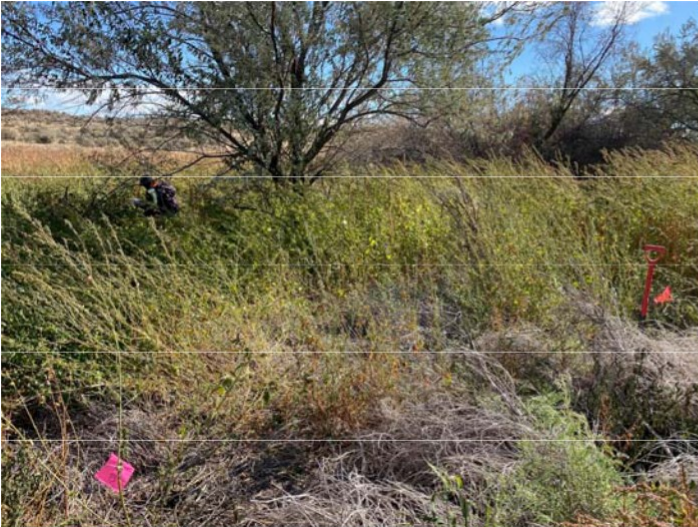
**Photo I.** View east of upland Plot 10 with Wetland A boundary and Plot 9 in the background during October 14, 2021 site visit.

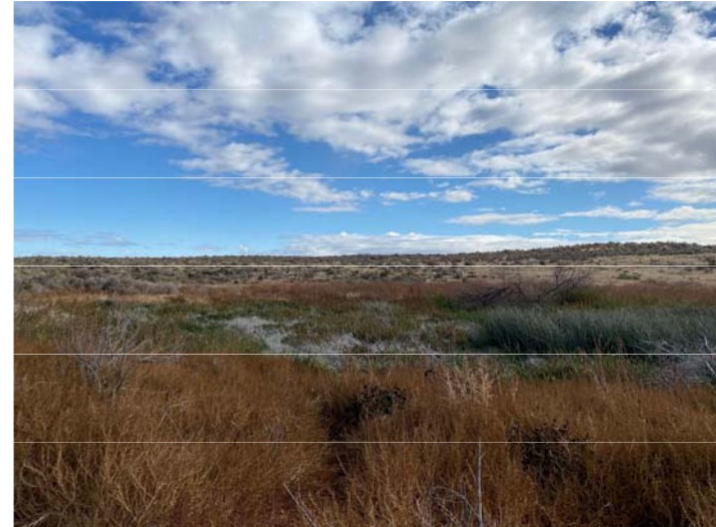
**Photo J.** View east of Wetland A located within low topographic depression during October 14, 2021 site visit.

Wetland A is a PFO/PEM wetland located in the southeastern portion of the study area within a low topographic depression. An intermittent drainage flows north into the southern boundary of Wetland A. No channel was observed flowing through or continuing north of the wetland; therefore, Wetland A lacks a surface water outlet. The main source of hydrology consists of direct precipitation and secondarily from subsurface flow and surface runoff from the adjacent upland that collects in the wetland from irrigation or from a period of heavy rain. Wetland A has an inlet channel, seasonal inundation, and a collection basin area greater than 2 feet deep; therefore, belongs to Depressional Closed Nonpermanent (DCNP) HGM subclassification.

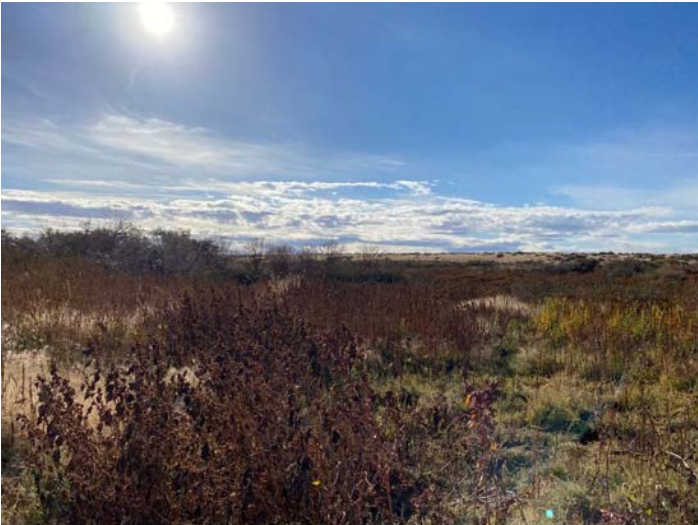
**Photo K.** View northwest towards Wetland A in low topographic depression from October 14, 2021 site visit.

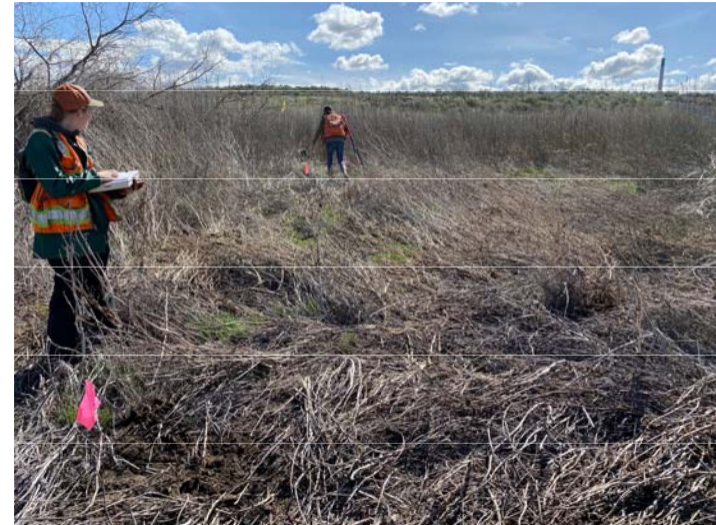
**Photo L.** View east of Plot 13 with Wetland A boundary toward upland Plot 14 located on approximately 3 feet higher in elevation than Plot 13. Photo taken March 2022 site visit.

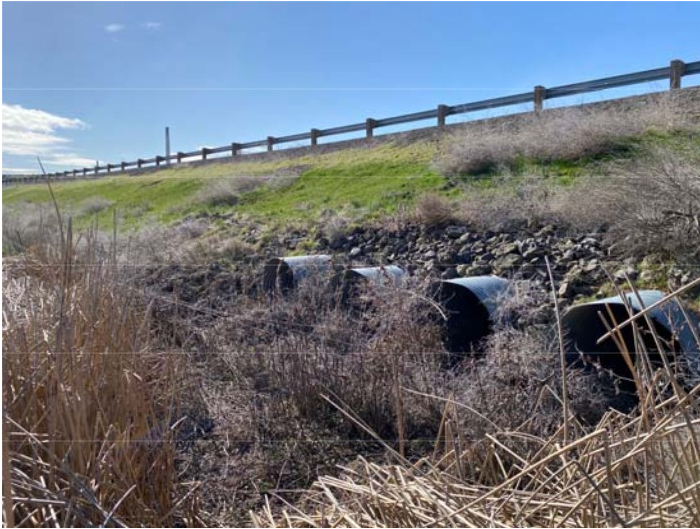
**Photo M.** View of 4 culverts under Tower Road draining into Interim Water 1 at March 31, 2022 site visit. No flow or surface water was present.

Intermittent Water 1 enters the study area from the southeast and connects to the southern boundary of Wetland A and does not continue north beyond the wetland. The channel bed was vegetated with Russian olive trees (FAC) and twoscale saltbush (FAC) with scattered Chairmaker's bulrush (OBL) and common reed (FACW) which were observed near the culvert openings under Tower Road. The slope of the stream reach is approximately 3 percent or less with undulating topography. Based on this data, the streamflow is considered intermittent. The EPA defines an intermittent stream as a channel that contains water for only part of the year, that may lack biological and hydrological characteristics, with greatly variable flow including stormwater runoff.

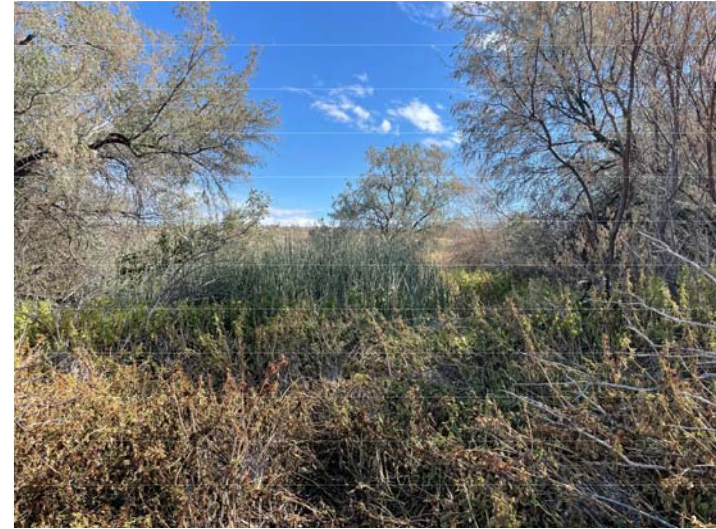
**Photo N.** View north of Interim Water 1 near Plot 18 from October 14, 2021 site visit.

loamy sand with duff from the Russian olive trees. Plots 15, 16, and 18 were taken in the channel to document the general conditions and all lacked hydric soil and indicators of wetland hydrology.

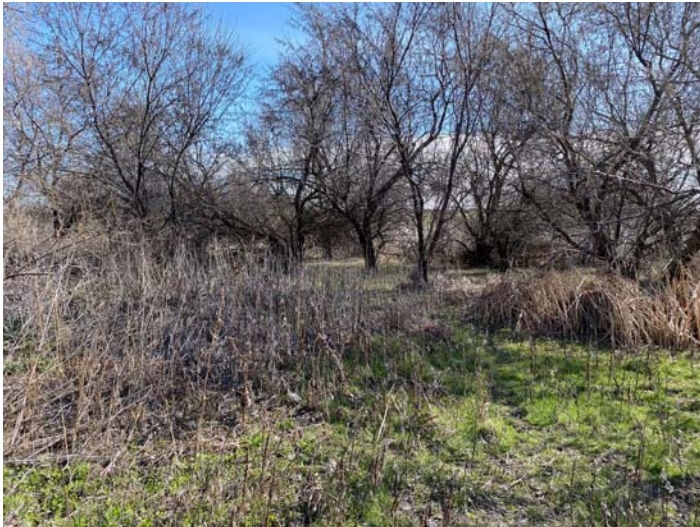
**Photo O.** View north of Interim Water 1 from Plot 15 during March 31, 2022 site visit.

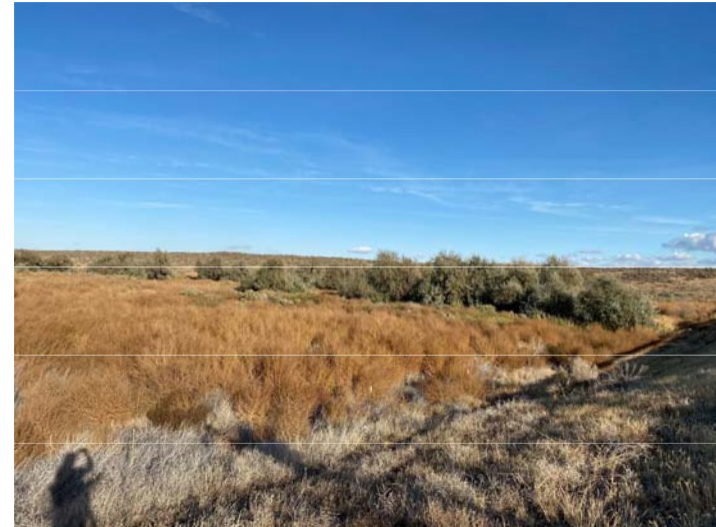
**Photo P.** View northeast towards Interim Water 1 within Russian olive tree grove from October 14, 2021 site visit.

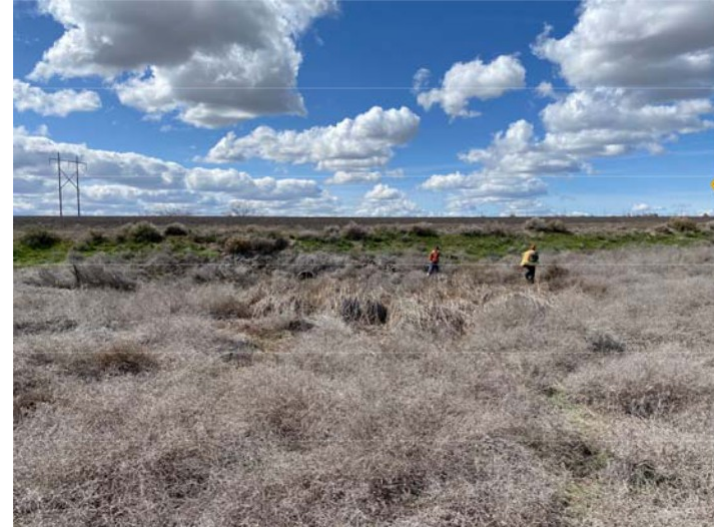
**Photo R.** View of Plot 17 facing southwest from March 31, 2022 site visit.

Plot 17 was documented in the northwestern corner of the study area to document the conditions on either side of a culvert crossing beneath Tower Road. The plot was taken in the lowest topographic area, approximately 15 feet from the culvert opening. No defined bed and bank or OHWM were observed on either side of Tower Road. Tumbled mustard (FACU), big sagebrush (NOL), and bitterbrush (NOL) were observed in the surrounding vicinity. The plant community at Plot 17 was dominant in Chairmaker's bulrush (OBL) and western goldentop (FACW). These species require prolonged periods of saturated soils for germination. Both species appeared to be dead with no evidence of new growth during both the October 2021 and March 2022 site visits. A reference site that was visited by AKS located several miles to the north of the study area contained both species, in which new growth was observed within conditions that contained saturated soils. Plot 17 lacked hydric soils and primary indicators of wetland hydrology. Therefore, this area was determined to be upland.

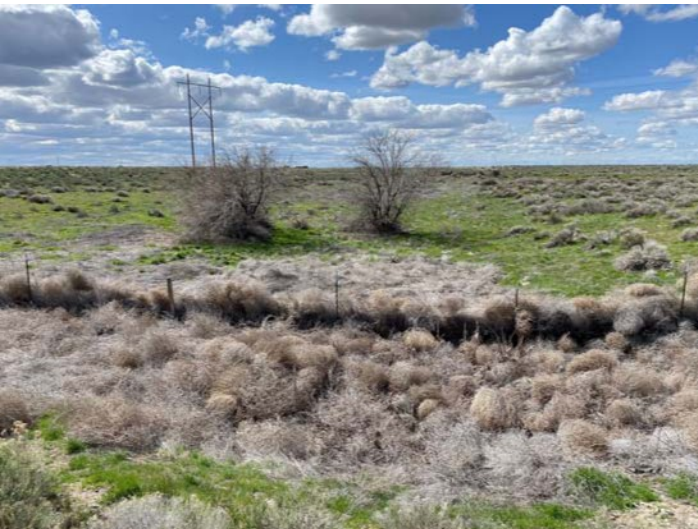
**Photo S** View facing southwest of the culvert on southern side of Tower Road from March 31, 2022 site visit.
