CORNER RESTORATION

CORNER: 1/4 corner between Section 34, T2N, R23E
and Section 3, T1N, R23E, W.M.

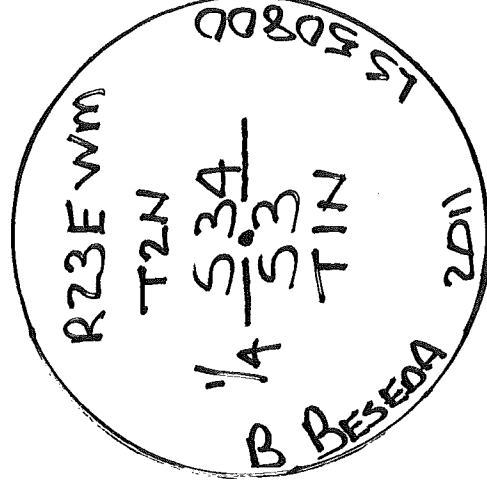
With no traces of the original monument found, the corner position was accepted to be at the intersection of the ancient fences running north and west from this location.

Set 5/8" x 30" rebar with 2-1/2" diameter stamped aluminum cap at the 1/4 corner position.
Monument is set 0.1 feet +/- out of ground.

The following references being 5/8" x 30" rebar with yellow plastic cap stamped "B BESEDA PLS #50800" were set flush with natural ground and bear as follows from the 1/4 corner, unless otherwise noted.

1. North 26°53'58" West 11.26 feet.
2. North 52°06'31" East 25.09 feet.
3. South 39°41'49" East 49.32 feet.
4. South 01°26'50" East 15.20 feet.
