CORNER RESTORATION

CORNER: Corner common to Sections 4, 5, 8 & 9,
T1N, R23E, W.M.

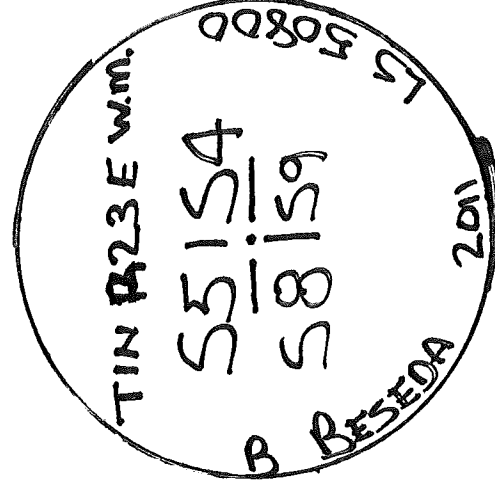
With no traces of the original monument found, the corner position was accepted to be at the intersection of the ancient fences running to the east, west and north from this location.

Set 5/8"x 30" rebar with 2-1/2" diameter stamped aluminum cap at section corner position.
Monument is set flush with the ground.

Set 5/8" rebar with yellow plastic cap stamped "B BESEDA PLS #50800" as references as follows from the section corner:

1. North 89°42'00" East 39.92 feet. Set in east west fence.
2. South 22°55'37" West 52.23 feet.
3. North 89°48'47" West 40.43 feet. Set in east west fence.
4. North 02°44'30" West 32.20 feet. Set on west side of north south fence.

All references are set flush with ground surface.
