CORNER RESTORATION

CORNER: Corner common to Sections 13 & 24, T2N, R22E, and Sections 18 & 19, T2N, R23E, W.M.

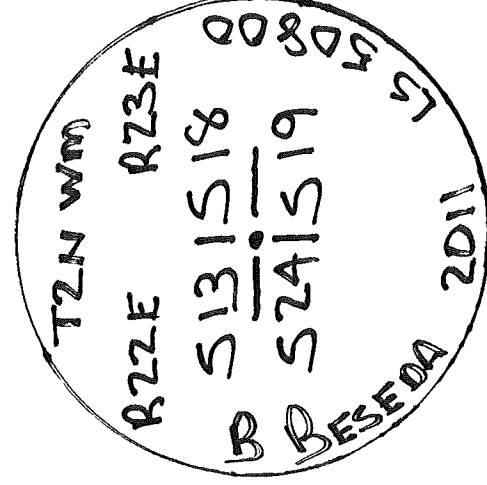
Set 5/8"x 30" rebar with 2-1/2" diameter stamped aluminum cap at section corner position. Monument is set flush with the ground.

Set 5/8" rebar with yellow plastic cap stamped "B BESEDA PLS #50800" as references as follows from the section corner:

1. North 67°13'47" East 58.43 feet.
2. South 20°29'57" East 66.07 feet.
3. South 47°20'42" West 69.33 feet.
4. North 29°26'59" West 65.72 feet.

All references are set flush with ground surface.
