### CORNER RESTORATION

**CORNER:** Corner common to Sections 13 & 24, T2N, R22E, and Sections 18 & 19, T2N, R23E, W.M.

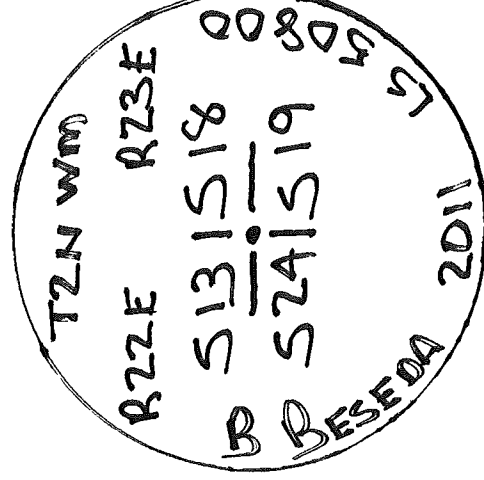
Set 5/8"x 30" rebar with 2-1/2" diameter stamped aluminum cap at section corner position. Monument is set flush with the ground.

Set 5/8" rebar with yellow plastic cap stamped "B BESEDA PLS #50800" as references as follows from the section corner:

1. North 67°13'47" East 58.43 feet.
2. South 20°29'57" East 66.07 feet.
3. South 47°20'42" West 69.33 feet.
4. North 29°26'59" West 65.72 feet.

All references are set flush with ground surface.

With no traces of the original monument found, the corner position was calculated per the ALTA/ACSM Survey for the Willow Creek Wind Farm at the location of ancient fence corner remnants.
