CORNER RESTORATION

CORNER: Corner common to Sections 21, 22, 27 & 28,
T2N, R23E, W.M.

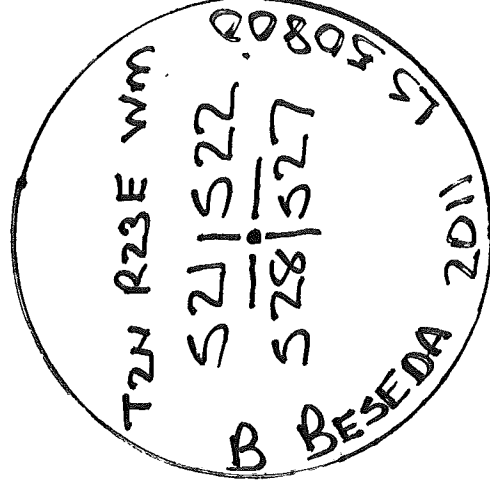
Set 5/8"x 30" rebar with 2-1/2" diameter stamped aluminum cap at section corner position.
Monument is set flush with the ground.

Set 5/8" rebar with yellow plastic cap stamped "B BESEDA PLS #50800" as references as follows from the section corner:

1. North 36°42'54" East 54.12 feet.
2. South 49°13'58" East 31.79 feet.
3. South 46°28'22" West 58.56 feet.
4. North 43°55'35" West 60.00 feet.

All references are set flush with ground surface.

With no traces of the original monument found, the corner position was accepted to be the intersection of the ancient fences running north, east and west from the corner location.
