CORNER RESTORATION

CORNER: Corner common to Sections 29, 30, 31 & 32,
T2N, R23E, W.M.

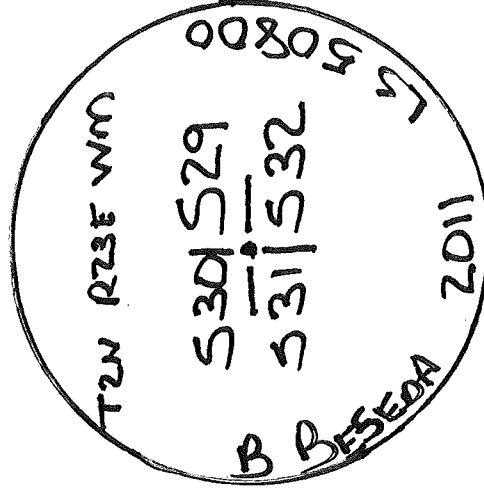
Set 5/8" x 30" rebar with 2-1/2" diameter stamped aluminum cap at section corner position.
Monument is set flush with the ground.

Set 5/8" rebar with yellow plastic cap stamped "B BESEDA PLS #50800" as references as follows from the section corner:

1. North 44°39'10" East 40.96 feet.
2. South 89°53'14" East 27.43 feet. Set in east west fence.
3. South 00°58'13" East 28.58 feet. Set in north south fence.
4. South 89°20'29" West 29.15 feet. Set in east west fence.

All references are set flush with ground surface.
