UMATILLA COUNTY 2004  
PUBLIC LAND CORNER REMONUMENTATION

**NARRATIVE OF SURVEY**  
For the narrative of survey and a list of the final Second Order NGS State Plane Coordinate values for the contract corners see Sheet 2 of this map.

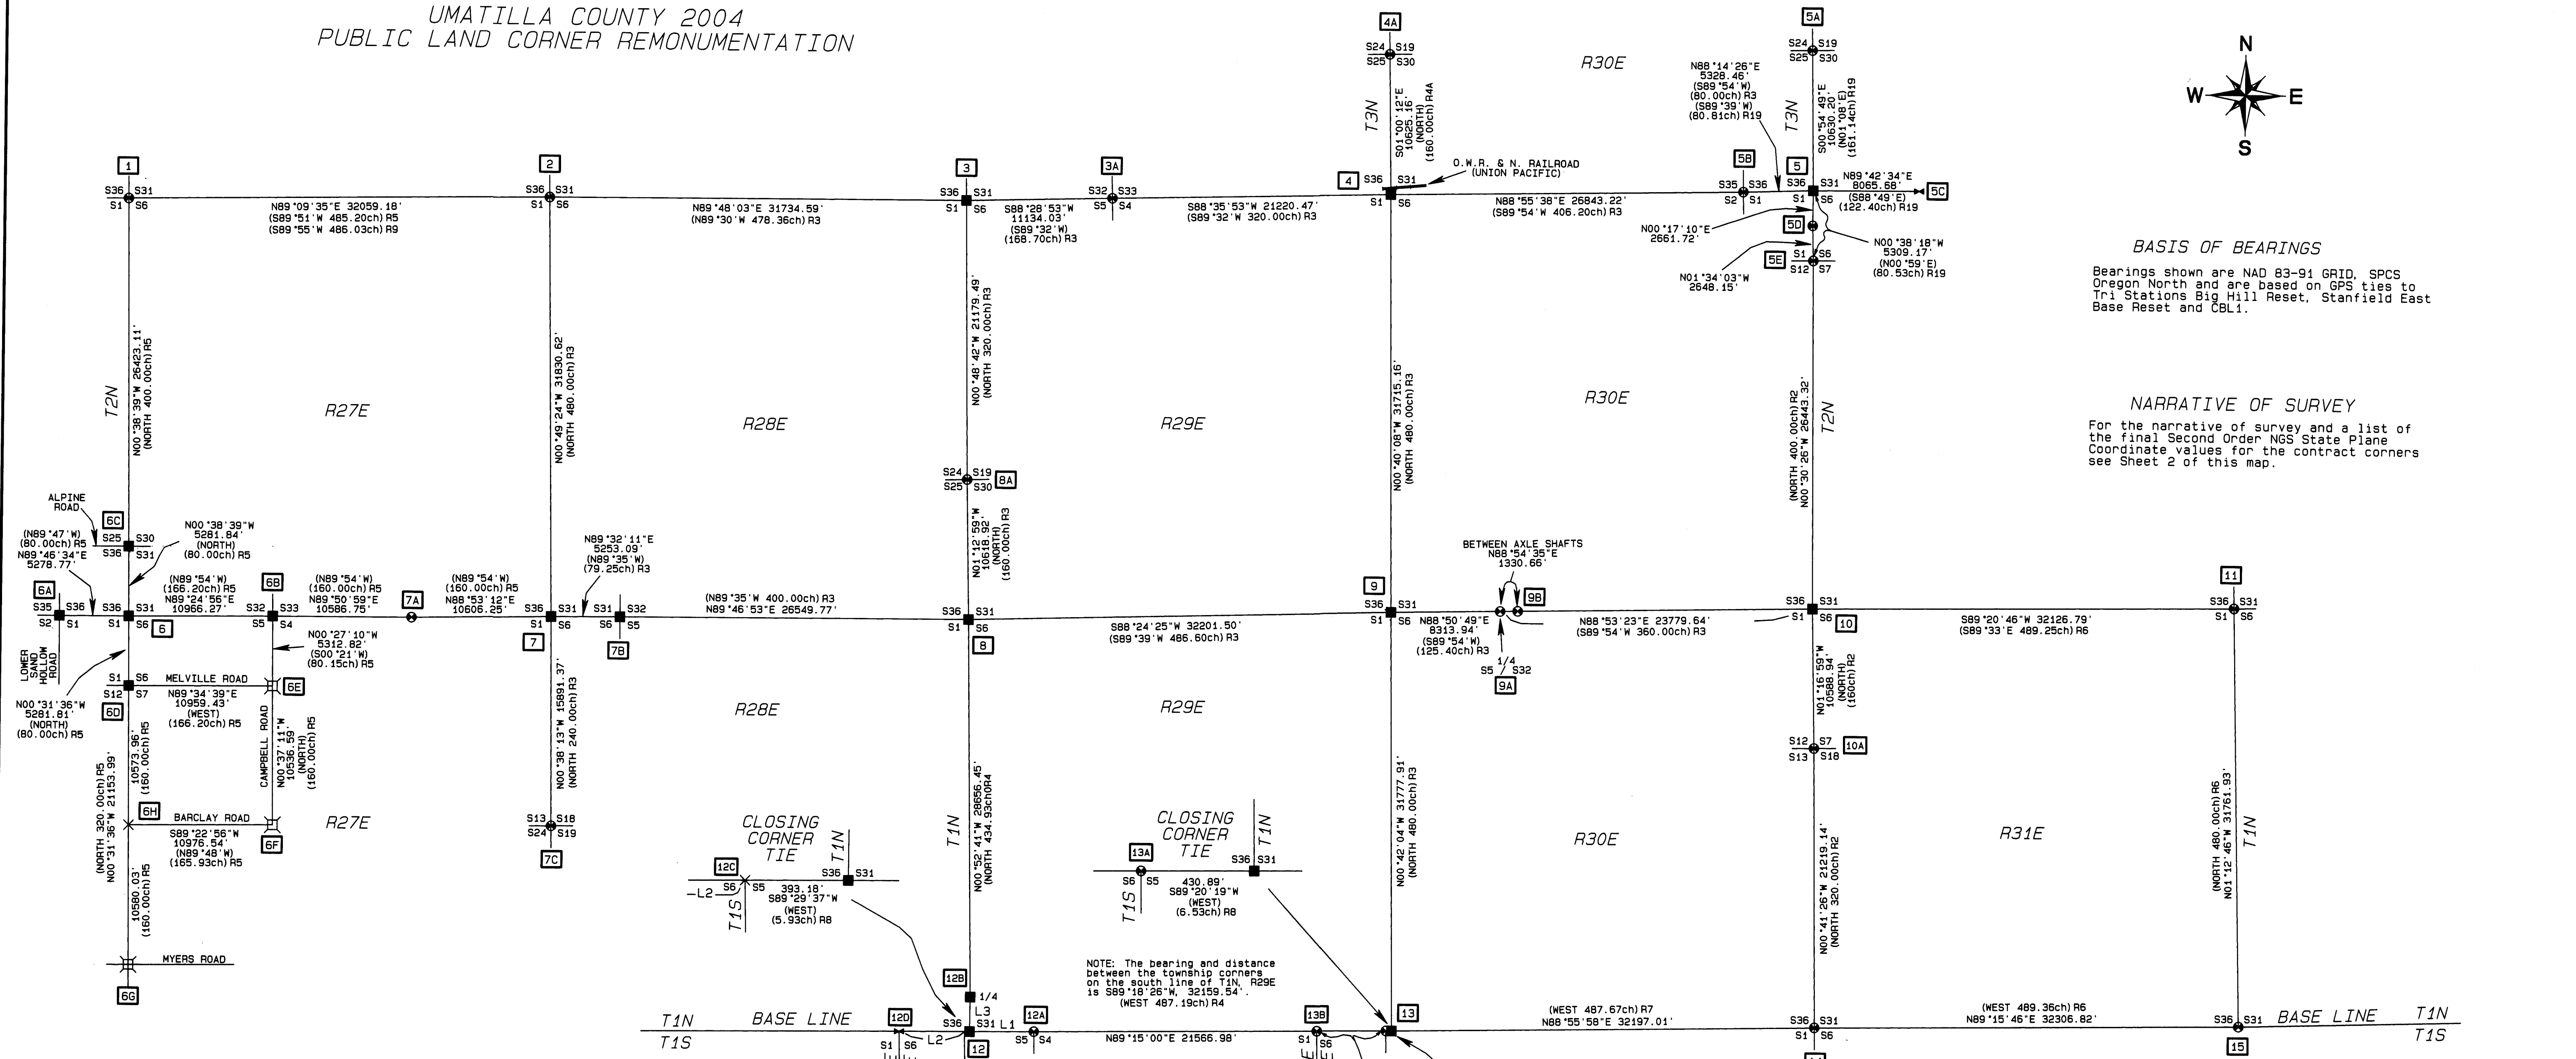
**BASIS OF BEARINGS**  
Bearings shown are NAD 83-91 GRID, SPCS Oregon North and are based on GPS ties to Tri Stations Big Hill Reset, Stanfield East Base Reset and CBL1.

The purpose of this survey was to find or re-establish the 15 primary township corners as shown on this map. The additional corners shown were positions used to verify or re-establish the primary corners. The measurements given are to show the relationship of these corners to one another. This survey should not be considered to be a complete display of all township / section line data as I only searched for enough of the corners along each line to verify or replace the primary corners.

**1** This corner is monumented with a 3" iron pipe and brass cap set by Mr. Otis Gould in 1939. The monument is in good condition and firmly set. The windmill Mr. Gould called for has been taken down.

**2** This corner is currently monumented with a brass cap in a valve box monument case in the west shoulder of Oregon Highway 207. It is firmly set in the asphalt and is in good condition.

**3A** This corner is currently monumented with an iron pipe and brass cap set by Mr. Don Staebler in 1974. The monument was firmly set and in good condition. I used it as one of the project base stations.

**4A** This corner is currently monumented by a 2" aluminum pipe with an aluminum cap set by Mr. Robert Stratton under survey No. 01-101-B. The monument is in good condition and firmly set.

**5** This corner was the subject of a dispute in 1915 as can be seen in the survey by Willard Bradley recorded in the Record of Private Surveys, Book 2, Page 270. Mr. Bradley chained from the disputed corner to accepted monuments north, south, east, and west and established a corner point by double proportionate measurement. He monumented his corner with a stone. The landowner, Mr. Bill Dick, levelled this area in the 1970's to build a corral. I found Mr. Bradley's stone, plainly marked, and out of position in the face of the fill made by Mr. Dick. In 1999, Mr. Gary Wagner established another position for this corner under survey 99-133-B. His survey says "fence corner held". There is no actual fence corner at this point. That position falls in an alley of the corral. Mr. Wagner did not set any monument. I reestablished this corner point at the position of the "disputed" corner using Bradley's record distances to the north, west, and south. This position fits the road centerlines to the east and west and is in line with the fence to the south. It is obvious from the continued occupation that Mr. Bradley's proportioned point, which was 90' to the west, was never adopted as the accepted corner position. I therefore hold the location which has been in use since some time prior to 1915.

**5A** At this corner I found a 1/2" iron pipe with a point forged on it set over the top of an old buggy spindle. I did not find Bradley's stone but the point now falls in the middle of a road intersection with roads running north, east, and south. The fence line to the north can still be seen.

**5B** This corner is currently monumented with a basalt stone as called for in both the Bradley and Wagner surveys. The stone is in good condition, is firmly set and has a County Monument sign on a nearby guard post.

**5C** I did not find the stone set by Bradley for this corner point. The position shown on this map is the intersection of the east - west road centerline and a north - south plow berm. I found a guy line anchor in the field south of the road that indicates there may have been a power line running along the plow berm to the north.
