SURVEY LOCATED IN T1S, R25E, W.M., MORROW COUNTY, OREGON

RECEIVED BY
Morrow County Surveyor
Date: 9-28-2015
Rec'd By: S.K.H.
No.: 2015-1748C
Folder No.: 1748

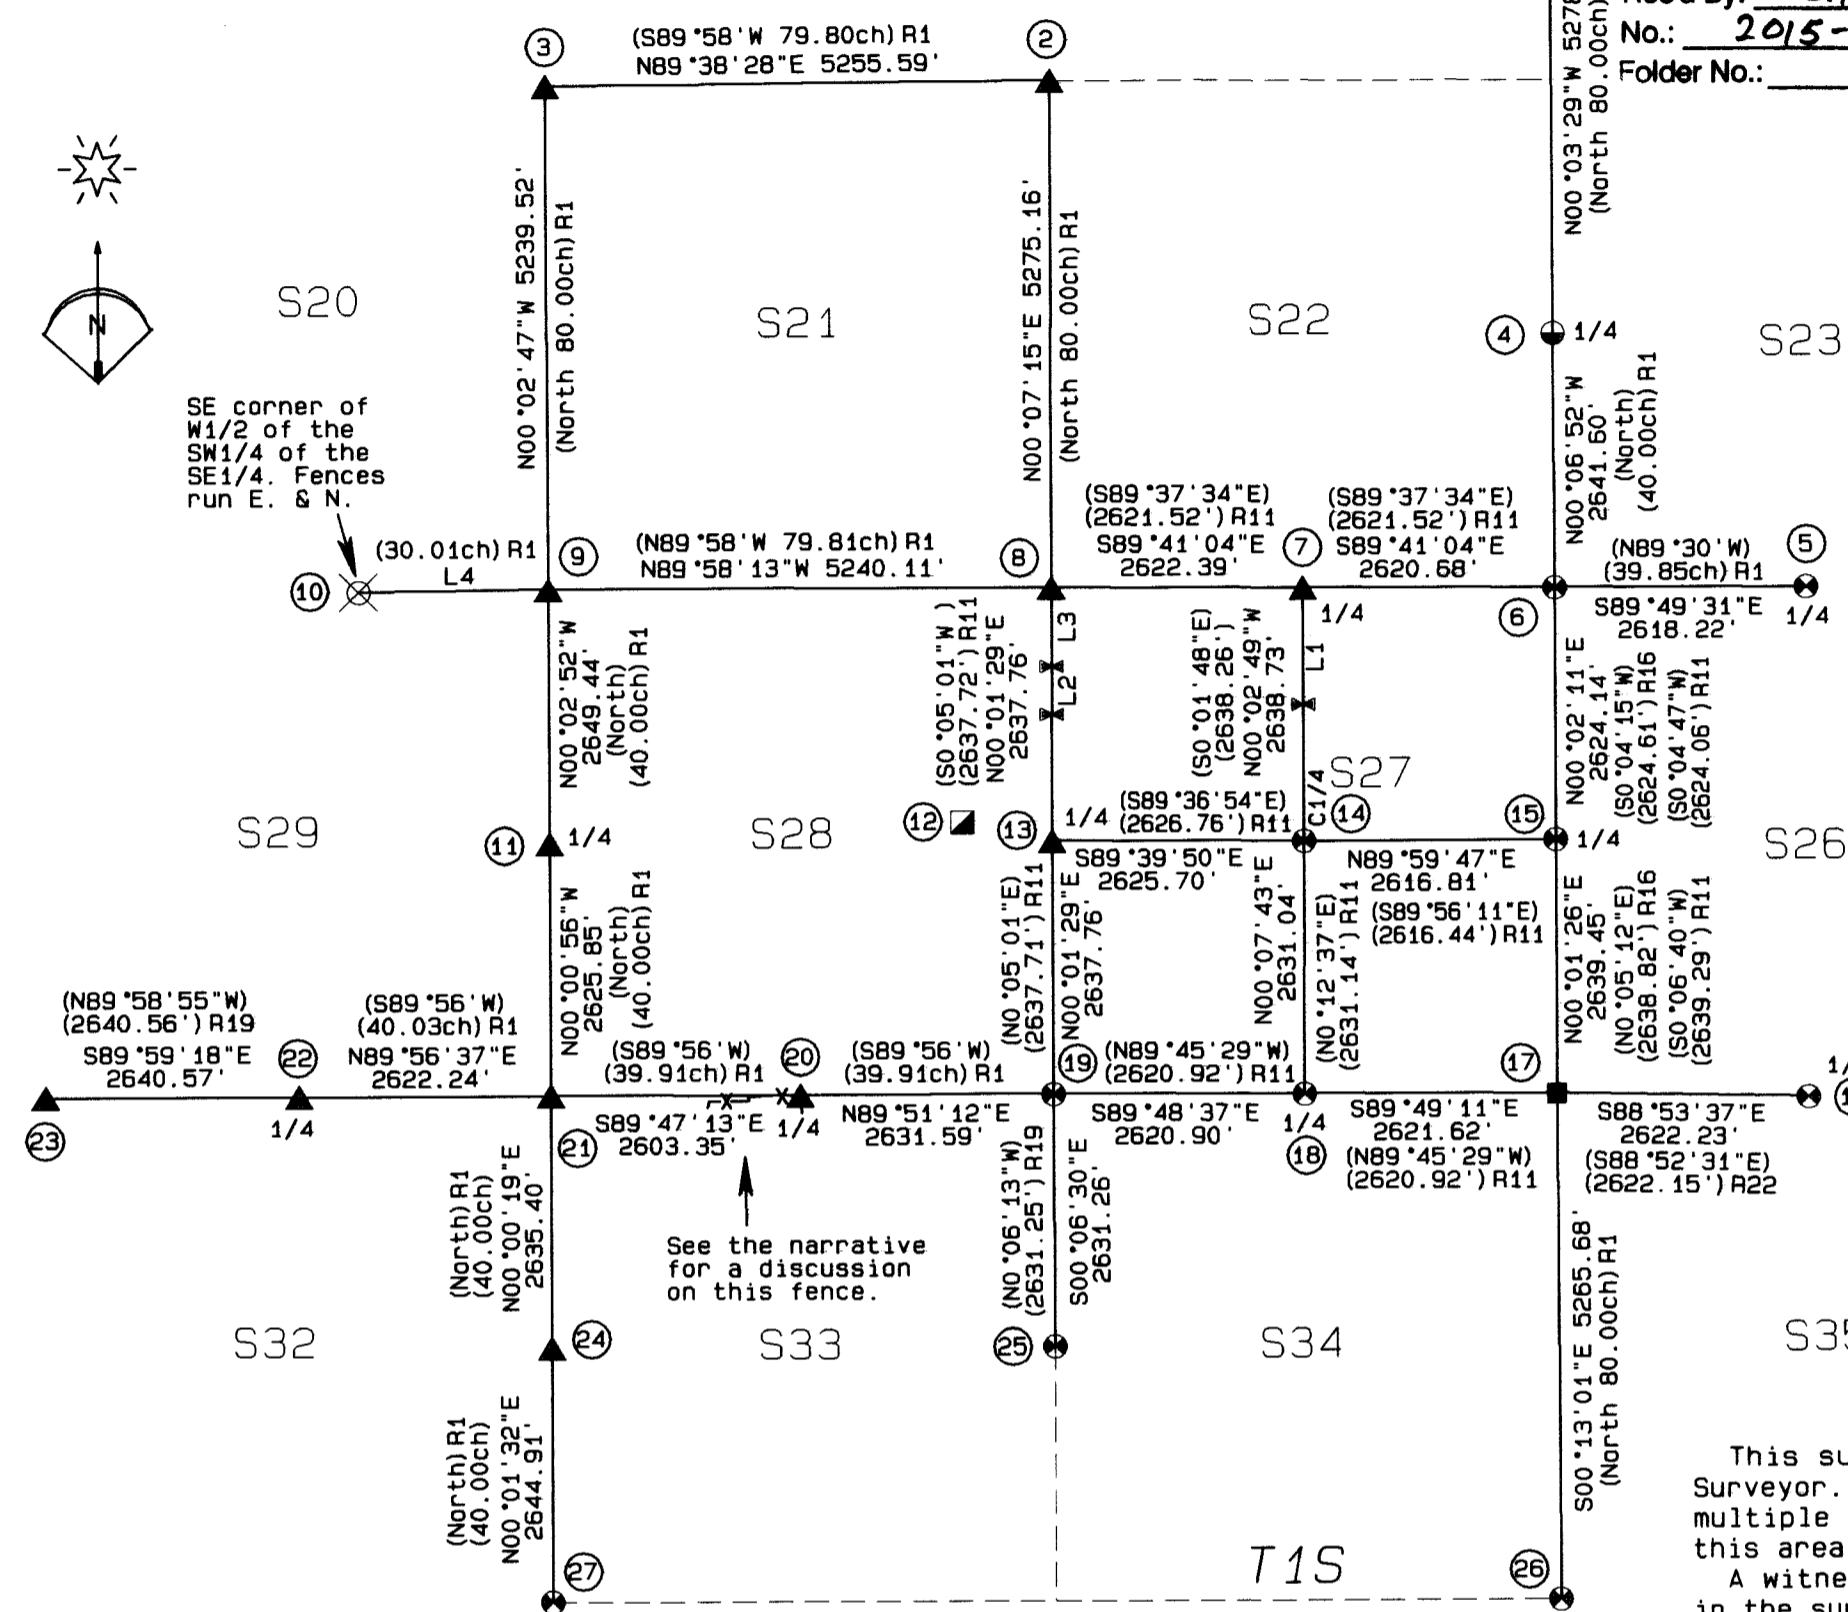
- ① Found brass cap set under the survey in folder 526 8 inches below the surface of the paved road.
- ② Held fence corner with fences running North, West and South.

- ③ Held four way fence corner with fences running North, West, East and Southwest and a plow berm south along the section line.
- ④ Held intersection of north-south Highway centerline and field line running east approximately one mile.

- ⑤ Held brass cap set under the survey in folder 1700. See the filed corner certificate.
- ⑥ Found brass capped witness corner from the survey in folder 624. The position shown is the true point calculated 35 feet west on line as per data on the cap.

- ⑦ Set brass cap 2 feet below the surface of a plowed field at the position determined by intersecting the north section line and the north - south center section line which were determined by holding the monuments from the survey in folder 624.

- ⑧ Found brass capped witness corner. Set brass cap at point of intersection of the west and north section lines which were projected through the found monuments from the survey in folder 624.

- ⑨ Held point of intersection of east-west fence line with the projection of a fence to the south and a plow berm to the north.
- ⑩ This rock jack was testified to by Century Farm owner, Mr. Robert Harrison, as having been rebuilt several times but always in the same place.

- ⑪ Found 10" spike at fence corner with fences running West and South. The brass cap reported in the survey in folder 1451 was not set. Held spike location and set brass cap.

- ⑫ Found 5/8" iron rebar at the westerly corner of parcel 3 partition plat 96-9. The point was tied to confirm the location of the monument at the SW corner of Section 27. Record tie = N18°10'16"W 2981.13'. Measured tie = N18°14'30"W 2981.21'.

- ⑬ Set brass cap at the proportionate point as per the Manual of Instructions and the survey in folder 624.
- ⑭ Found brass cap set by the survey in Folder 624.

- ⑮ Found brass cap and references reset by the survey in folder 1348 from information shown on the survey in folder 624.
- ⑯ Found brass cap set by the survey in folder 1700. See the filed corner certificate.

- ⑰ Found a 5/8" iron rebar, apparently from the survey in folder 605 at the corner point. Also found the brass capped witness corner 10 feet north.
- ⑱ Found brass cap set by the survey in Folder 605.

- ⑲ Found a brass cap 0.4' south of a 2 1/2" galvanized iron pipe. Both are visible at ground surface. Ties were made to the 1/4 corners S. and E. and to the rebar at the westerly corner of Parcel 3, Partition 96-9 to confirm that the pipe was moved when the brass cap was set. The brass cap was set under survey 1451.

- ⑳ Set brass cap at fence corner with fences running south and west. No monument was found at the proportioned point from survey 1451.
- ㉑ Set brass cap at the intersection of a projected fence from the north and plow berm west that was held in survey 1451. This position falls 1' west and 6.5' north of the proportioned point from survey 1451. No evidence of the monumentation from that survey was found.

- ㉒ Found a 5/8" iron rebar from survey 1451 with plow berms running east, west, and north. The brass cap reported in that survey was not set.
- ㉓ Found a PK nail in the burnt remains of a 5" locust fence corner post with plow berms running east, west, and south. No evidence of the brass cap reported in survey 1451 could be found.

- ㉕ Found a brass cap from survey 1451 set at the remains of a four way fence intersection with fences running in cardinal directions.
- ㉖ Found a brass cap from survey 1451 set at the remains of a fence intersection with the remains of fences running west and south.

- ㉗ Found a brass cap from survey 1451 set at railroad tie fence corner with fences northwesterly and east, a plow berm south, and the projected centerlines of the county road to the north and west.

A witness monument was set for the Northwest corner of Section 27 in the survey in folder 624. The found witness monument was stamped 15' West. However, there were serious distance discrepancies between the found monuments and the distances reported on the survey along the north and west section lines. To locate the true corner point, I held the found monuments as controlling the north and west section lines and projected those lines to an intersection point. This resulted in much better agreement with the record section line lengths.
