THE PURPOSE OF THIS SURVEY IS TO STAKE THE CORNERS OF LOT 6, BLK 3 "HILLVIEW ESTATES" SO SEE WHERE A SANITARY SEWER LIES ON SAID LOT.

MAP FOR BILL ESTES  
 LOT 6, IN BLOCK 3, "HILLVIEW EST,"  
 IN NW 1/4 SEC. 17, T 4 N, R 25 E,  
 W.M., MORROW COUNTY, OREGON  
 09/26/2006 JOB#S0609164  
 EDWARDS SURVEYING P.O. BOX 763  
 541-567-3336 HERMISTON, OR 97838  
 DRAWN BY JMC

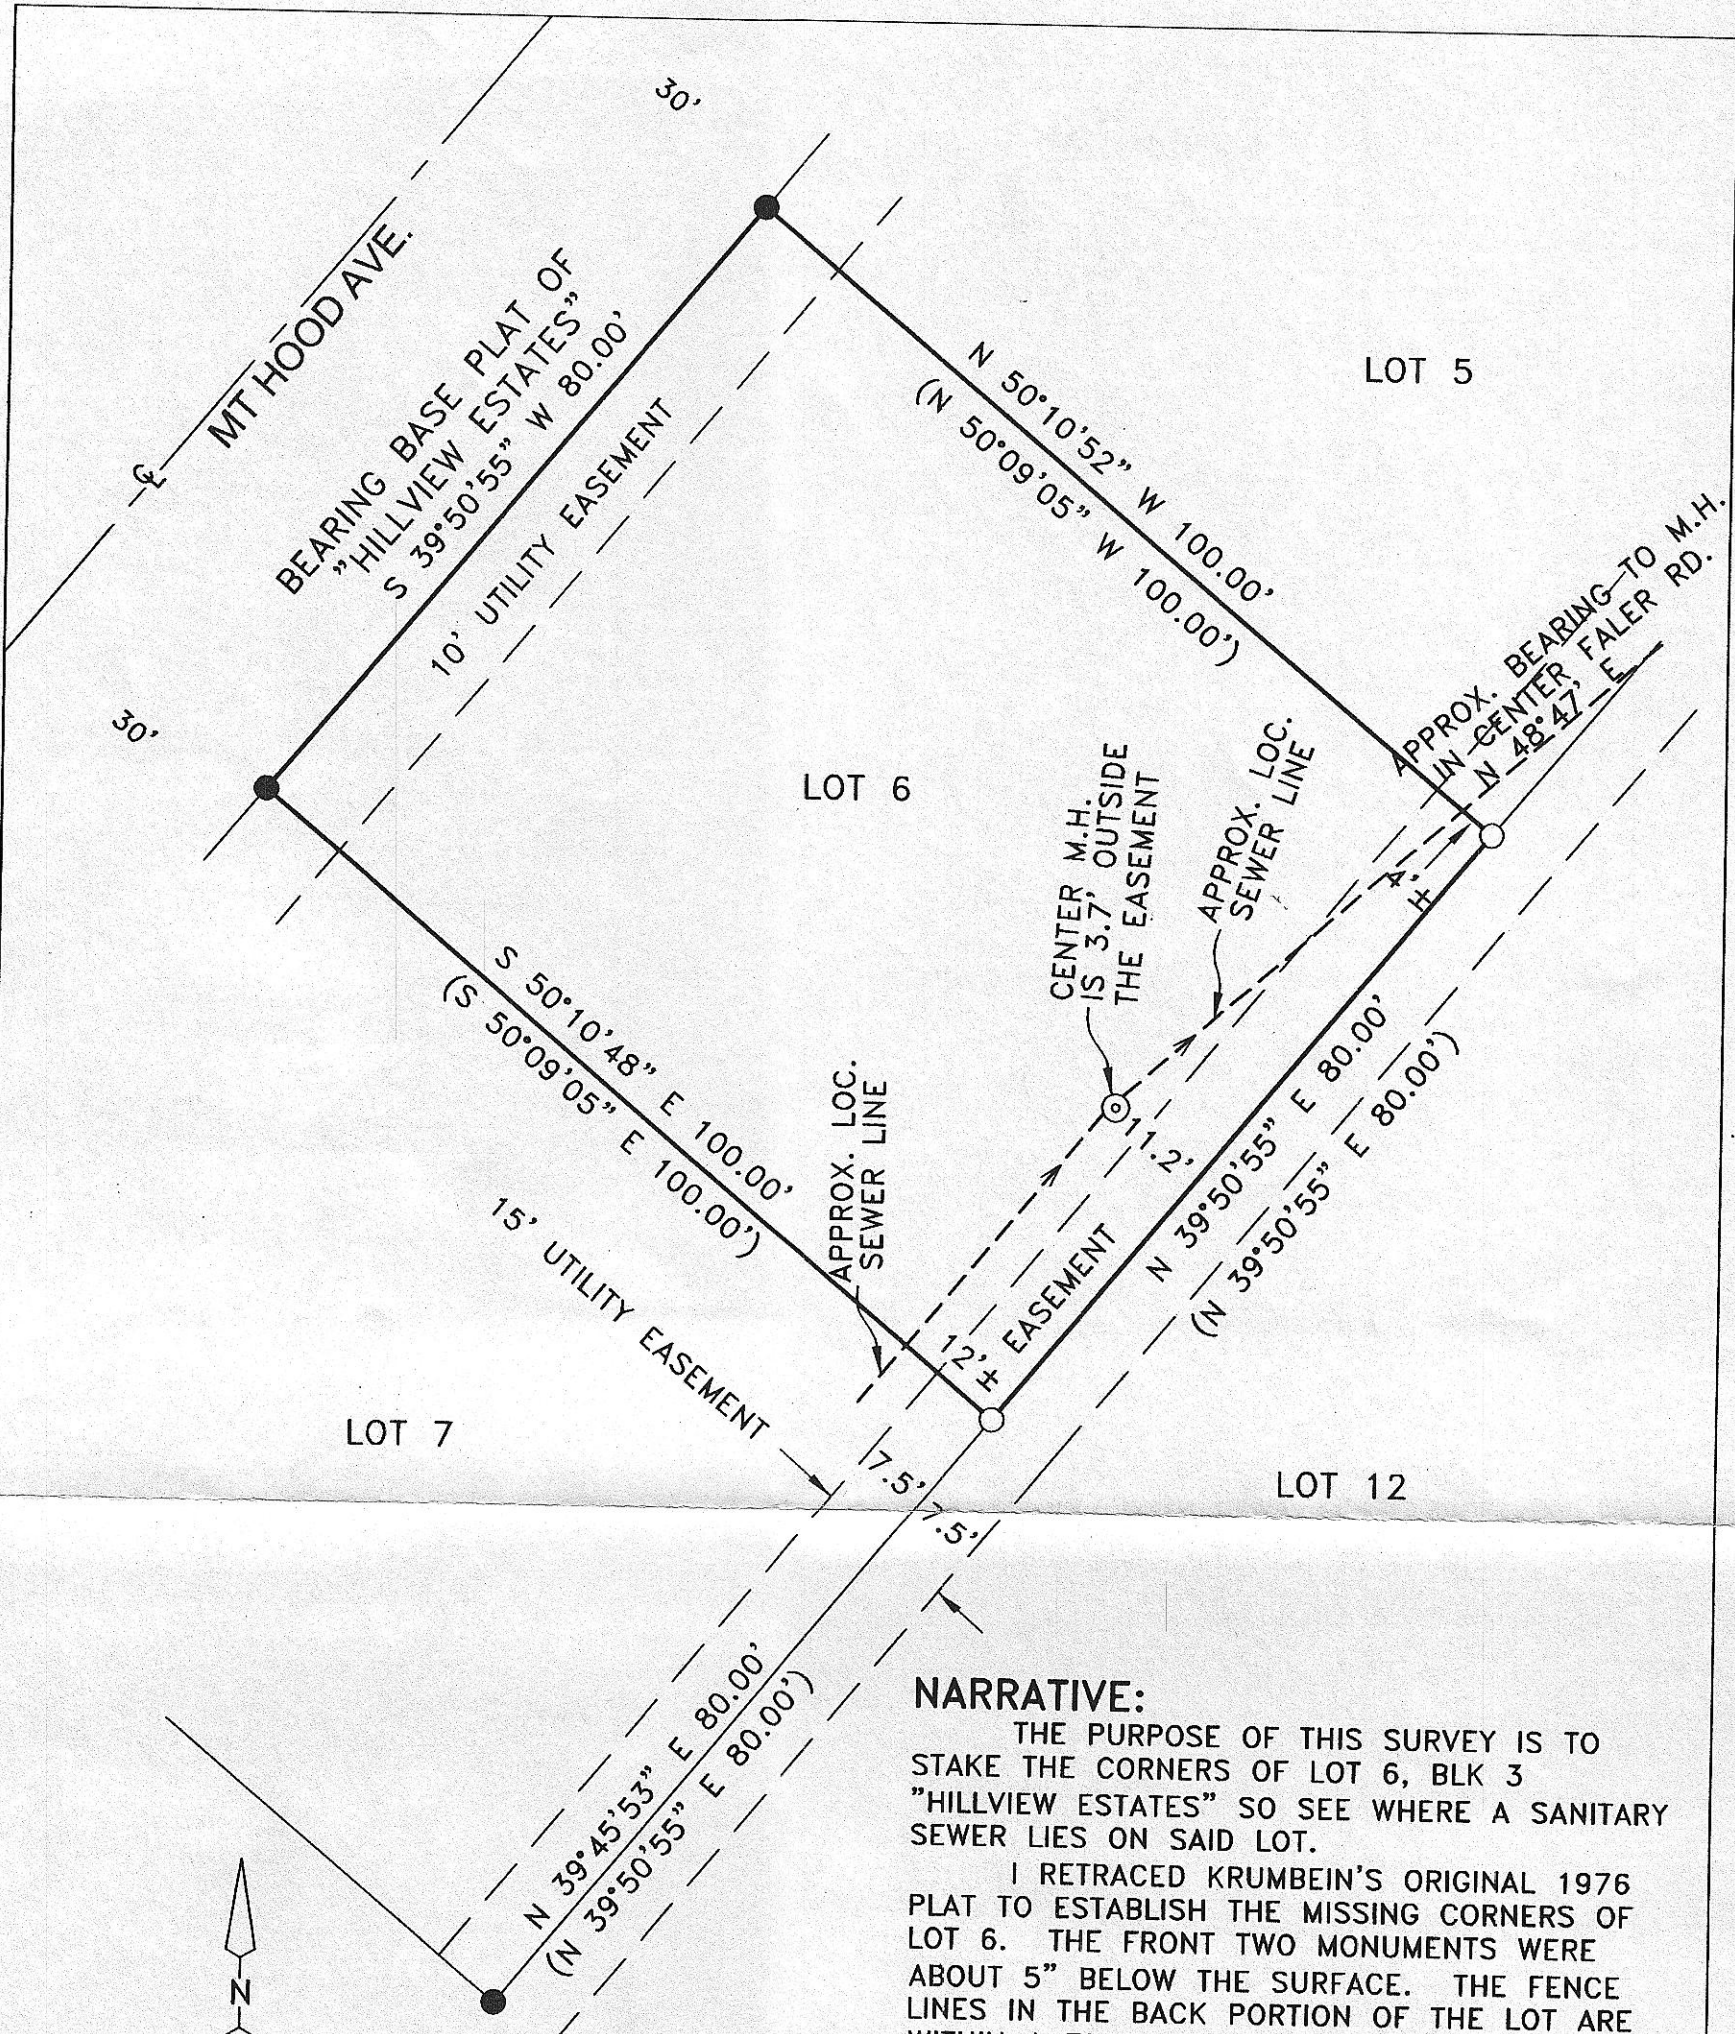
I RETRACED KRUMBEIN'S ORIGINAL 1976 PLAT TO ESTABLISH THE MISSING CORNERS OF LOT 6. THE FRONT TWO MONUMENTS WERE ABOUT 5" BELOW THE SURFACE. THE FENCE LINES IN THE BACK PORTION OF THE LOT ARE WITHIN A FOOT OF THE PROPERTY LINE.

I FOUND THAT THE CENTER OF THE SANITARY SEWER MAN HOLE LIES 3.7 FEET OUTSIDE OF THE UTILITY EASEMENT IN THE BACK OF THE LOT. THE SEWER LINES ARE ESTIMATED. I COULD FIND NO MAN HOLE WEST OF THIS LOT. THE MAN HOLE EAST IS IN THE CENTER OF FALER ROAD AND THE SEWER LINE RUNS APPROXIMATELY AS SHOWN.
